Investigation of the structural changes in LDPE and XLPE induced by high electrical stress.

Investigation of the Structural Changes in LDPE and XLPE Induced by High Electrical Stress

Paul William Charles Sayers

Thesis submitted to the University of Wales in
candidature for the degree of Doctor of Philosophy
September 2001

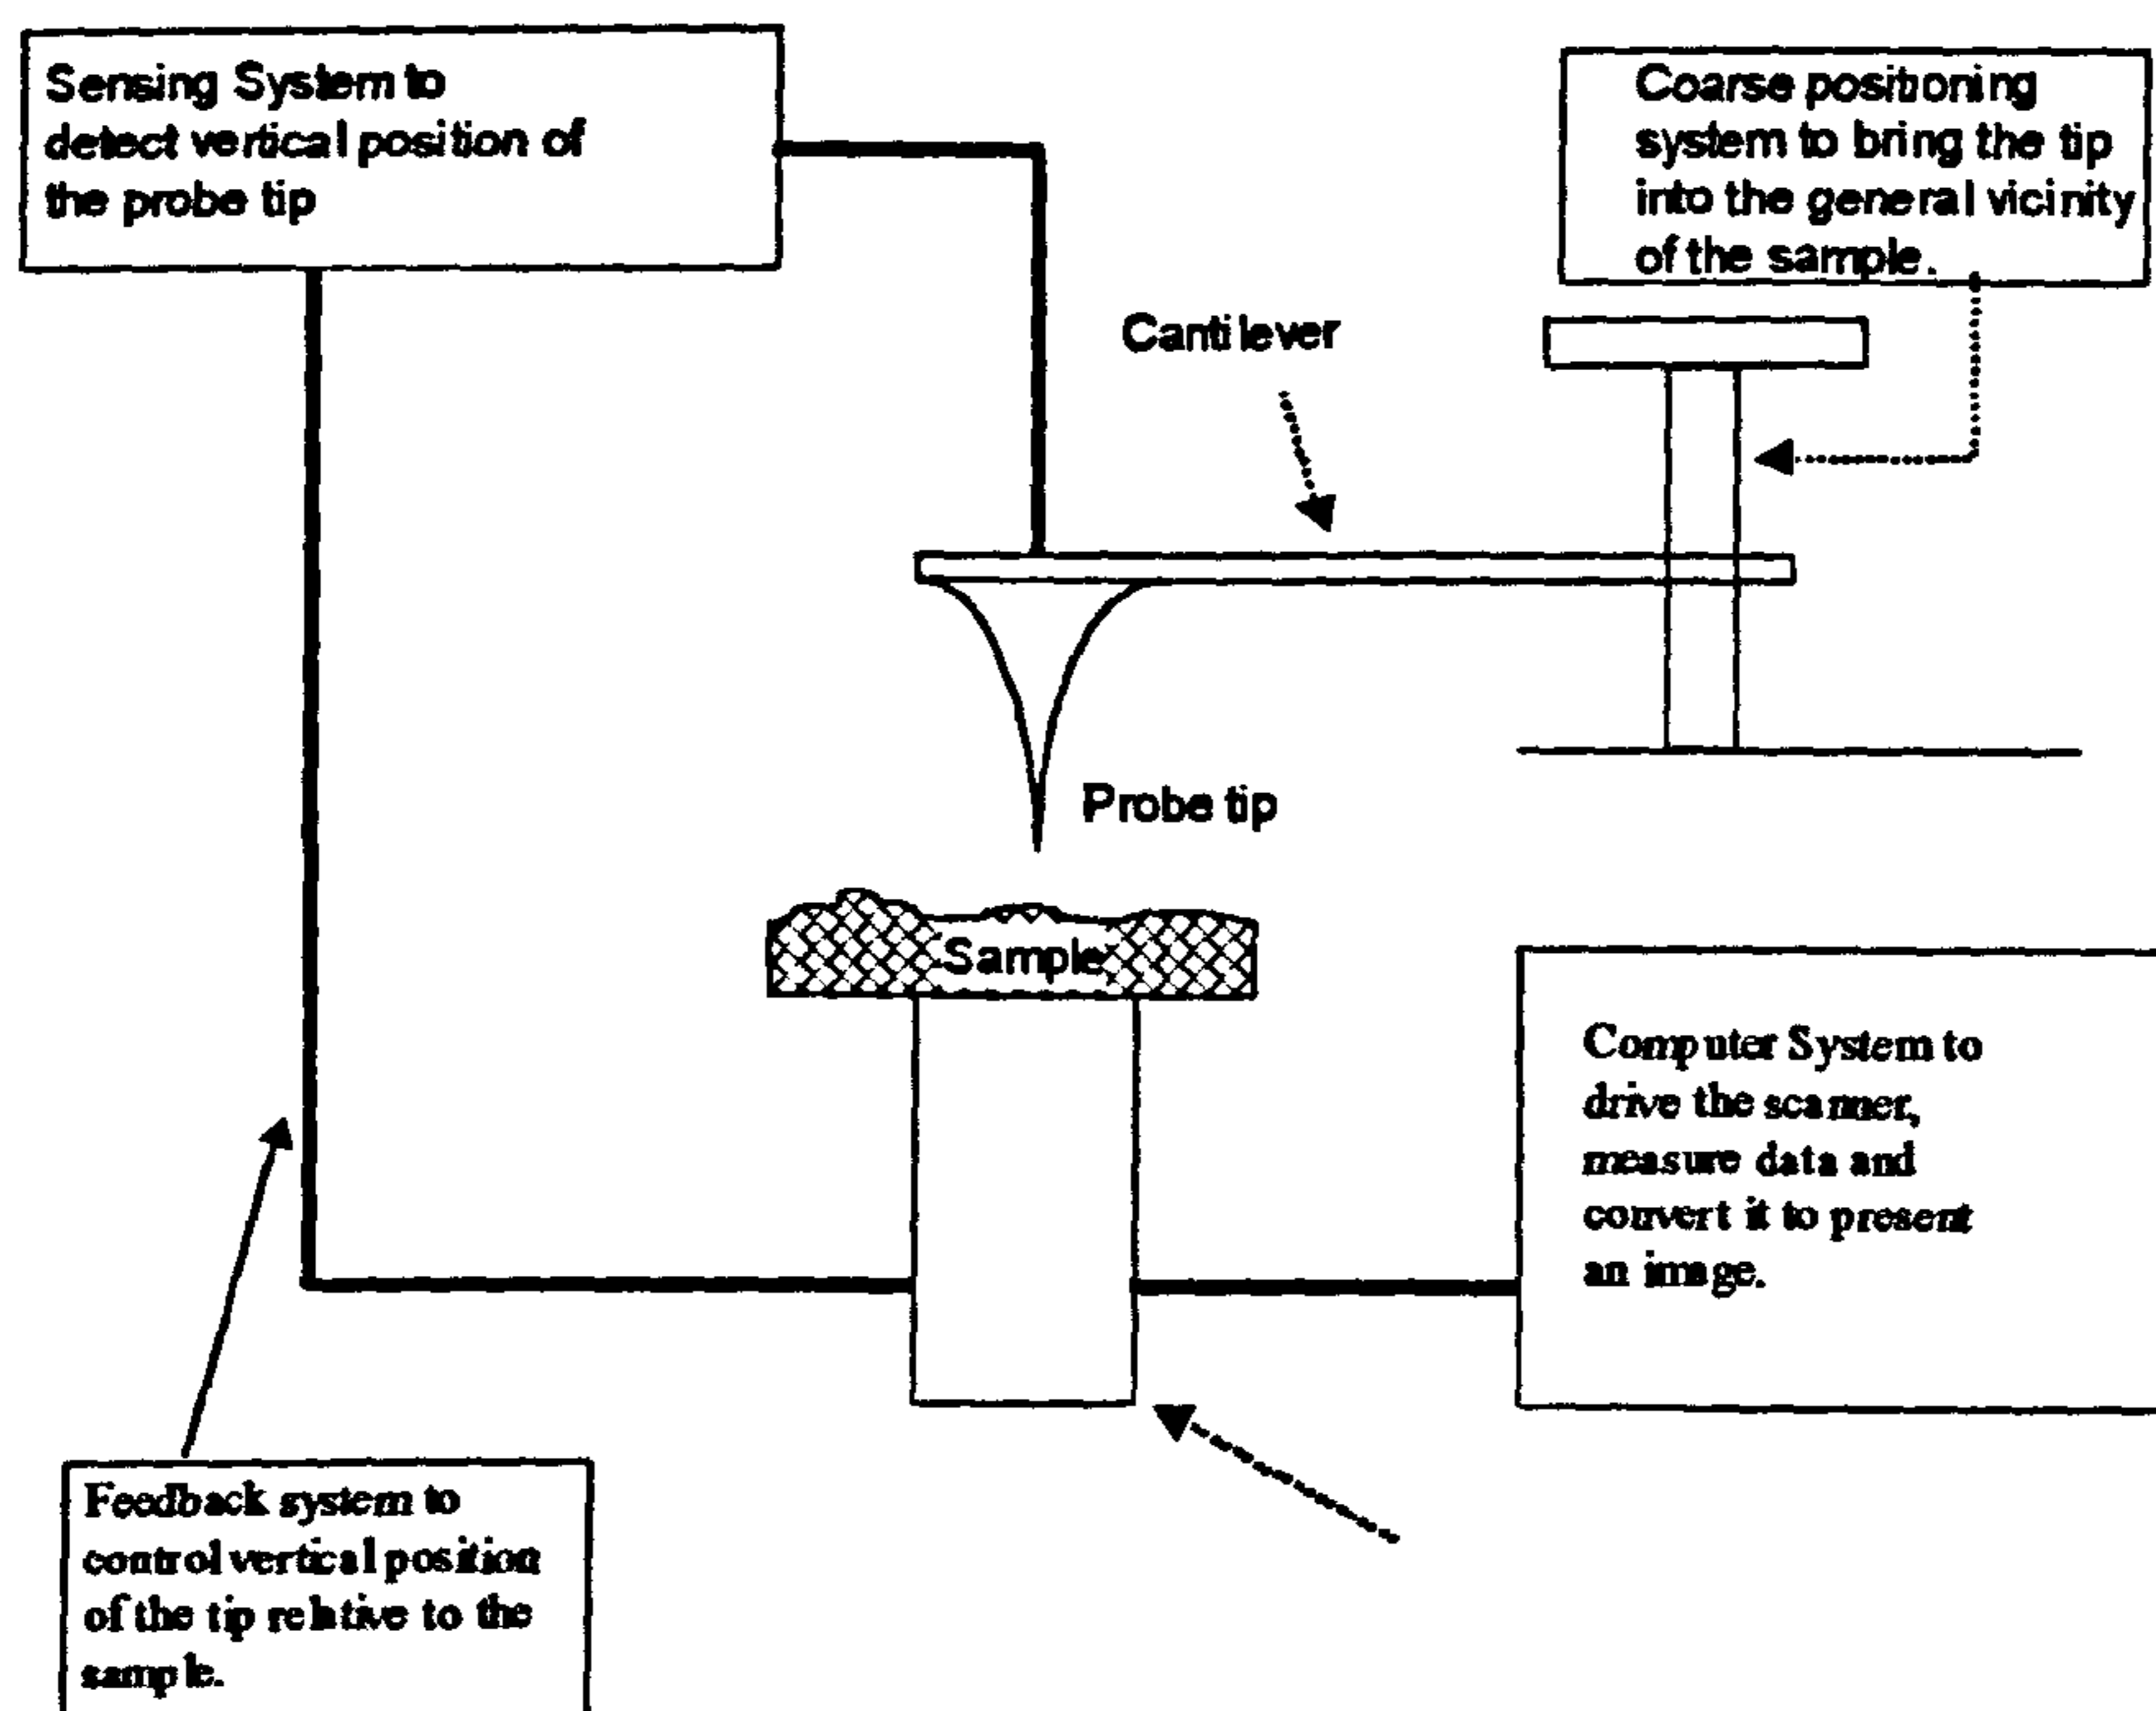
Figure 4.05 Generalised schematic of an SPM showing the principal components – individual elements are necessarily not to scale.

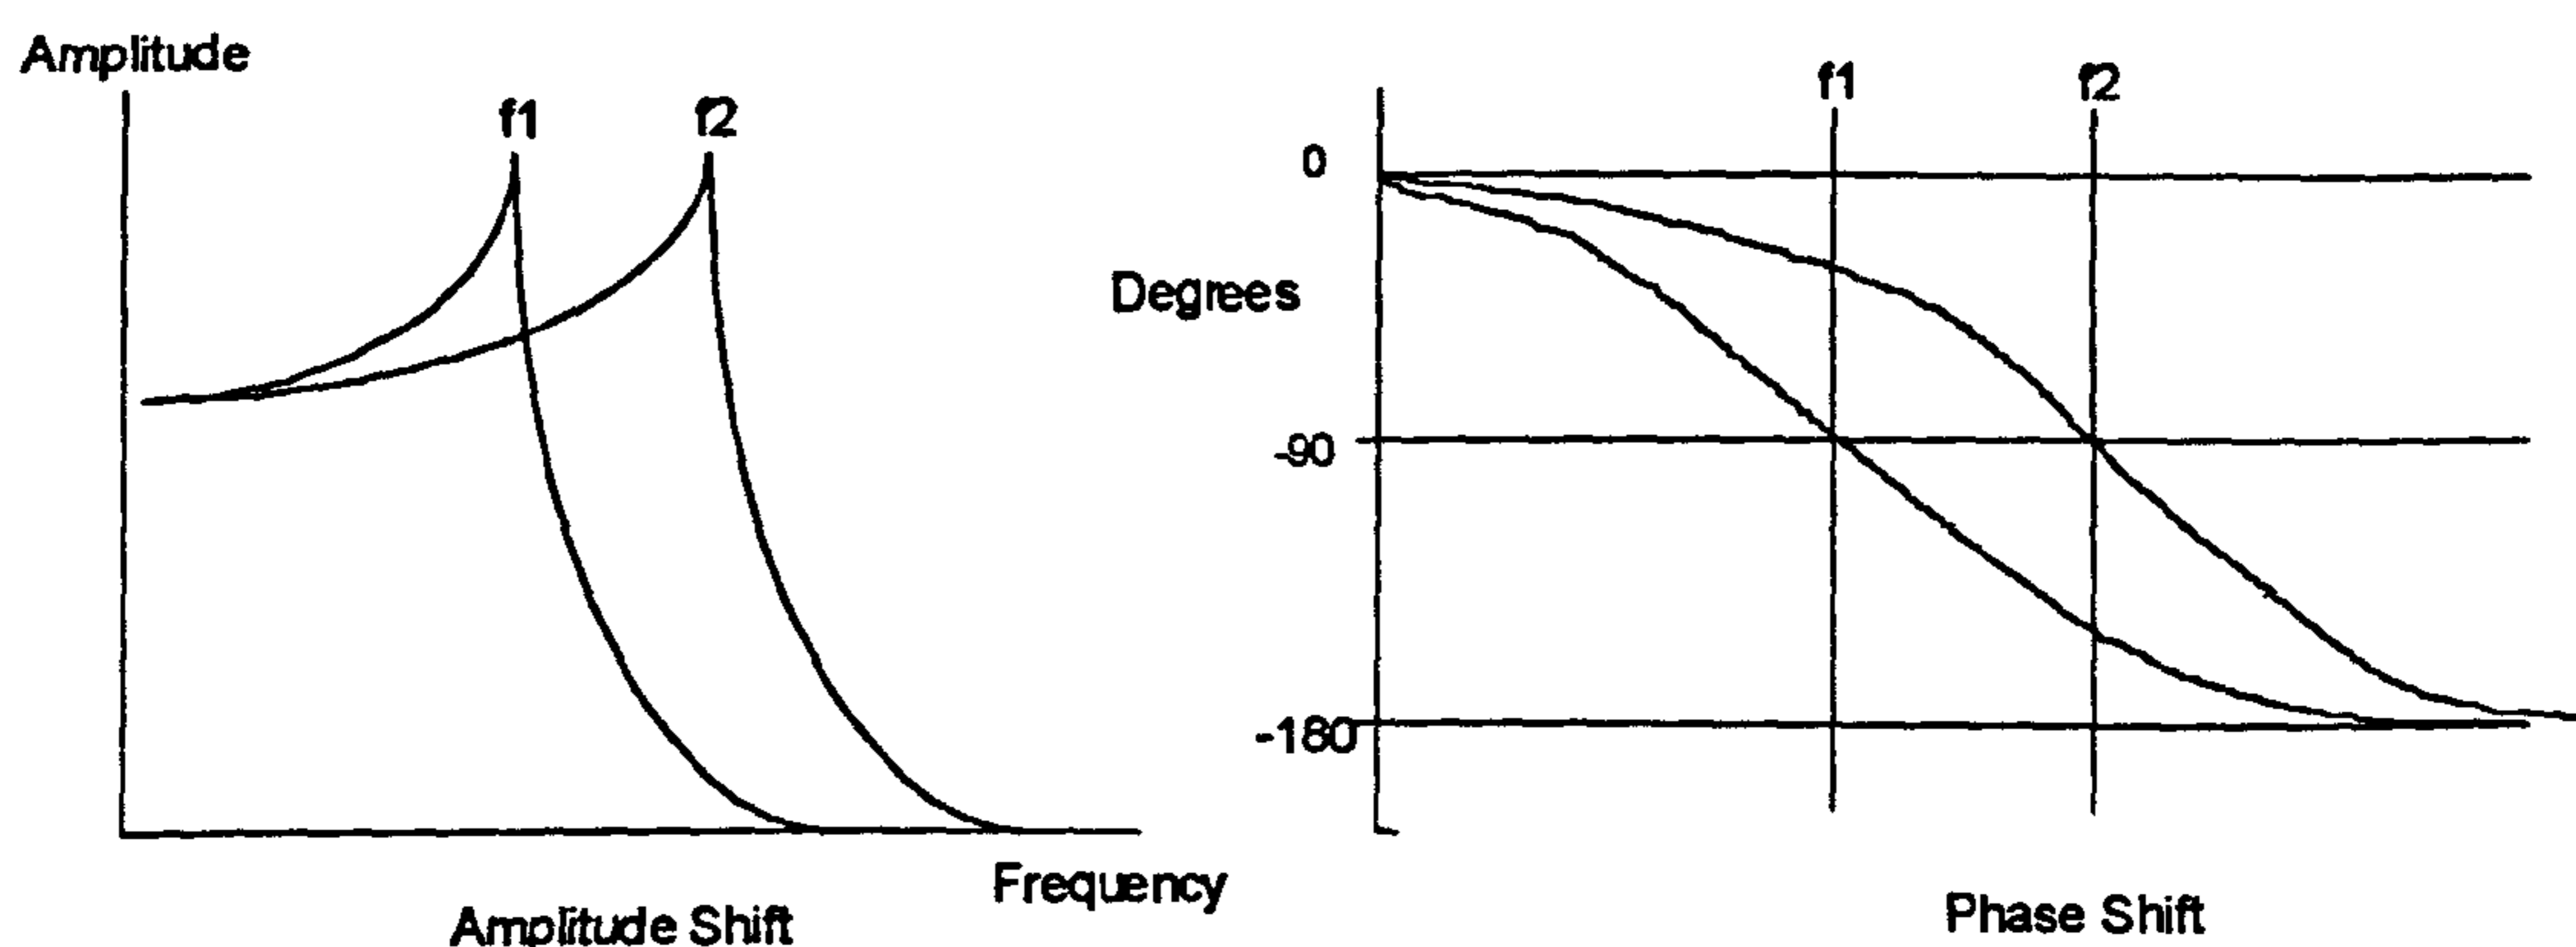
Figure 4.09 Sketch showing frequency dependence. Frequency f_1 is for a tip far from the sample and f_2 is for the tip and sample close together.

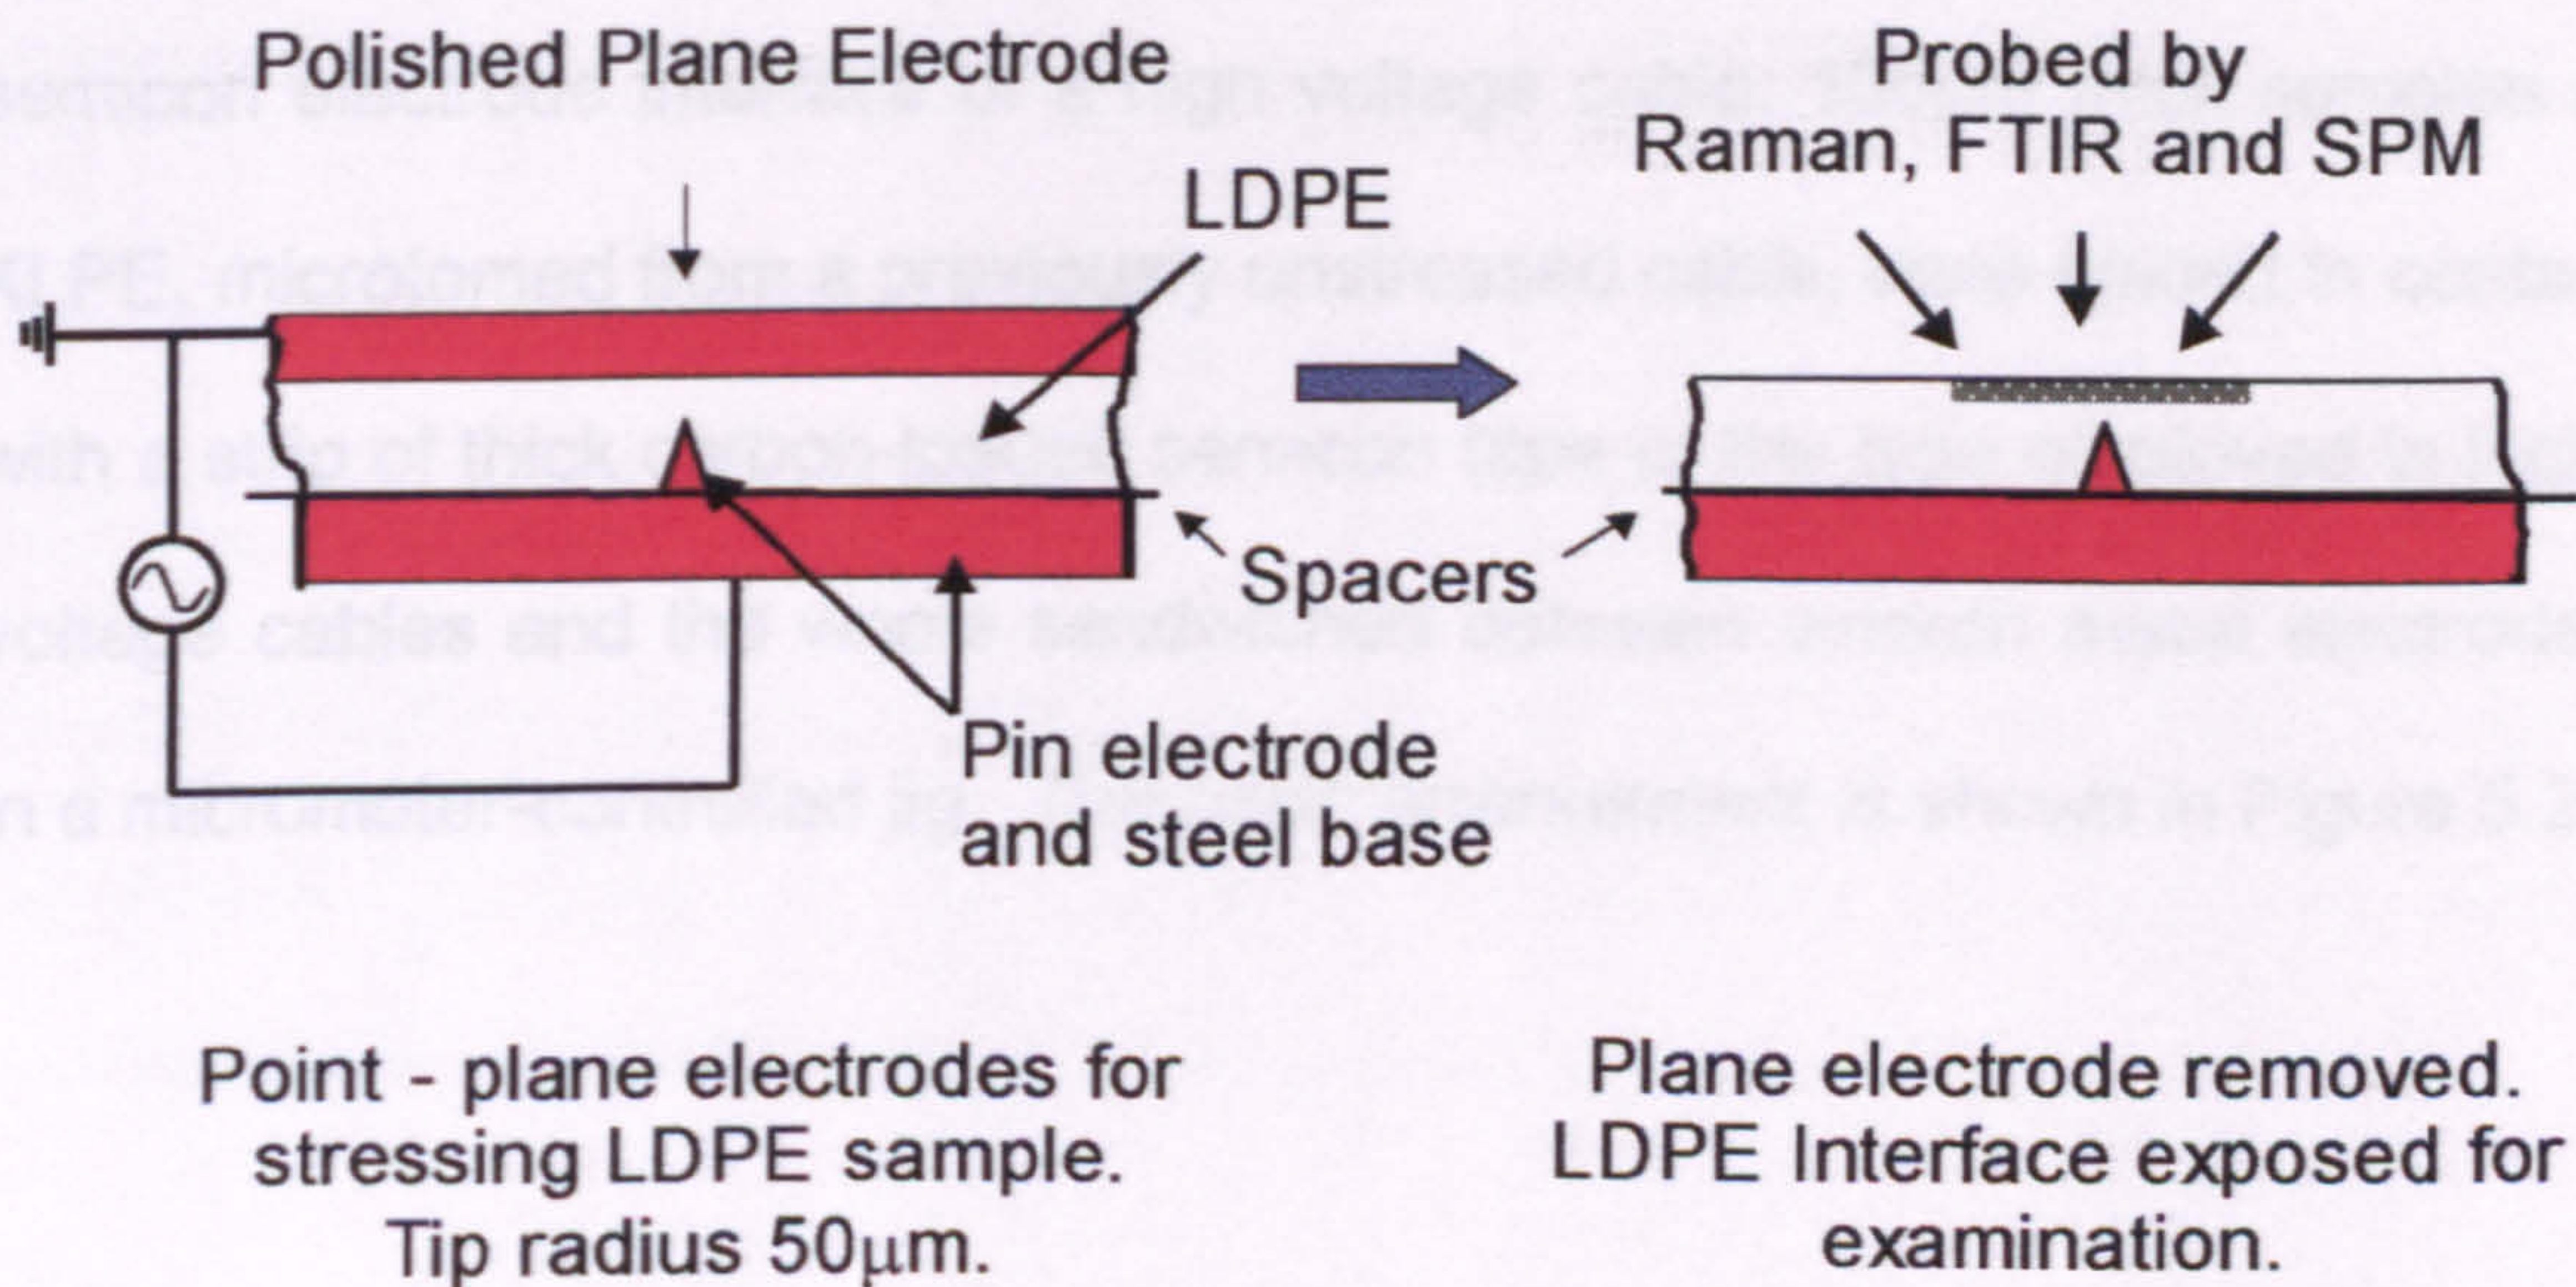
Figure 5.1 Point plane electrode arrangement showing removable plane electrode, sample, spacers, steel point electrode and steel base. The grey region defines the area examined.

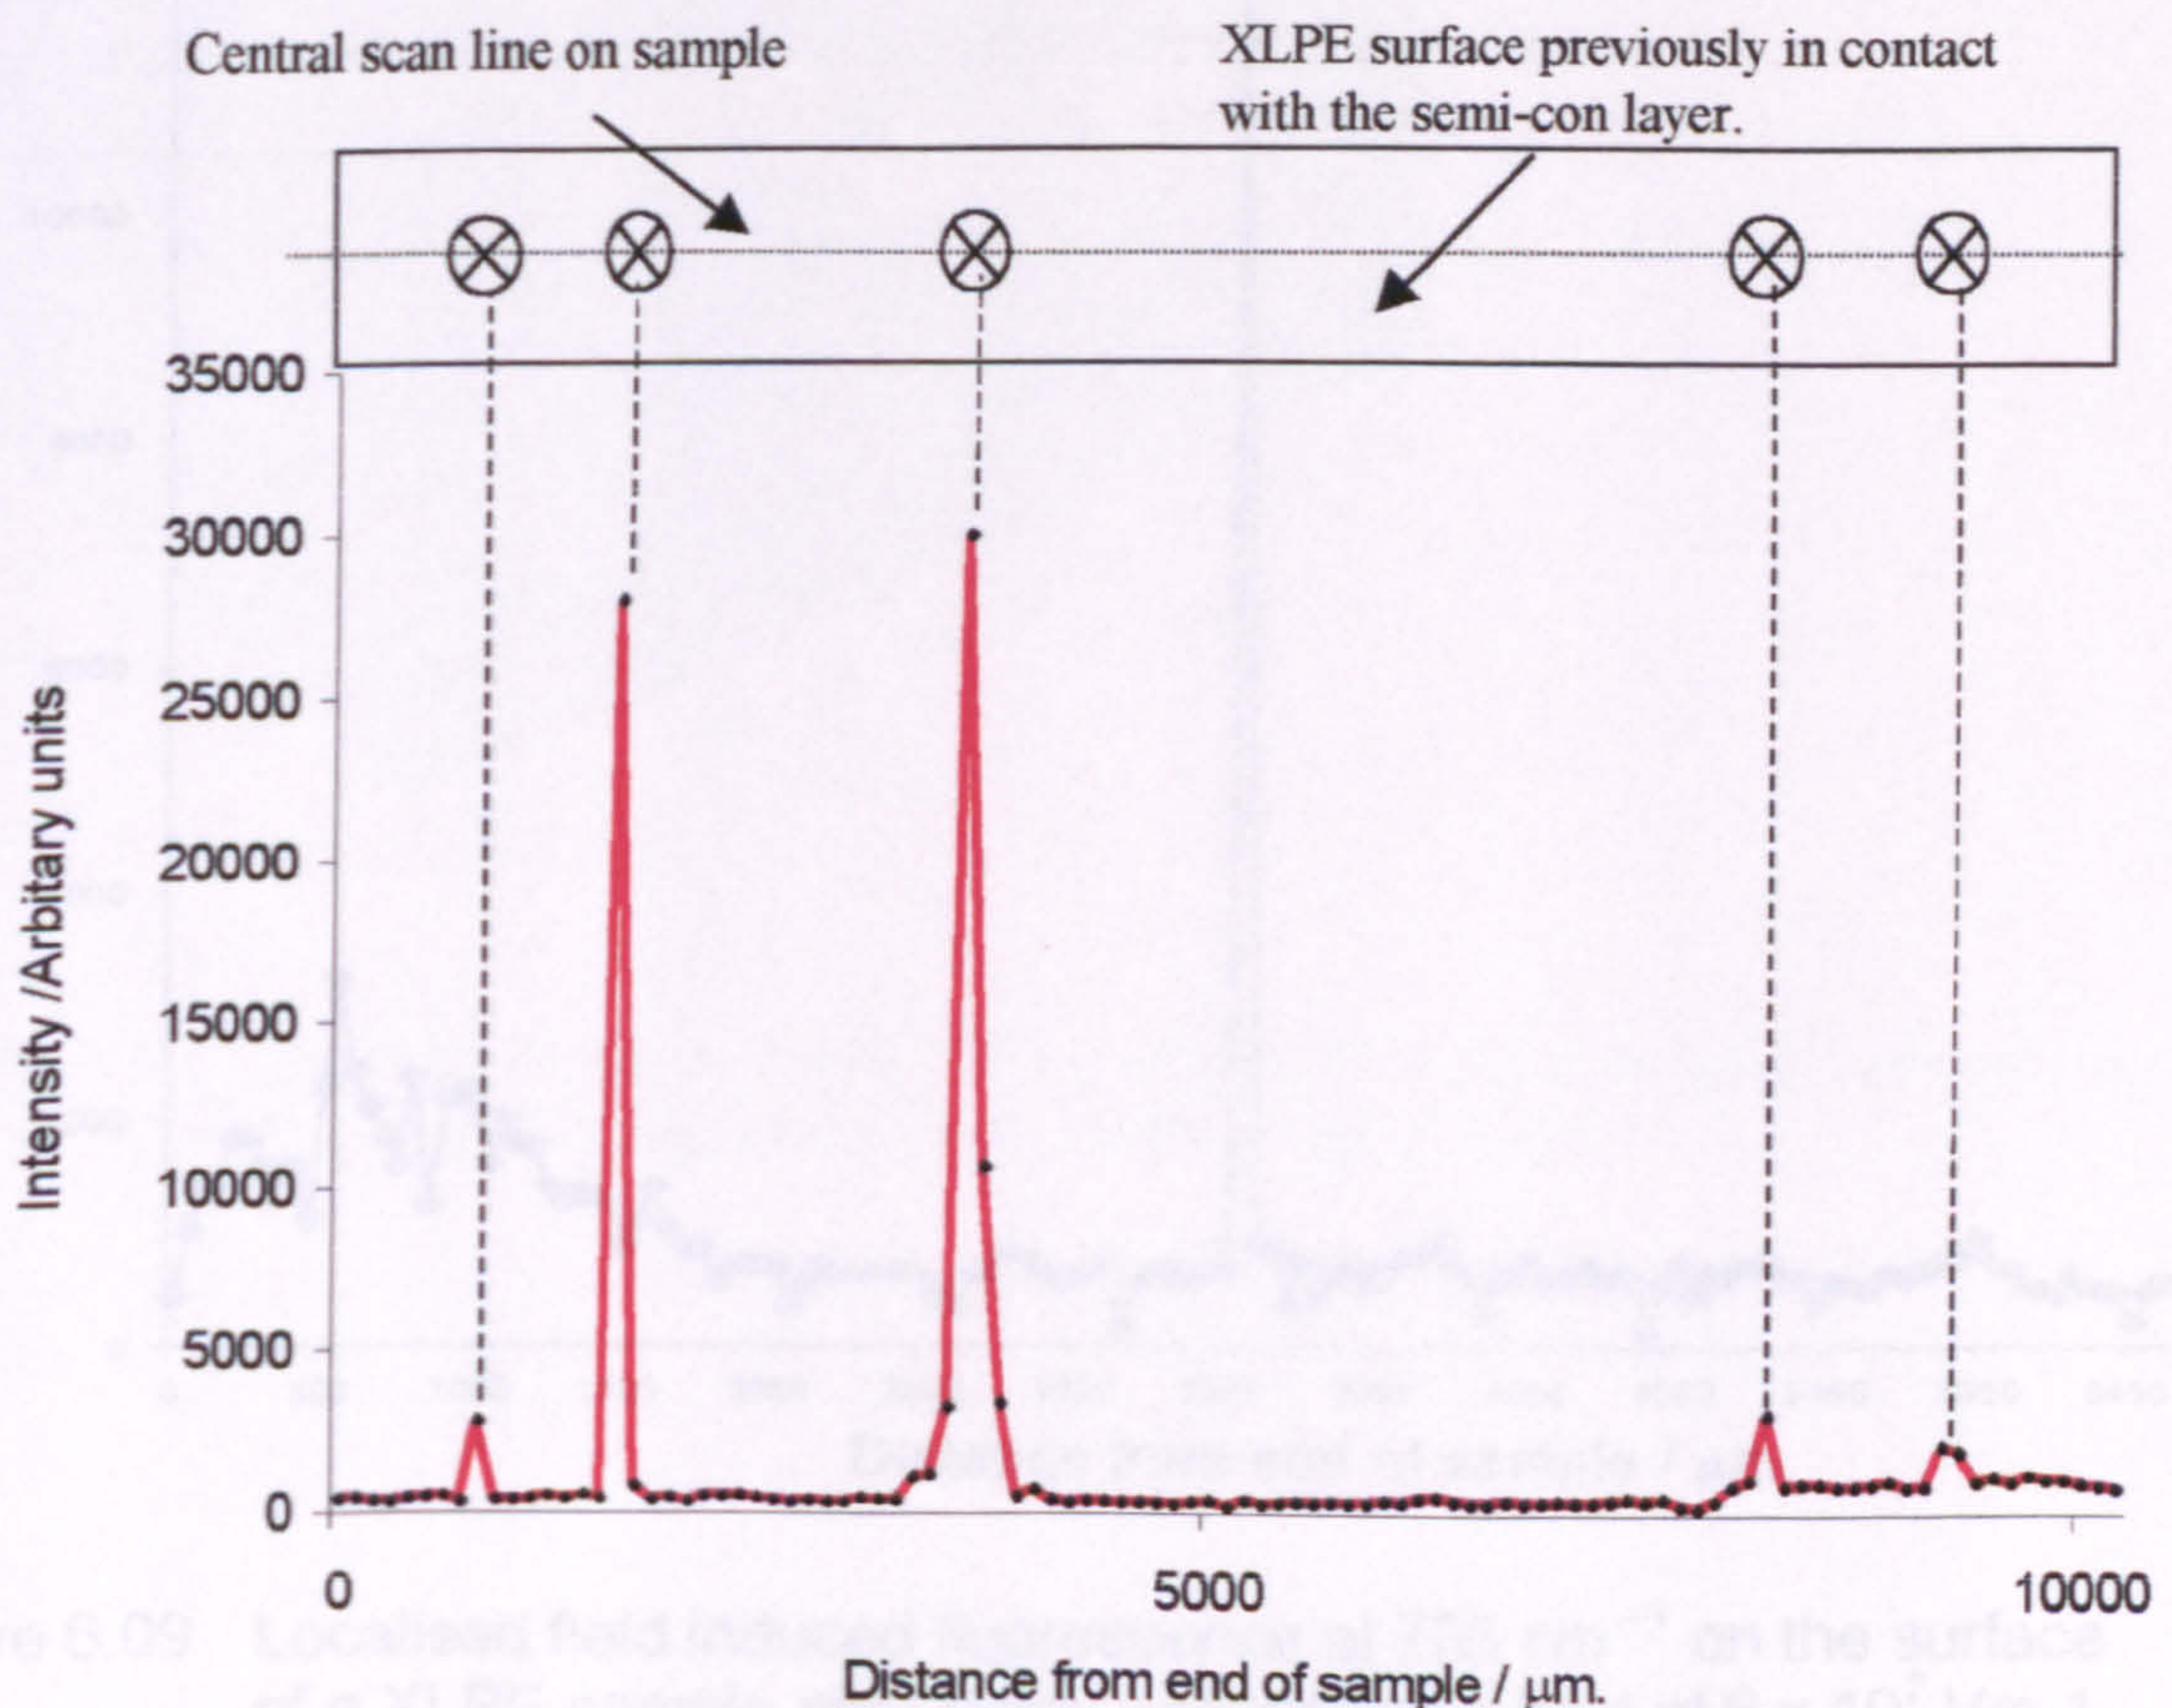
Figure 6.08 Field induced fluorescence at a Raman shift of 767 cm^{-1} on the surface of a XLPE sample exposed to a field of $6 \times 10^7\text{ Vm}^{-1}$ in contact with a semicon electrode for a time of 6 hours.

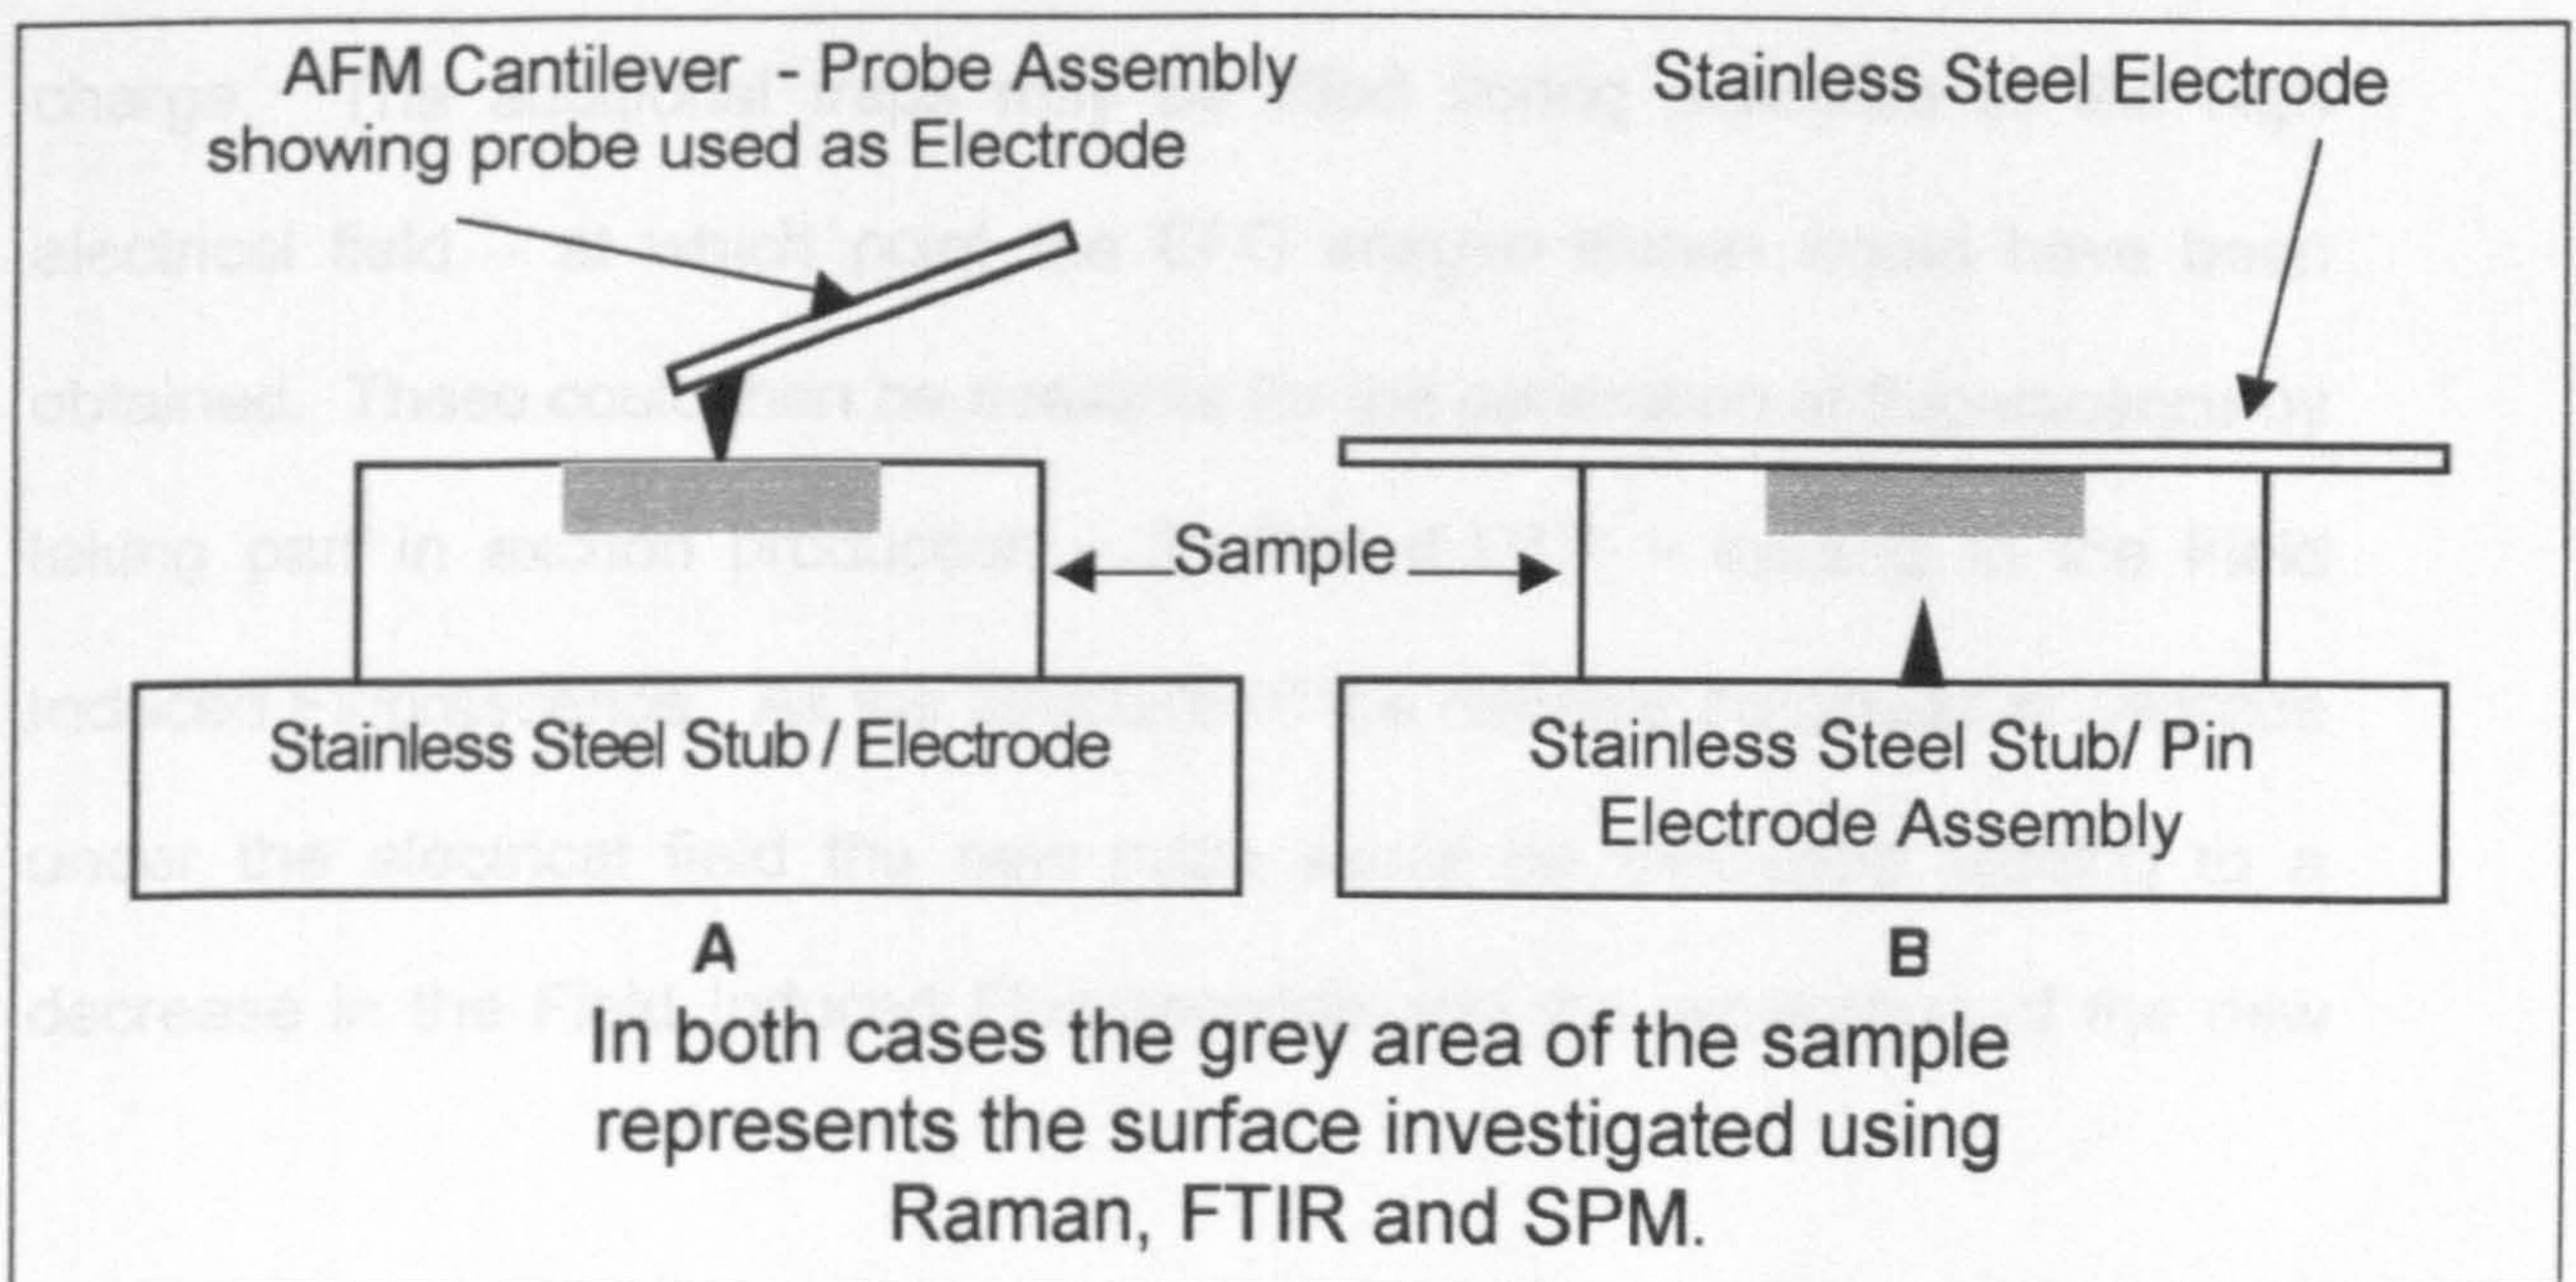
Figure 7.07 Outline sketch comparing the two sample arrangements.
