A study of the archaeological remains of vernacular boat finds from North Wales in the care of University of Wales Bangor.

**A study of the archaeological remains of vernacular boat finds
from North Wales in the care of University of Wales Bangor.**

**In fulfilment of the requirements of the Degree of Doctor of
Philosophy in the University of Wales.**

**School of History and Welsh History,
University of Wales Bangor.**

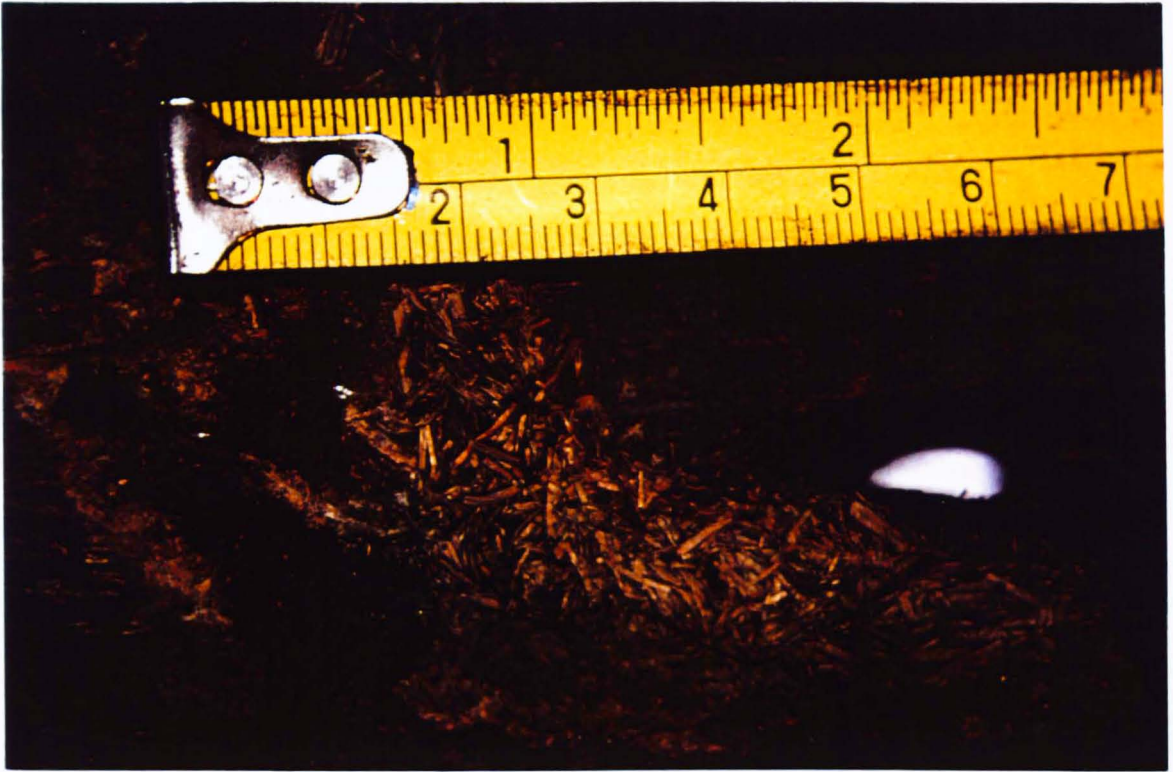
Fig. 3.52- Sample of luting from lands.
