A study of the archaeological remains of vernacular boat finds from North Wales in the care of University of Wales Bangor.

McElvogue, Douglas Murdo

Award date:
2002

**In fulfilment of the requirements of the Degree of Doctor of
Philosophy in the University of Wales.**

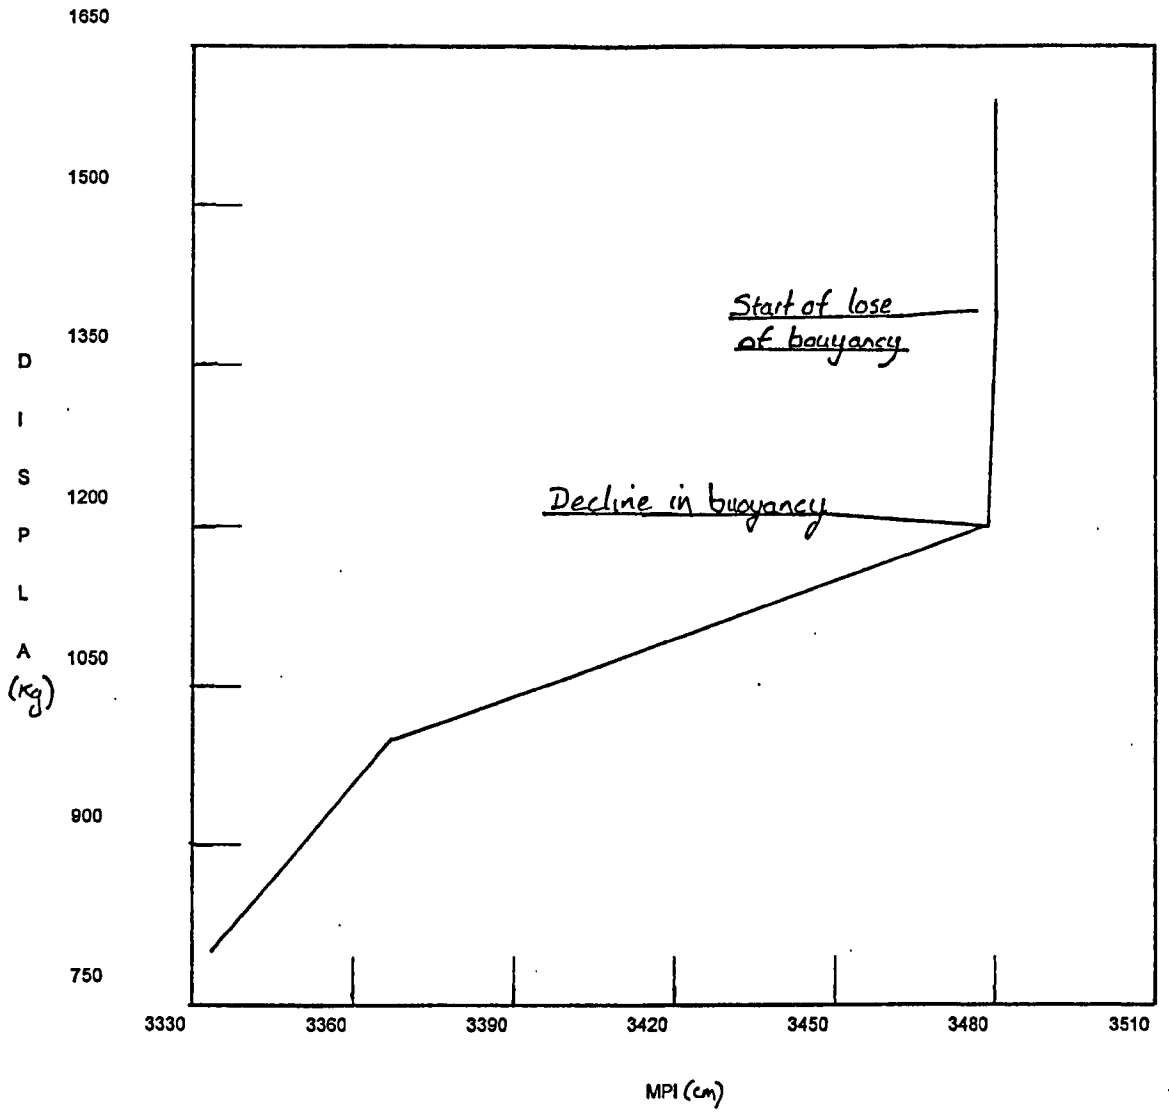
Appendix 2a.4- Draft/Displacement curve.

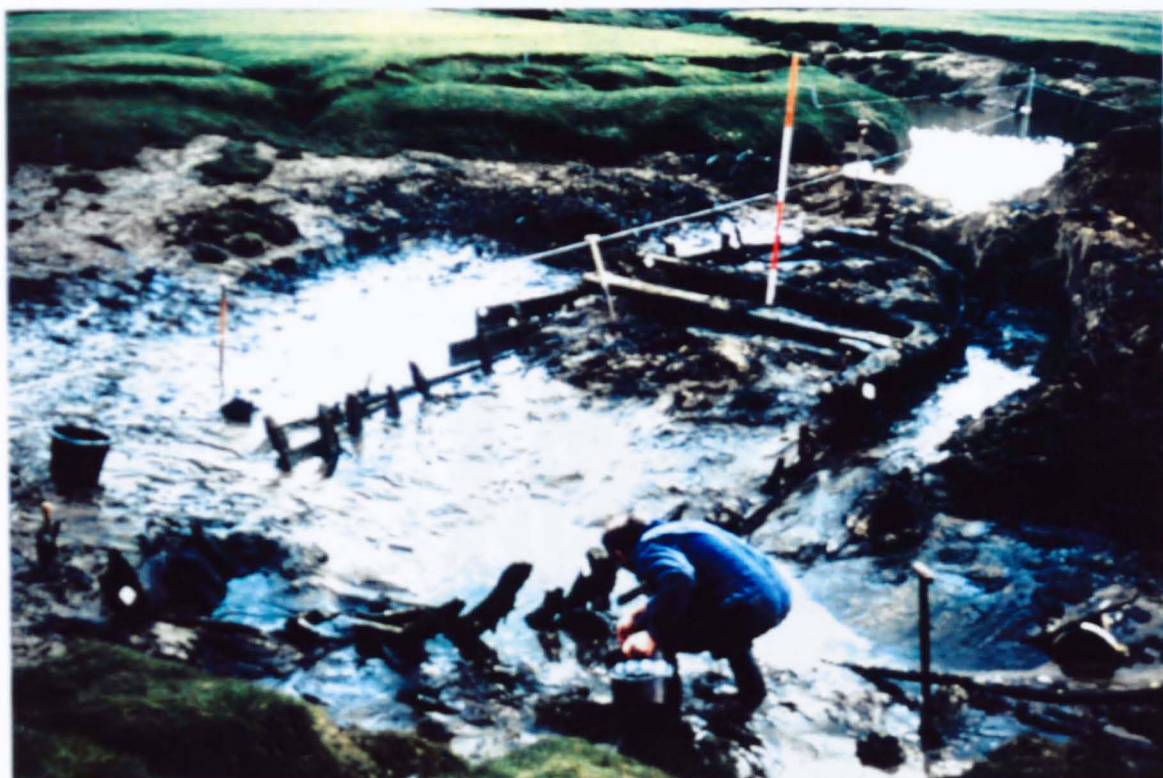
Fig. 5.25a- Excavated boat showing extent of surviving planking.
