A study of the archaeological remains of vernacular boat finds from North Wales in the care of University of Wales Bangor.

**A study of the archaeological remains of vernacular boat finds
from North Wales in the care of University of Wales Bangor.**

**School of History and Welsh History,
University of Wales Bangor.**

2000

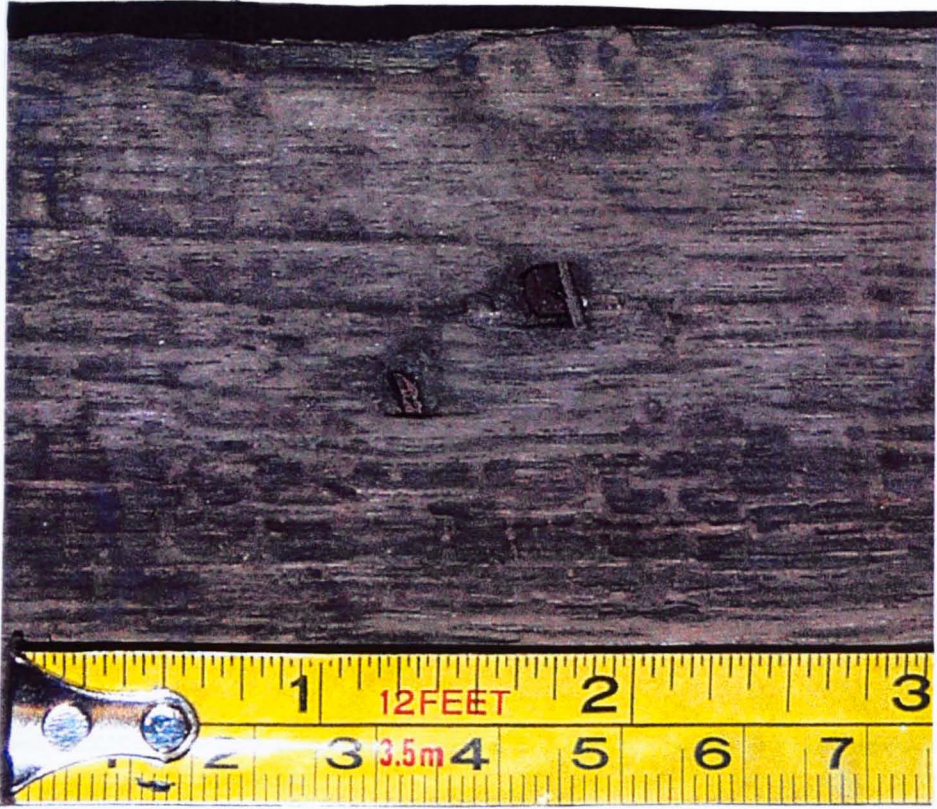
Fig.1.7a- Logboat clenched wrought iron nails.

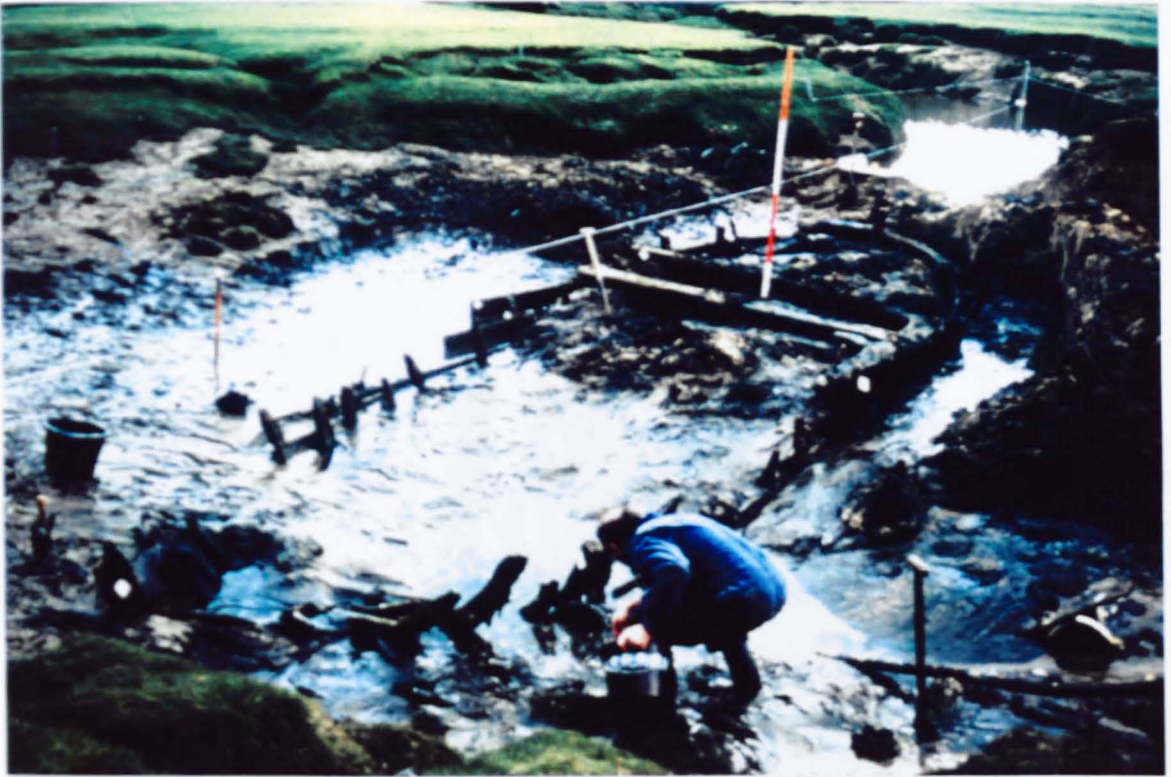
Fig. 5.25a- Excavated boat showing extent of surviving planking.
