A study of the archaeological remains of vernacular boat finds from North Wales in the care of University of Wales Bangor.

McElvogue, Douglas Murdo

Award date:
2002

**In fulfilment of the requirements of the Degree of Doctor of
Philosophy in the University of Wales.**

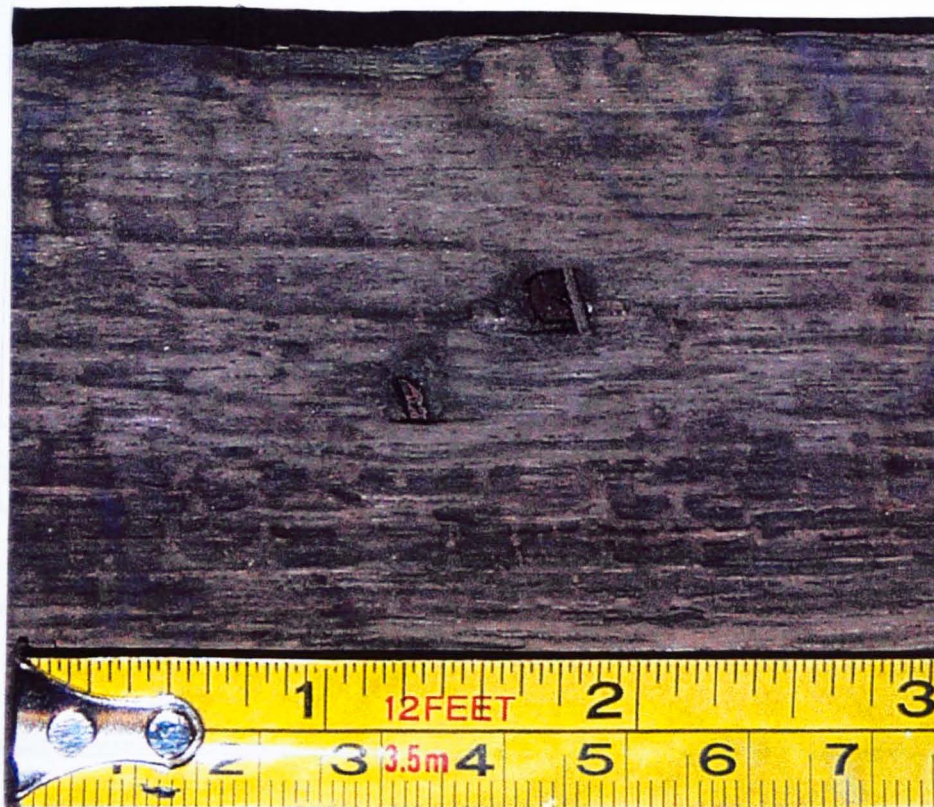
Fig.1.7a- Logboat clenched wrought iron nails.
