**Richard Pennant, Samuel Worthington and the mill at Penlan
a history of the Penrhyn Mills on the Lower Ogwen**

Richard Pennant, Samuel Worthington, and the Mill at Penlan

A History of the Penrhyn Mills on the Lower Ogwen

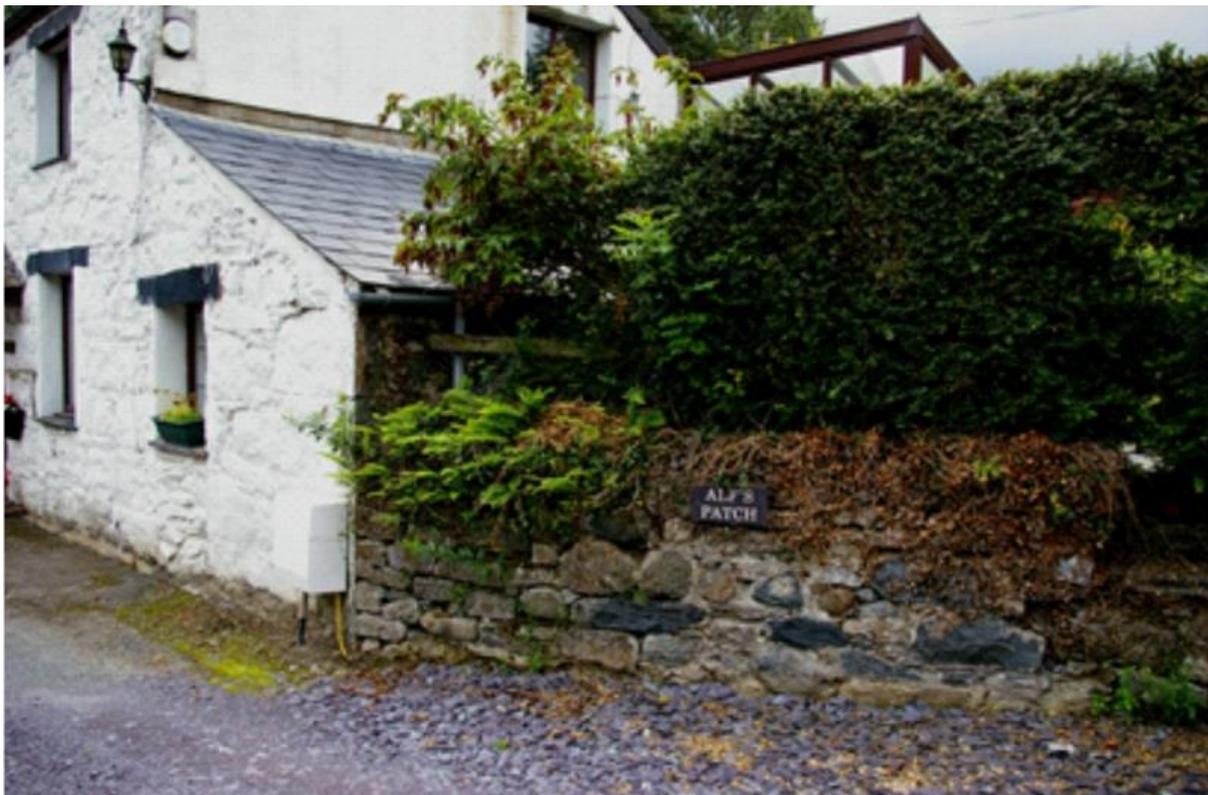
Fig.3.1.1: Penlan Mill Cottage with plaque (2010)

Penlan Mill Cottage is on the right-hand side of the driveway, and adjacent are three stone-built sheds. On the garden wall of the cottage there is a slate plaque bearing the legend 'Alf's Patch' (Fig.3.1.1).¹⁵² The open area in front of the sheds was known as the Upper Yard (not to be confused with the Timber Yard which also was often referred to by the same name), and it is here that in 1885 Lewis & Son built an extension to the mill (see Section 3.1.5). Originally the yard had a cobbled surface, although following work carried out by the water authority there is no evidence of this today (Fig.3.1.2). Adjacent to the sheds, at the east end, there is a gate leading into a grassed area that is part of the private garden belonging to the cottage. Until the 1980s a two-roomed 'privy' or 'Ty Bach' stood in the corner of the garden, although it has since been demolished (Fig.3.1.3).¹⁵³

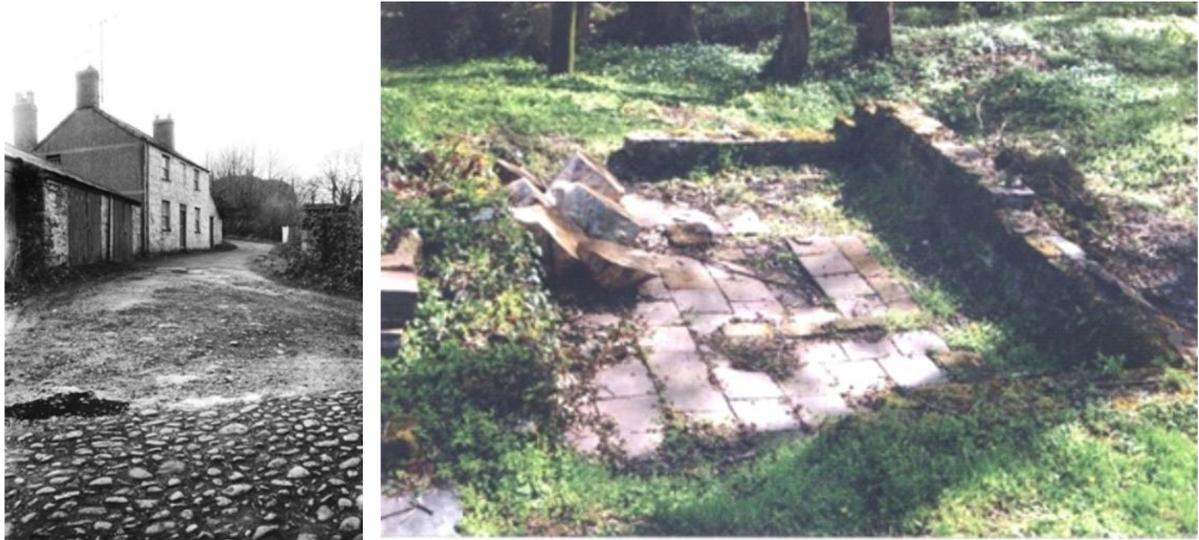
Fig.3.1.2 (left): Penlan Mill Cottage and cobbled yard.¹⁵⁹ (1980)

Fig.3.1.3 (right): Remains of the 'Ty Bach' at Penlan Mill Cottage. (2006)

In 1974 the water authority installed a sewage disposal system for the Llandegai area that involved laying pipes beneath the upper yard, passing in front of the cottage and sheds. During the course of this work virtually all of what hitherto had been a cobbled surface was either covered or removed (Fig.3.1.2).

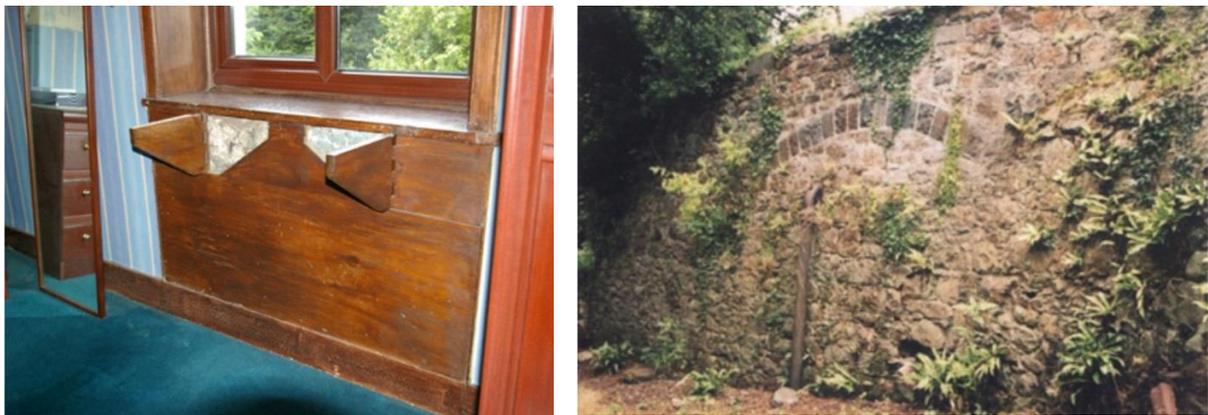
Fig.3.1.4 (left): Writing table support arms. It is believed that this is an original feature dating from the 19th century.¹⁶⁰ (2010)

Fig.3.1.5 (right): The water pipe to Trefelin and stone arch inset into wall. (2004)

although one interesting feature has been retained, namely the support arms of a wall-mounted writing table, that is situated beneath the western-most bedroom window (Fig.3.1.4). It is not known whether this was positioned there simply to benefit from the light, or whether to provide a view into any of the carts or wagons that either passed beneath the window or were in the railway siding. If this was the case, it would have provided an ideal vantage point for a tallyman to observe traffic passing to and from the mill.

The wall at this point contains what appears to be a large stone arch, now filled in. Whether the arch was incorporated as a means of strengthening the wall or whether it provided access to an inner chamber is not known. However, from its position on the slope it is thought unlikely that it is the latter, rather that it was inserted to strengthen what is a high, load-bearing, wall. Just before the arch, to the west side, there is a broken section of pipe protruding from the wall, with what remains of the bottom coupling directly beneath, buried in the ground. There is nothing to indicate the purpose of this second pipe.

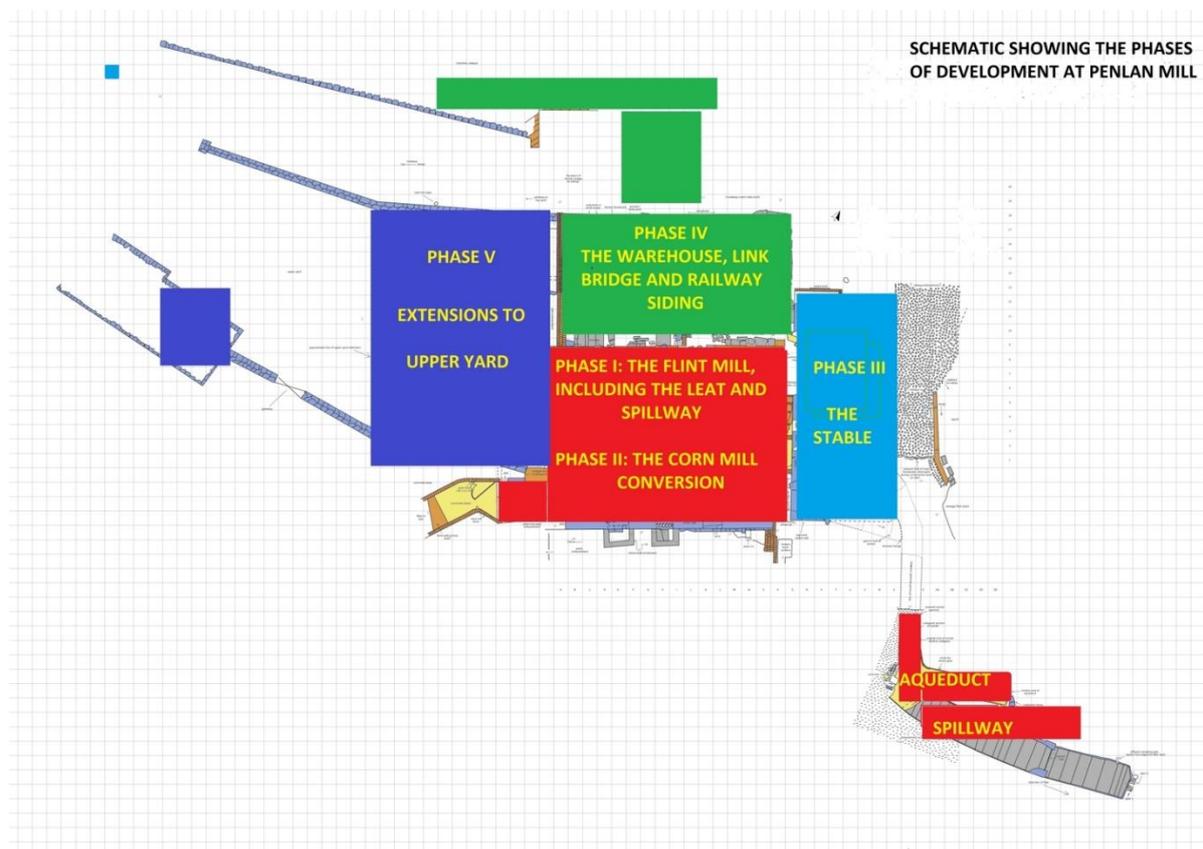
Fig.3.2.1: The phases of development at Penlan Mill

The construction phases are represented by the following schematic, which is not to scale, and the detailed description of the site follows these phases.

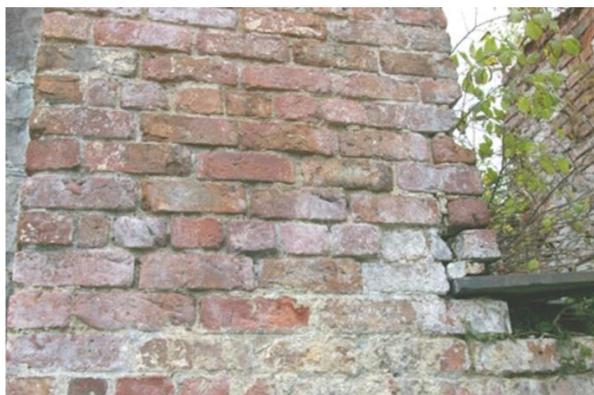
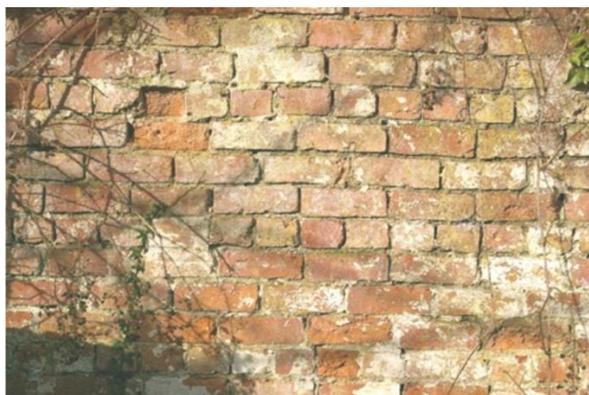
Fig.3.3.1 (left): The darker brick of the original walls from c.1798, as represented in the east (end) wall of the water wheel pit. (2011)

Fig.3.3.2 (right): The slightly lighter brick from Phase 4, the 1852 support wall for the bridge connecting the warehouse extension and railway siding. (2015)

The north, east and south walls of the flint mill are constructed in this way, the only variation being the west (embankment) wall. The style of brickwork is the same throughout the rest of the site, including the warehouse extension and the support wall for the bridge that connected it to the railway siding.¹⁶¹ Where the later brickwork does differ, for example in the warehouse extension, is that whereas the main fabric of the building is constructed using red brick, the newer work is formed from bricks of a somewhat lighter colour (Figs.3.3.1 & 3.3.2).

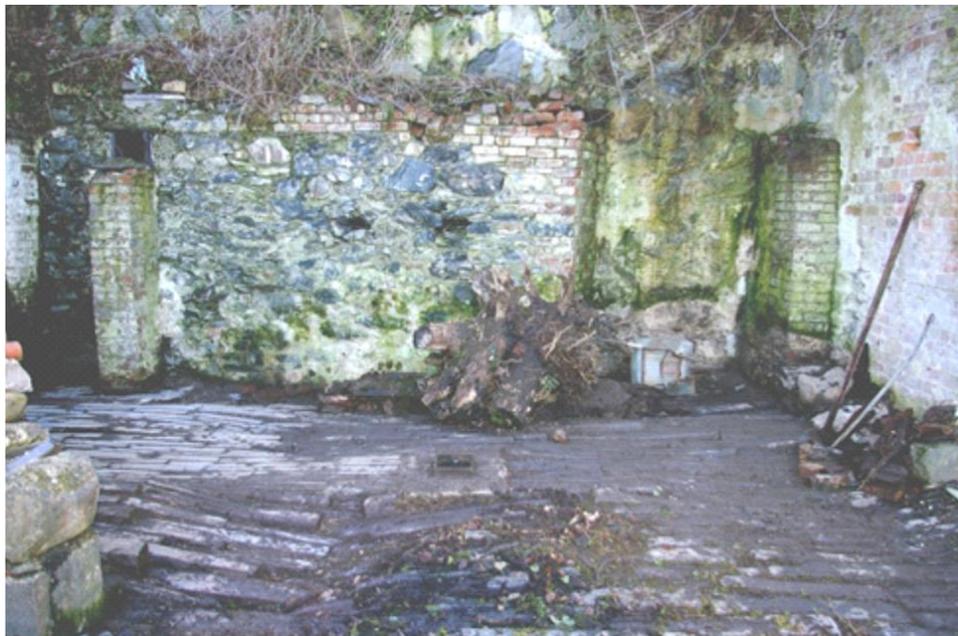
Fig.3.3.3: The west wall of the flint mill (A1-8). The revetment is to the centre in A1-6, with A7 stepped back to the right. The brick column in A8 is shown to the right-hand side, abutting the north wall. The second brick column supporting the water chute is shown to the left in A2, and the holes are in the centre, half way up the wall. (2005)

The west wall of the flint mill (A1-8) stands against the embankment to the Upper Yard and is largely intact; certainly up to second floor level (approximately 6.5m). It is constructed from a combination of materials. The face immediately abutting the earth embankment is constructed from stone, whereas the abutting revetment (A1-6) is constructed from a combination of brick and stone (Fig.3.3.3). The revetment stands approximately 2.65m high and projects approximately 70cm from the main wall. Above the corner section in A7 there appears to be the opening to a chute, this probably having been the method by which the raw flint was introduced into the mill. The top surface of the revetment is mainly capped with brick, although some sections of it are capped with slate; particularly the return section that abuts the south wall in A-C1 (Figs.3.3.4 & 3.3.5). More or less centrally in the revetment there are two irregular holes, and at this point the wall appears to be hollow. However, there is no evidence in the form of an inlet or outlet to support this.

There are three brick columns abutting the wall, one in each of the corners (A1 and A8) and one in A2. The columns in A1 and A8 appear to act as buttresses, whereas the column in A2 supports the outlet from a small chute that carries water from the head race. The top surface of the two southerly columns, those in A1 & A2, are capped with slate. The wall between these two columns is constructed in rough stone, as is the return leg of the revetment to the section of the south wall in A-C1 (Fig.3.3.6). The column in A1 stands 2.1m in height and measures 35cm by 37cm. The adjacent pillar in A2 stands 1.76m high and measures 47cm deep by 35cm wide, with the aperture above, the water chute, being slate lined.

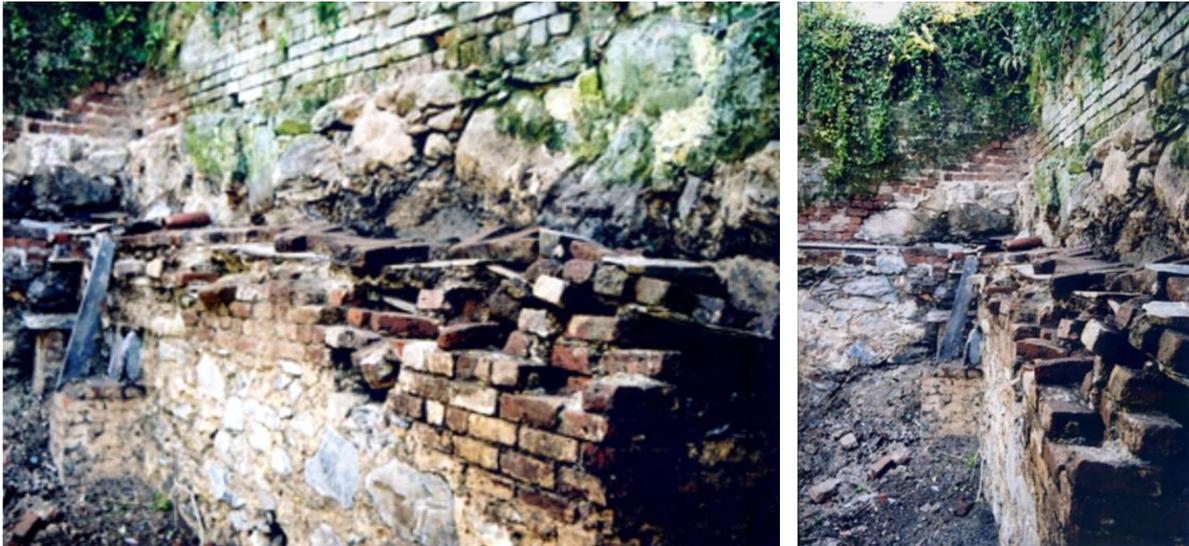
Fig.3.3.4 (left): The top surface of the revetment to the west wall. Although still under excavation, the top of the two brick columns in A1 and A2 can be seen in the bottom-left corner. (2005)

Fig.3.3.5 (right): The top surfaces of the revetments. Brick to the west wall and slate to the south wall. (2005)

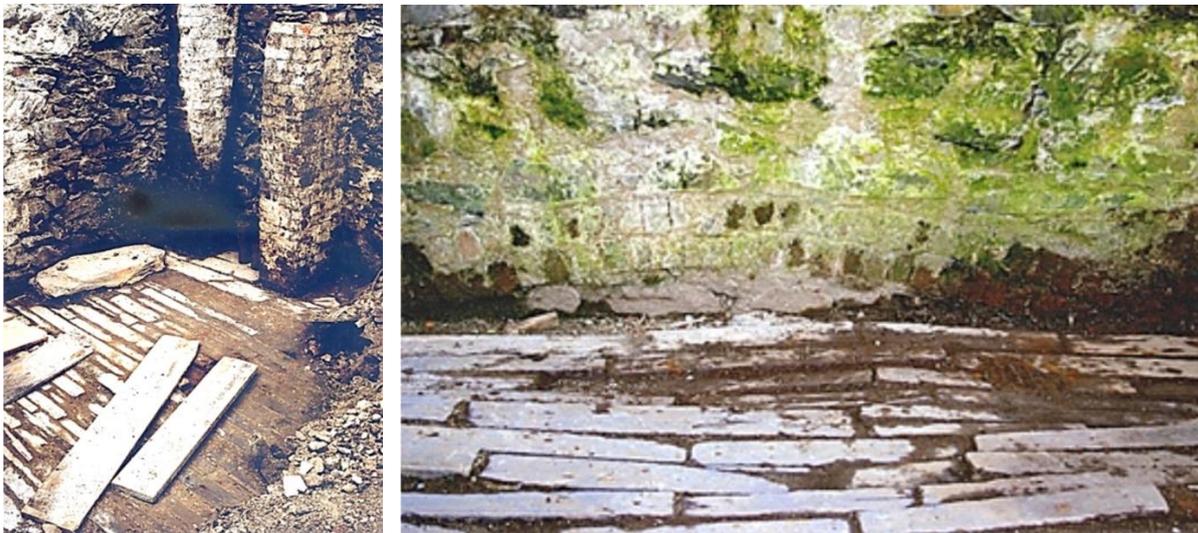
Fig.3.3.6 (left): The brick columns in A1 and A2 and the revetment to the south wall in A-C1. In both cases the wall is built from rough stone. (2005)

Fig.3.3.7 (right): The brick arch at the base of the revetment in A3-5. (2010)

The column in A8 is slightly different in that it is formed in two contiguous and equal parts and stands on what effectively is a stone plinth. The plinth, which continues along the base of the remaining section of the north wall, is 40 cm high. The half of the column nearest to the embankment stands 1.9m tall above the plinth, whereas the other half stands 1.75m above the plinth. Each half measures 50cm wide (an overall width of one metre) by 37cm deep. At the base of the revetment in A3-5 there is a brick arch, which is in line with the sunken area of slate floor that runs west-east through the centre of the flint mill (Fig.3.3.7). This is discussed later.

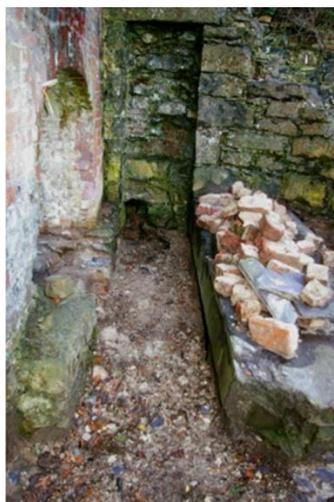
Fig.3.3.8: The recess to the inner face of the retaining wall, sitting above the wheel pit. The axle mounting slab is to the right and the archway through to the water wheel pit to the left. (2009)

In D1 part of the inside face of the wall sits above the fly-wheel pit, and at this point it is recessed. Initially it was thought that this was a doorway (Fig.3.3.8) although based on the depth of the pit it soon became apparent that this was not the case. A more likely option is that it was hollowed to allow more room for the pit wheel. The fact that the wall sits upon the large slab on which the axle mounting was based and not alongside it suggests that the wall was a later addition; which again would tend to support the supposition that the recess was to accommodate the pit wheel. The wall may have been built on top of the slab in order to provide a degree of stability. From the remaining footings there is evidence that there was a similar structure adjacent to the second wheel pit (Fig.3.3.9). The likelihood is that they were built as retaining walls, as a means of keeping raw materials away from the adjacent machinery. The fact that they are built of stone rather than brick reinforces the suggestion that possibly they may have been a later addition.

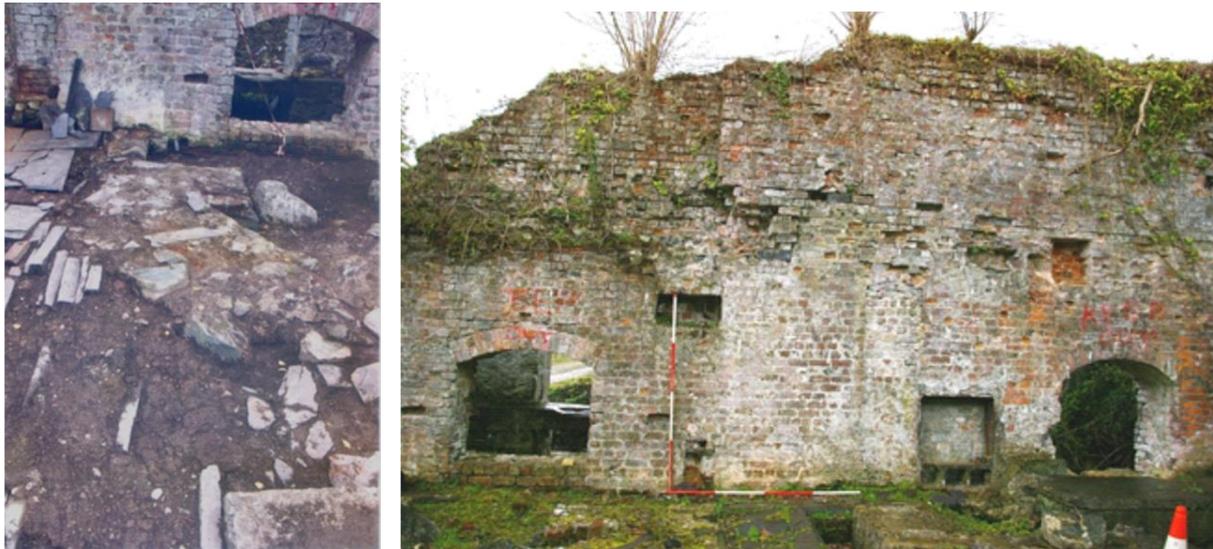
Fig.3.3.9 (left): The remains of the retaining wall footings in L-N 1-4. (2009)

Fig. 3.3.10 (right): The south wall, showing the openings for the axle housings. (2012)

In E-F0 and K-L0 there are large archways, each measuring 1.38m wide by 1.2m high at the apex (Fig.3.3.10). The axles from the water wheels passed through these before connecting to the pit wheel (so called because of its location; it can also be known as the 'cog' wheel). Only the wheel pit in front of the western-most wheel has been excavated (D-F1), although the second pit (J-M1) appears to provide a mirror image. When the students from Bangor University were on site in 1980 the axle through E-F0 was still in-situ (Fig.3.3.11), although what remains of it today lies in the water wheel pit, half buried beneath debris (Fig.3.3.12). It is believed that the mounting that originally supported the axle may have been taken for its scrap metal value.

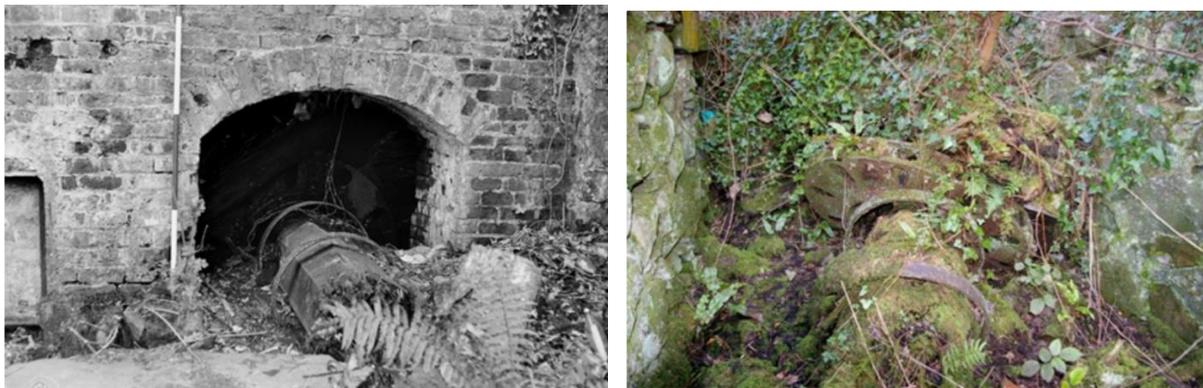
Fig. 3.3.11 (left): The opening in E-F0 with axle still in place.¹⁶⁹ (1980)

Fig.3.3.12 (right): The remains of the axle lying in the water-wheel pit. (2015)

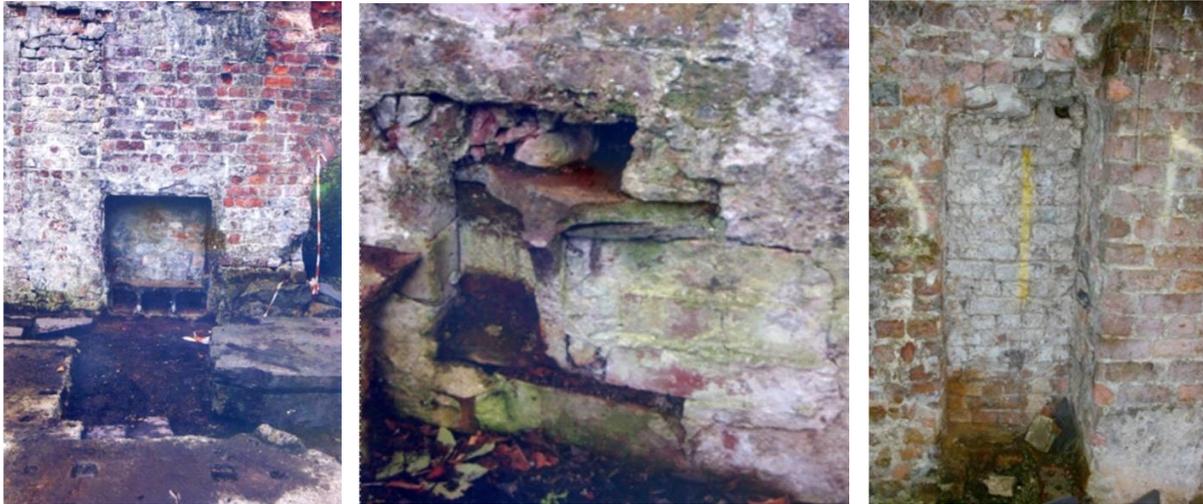
Fig.3.3.13 (left): The metal housing and bricked-in doorway: G0-H0. (2009)

Fig.3.3.14 (centre): The end of the metal beam in J0 (2009)

Further along the south wall there is a metal mounting inset at G0, and adjacent to this, in H0, there is a bricked-in doorway (Fig.3.3.13). The doorway is also visible from inside the water wheel pit. In J0 there is what appears to be the offcut end of a metal beam set into the wall approximately 30cm above ground level (Fig.3.3.14). This in turn is located beneath a rectangular aperture in the brickwork approximately 1.25m above, that appears to have housed a large beam. Above the aperture the brickwork to the upper half of the wall is stepped back and appears to be narrower than that at the base (Fig.3.3.10), and this continues to the end of the wall in O0. The aperture is also in line with the main entrance to the flint mill, which is in the north wall.

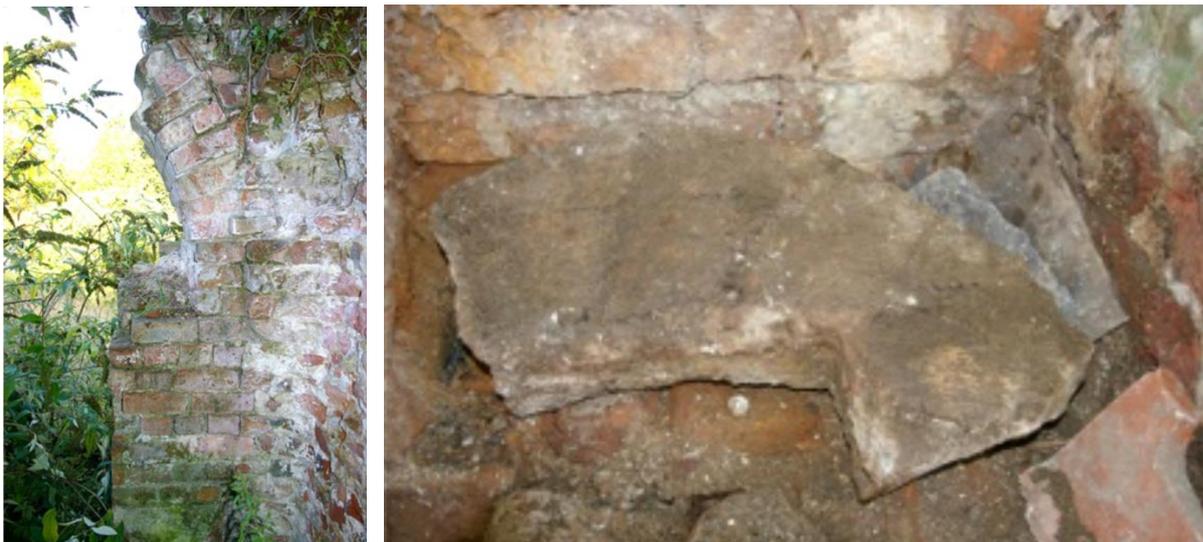
Fig.3.3.16 (left): The arched section of wall in P1. (2015)

Fig.3.3.17 (right): The piece of curved stone found in O2. (2006)

The east wall of the flint mill begins in P1 and continues to P8, where it abuts with the north wall. There is virtually nothing left of the wall above ground level. In the corner of P1 there is evidence that at one time there may have been some form of arched feature, possibly either a window or even a doorway (Fig.3.3.16).

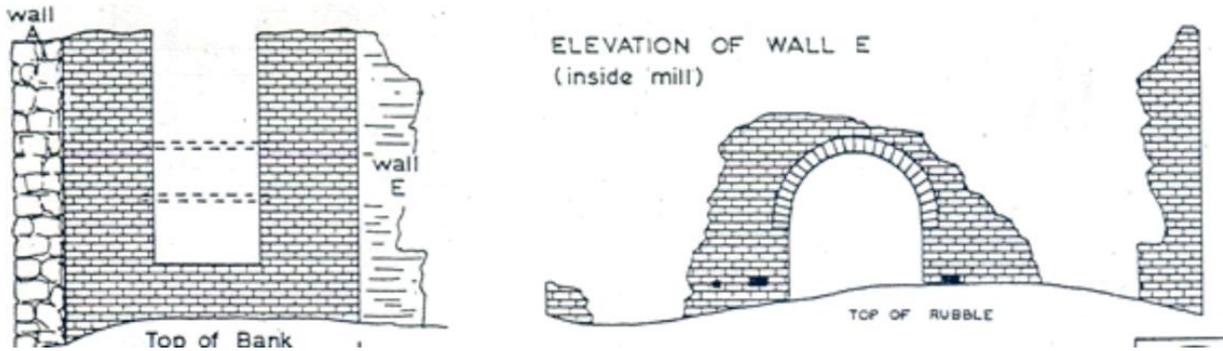
Fig.3.3.19: (Left) Elevation of the east wall of the water-wheel pit (Wall A), facing west.
 (Right) Elevation of east wall (E), facing east.¹⁷⁰ (1980)

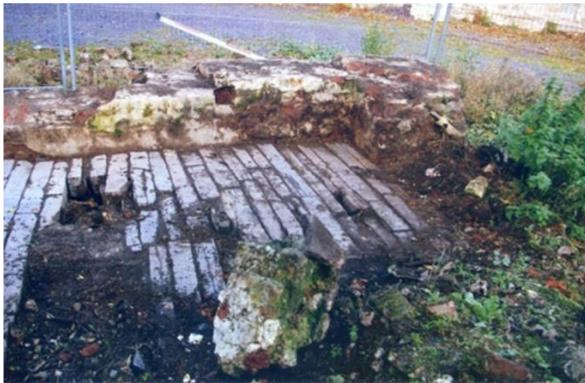
Fig.3.3.18 (left): The junction of the east and north walls in P8: east wall to right of the picture. (2009)

The remainder of the east wall has been demolished apart from a small section of standing brickwork in P8, where it forms the corner with the north wall (Fig.3.3.18). At this point the wall is a maximum of approximately 60cm high by 80cm long.

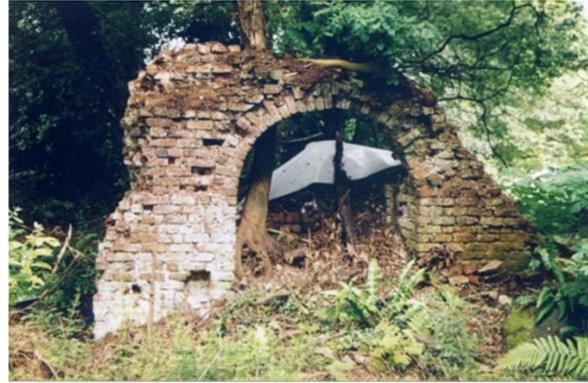
Fig.3.3.20 (right): The remains of the archway P2-6, viewed from inside the mill (facing east). (2004)

The exact nature of this feature is difficult to ascertain. The position of the remaining arch suggests a window, whereas the straight edge of the wall below suggests a door: possibly a door with transom above. Either way, the joins in the brickwork would tend to suggest that this section of wall was a modification, possibly even a later addition. During excavation a shaped piece of stone was found in O2 that possibly could have fitted into the arched section above the vertical edge (Fig.3.3.17). Also found was a piece of curved wood with a bevel edge to one side, possibly a window frame (see Section 8, Finds, Item 10/01/005).

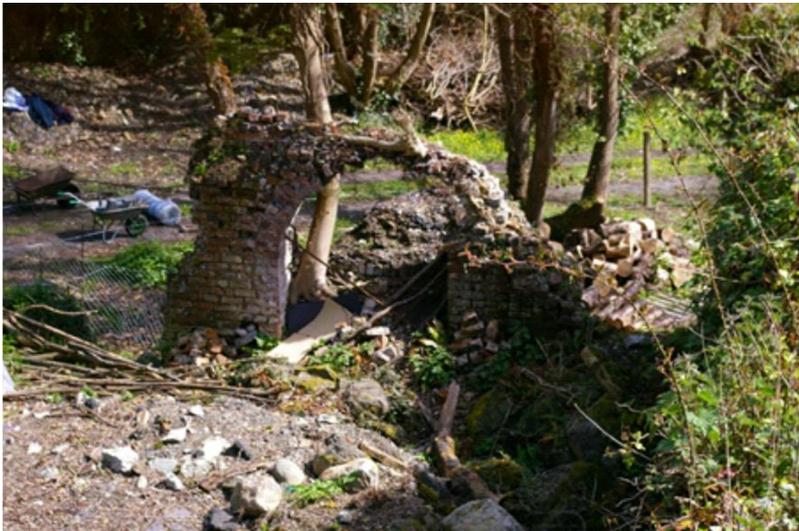
Fig.3.3.21 (left): The remains of the archway in April 2006, viewed from inside the mill. Note the deterioration in less than 2 years.

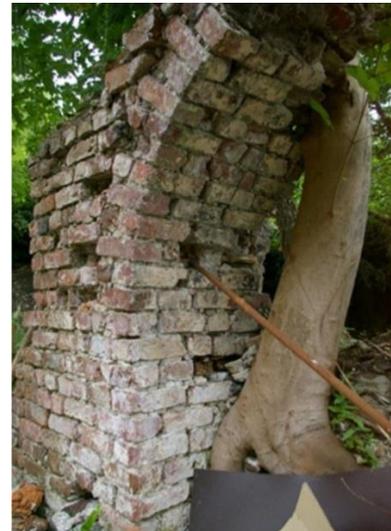
Fig.3.3.22 (right): The left front face of the archway. (2006)

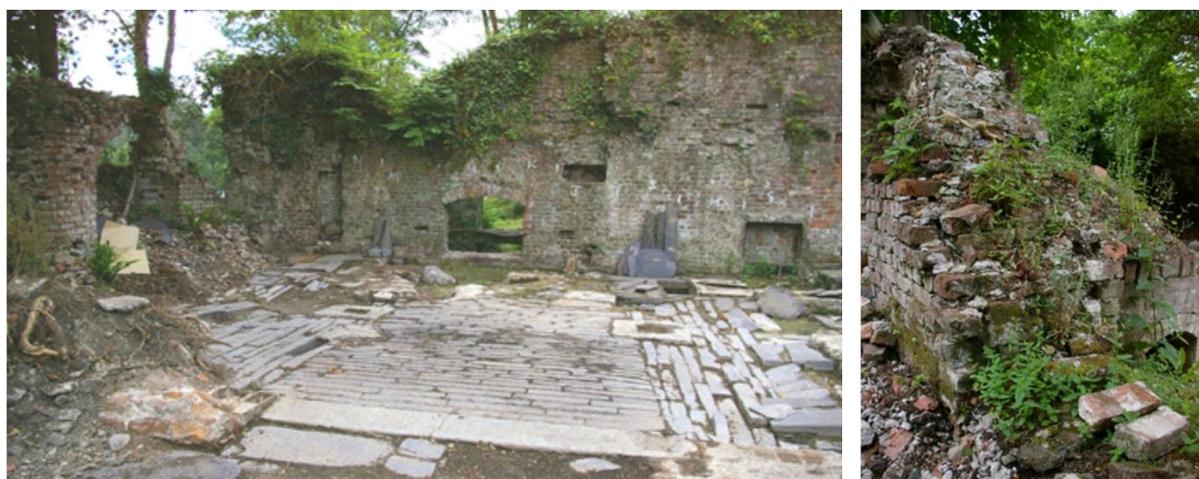
Fig.3.3.25 (left): The position of the archway (left) in relation to the main body of the mill. (2006)

Fig.3.3.26 (right): Side view of the archway from the south with oven in the background. (2006)

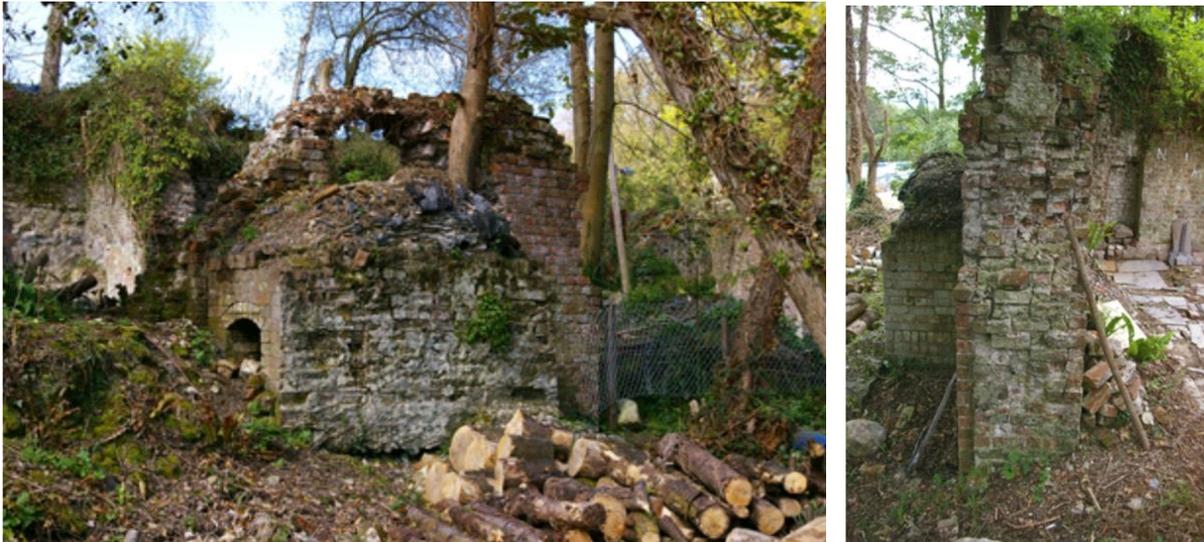
Fig.3.3.27 (left): East side of the oven. The logs are lying in the stable area, from where they were cut. (2006)

Fig.3.3.28 (right): Side view of the archway from the north, with oven in the background. (2006)

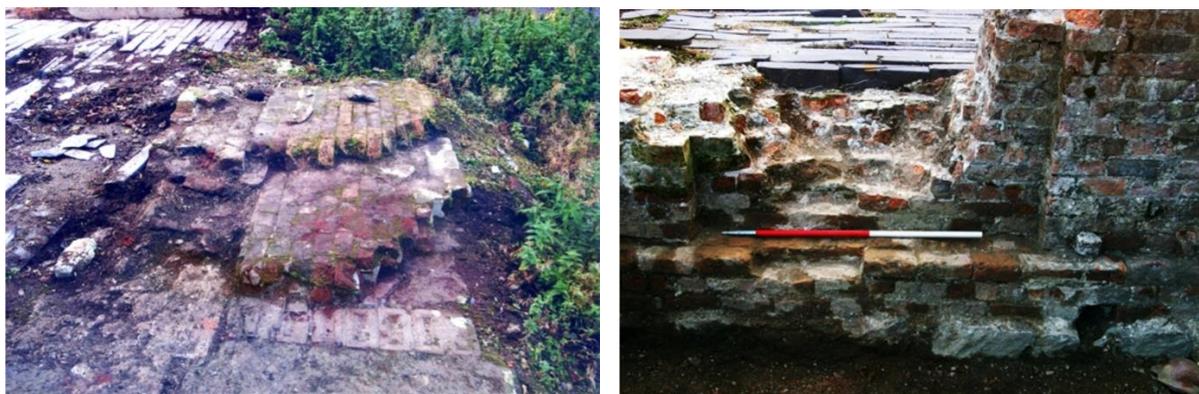
Fig.3.3.29 (left): The location of the archway and oven in P & Q 3-7. The archway stood upon the brick wall adjacent to the slate floor, and the oven upon the raised brickwork in the centre. (2009)

Fig.3.3.30 (right): The break in the east wall and the brick ledge. (2010)

Immediately adjacent to the site of the archway, in P7-8, the wall is stepped downwards. In front of this section there is a narrow ledge two bricks wide that continues to the junction with the north wall, where it then narrows to one brick wide to the junction with the east wall of the outer mill (Fig.3.3.30). Beneath the junction of these two walls, in P9, there is a vitreous clay trap that is embedded into the ground (Fig.3.3.31). This in turn is in line with another pipe that emanates from beneath the base of the oven, and from their position it would seem that originally a length of pipe ran between them, parallel to the mill wall. The pipe originates in O1, turns through ninety degrees beneath P1, and continues to where it emerges in P6. At this point it is encased in concrete above which there is a course of bricks, that do not appear to have been cemented together. The layer is one brick wide and three bricks high, and these are the only bricks found on the site that are 'frogged'. Behind them there is another layer of concrete that stands level with the top of the bricks and extends to the brick base

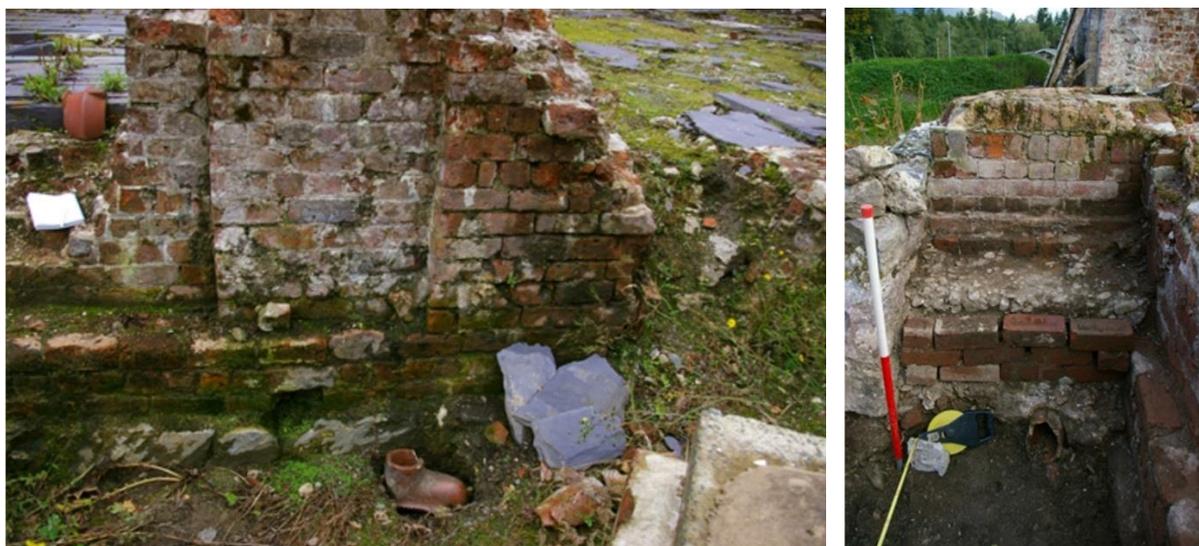
Fig.3.3.31 (left): Location of the clay trap adjacent to the east wall of the mill. (2011)

Fig.3.3.32 (right): The pipe emerging from beneath the oven in P6. The east wall of the mill is to the right, and the west wall of the stable to the left. (2010)

of the oven. The entire structure stands between the east wall of the mill and the west wall of the stable. The ledge that runs in front of P7-8 begins at this point, being only one brick wide (Fig.3.3.32).

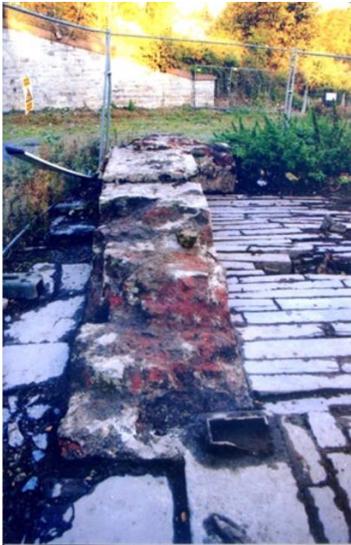
Fig.3.3.33 (left): The remaining section of the north wall in L-P9, with the post holder in L8. (2009)

Much of the north wall has been demolished, the only sections remaining standing being in A-C9 and L-P9. It is a maximum of 60cm high in P9, gradually reducing to 8mm in L9. The main entrance to the inner mill (the original flint mill) is between I9 and L9, where there is a break in the wall. Immediately in front of this, from I-J8/9 and K-L8/9, there are two abutting slate blocks that together form the threshold. There are rectangular post holders at the outer end of each of the slabs (I8 and L8) that would have housed the door frame, and there is a drop-bolt holder at the inner edge of the slab in J9, where the two slabs join. The post holder in L8 still has its metal frame, whereas the frame for the one in I8 is missing (Figs.3.3.33 to 3.3.35).

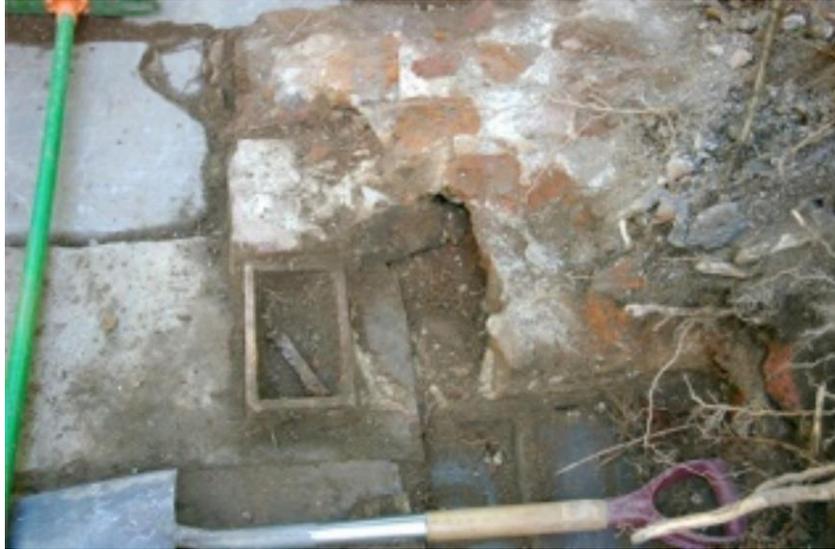
Fig.3.3.34 (right): The metal post holder in L8. (2006)

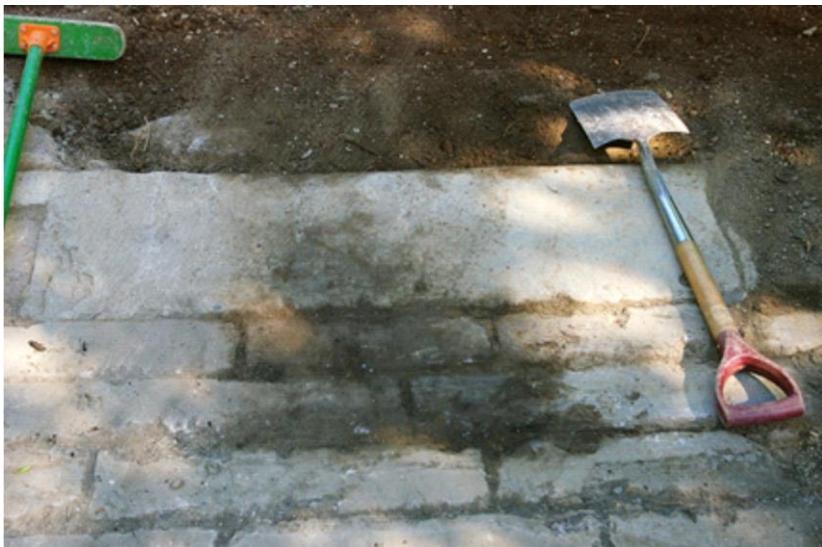
Fig.3.3.35 (left): The threshold slate in I-J8. The edge of the post holder is shown left of picture, and the drop-bolt holder is to the right, adjacent to the spade handle. (2006)

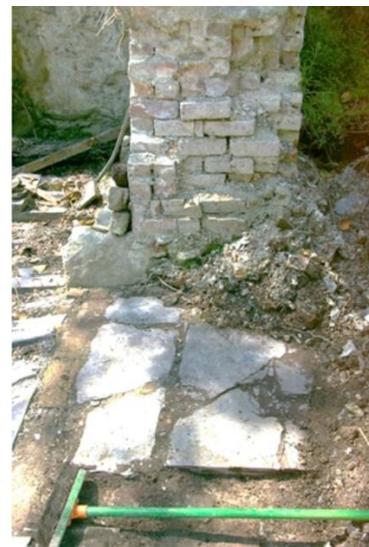
Fig.3.3.36 (right): Threshold to pedestrian doorway in D9. (2010)

The base of the brick wall then continues from E9 to I9, and in D9 there is the threshold for a pedestrian doorway. Unlike the threshold to the main entrance which is fashioned from carefully dressed and fitted slabs, the pedestrian threshold comprises a number of irregularly shaped pieces of slate. Possibly at one time they may have been more closely fitted together, but from the available evidence this perhaps is unlikely (Fig.3.3.36).

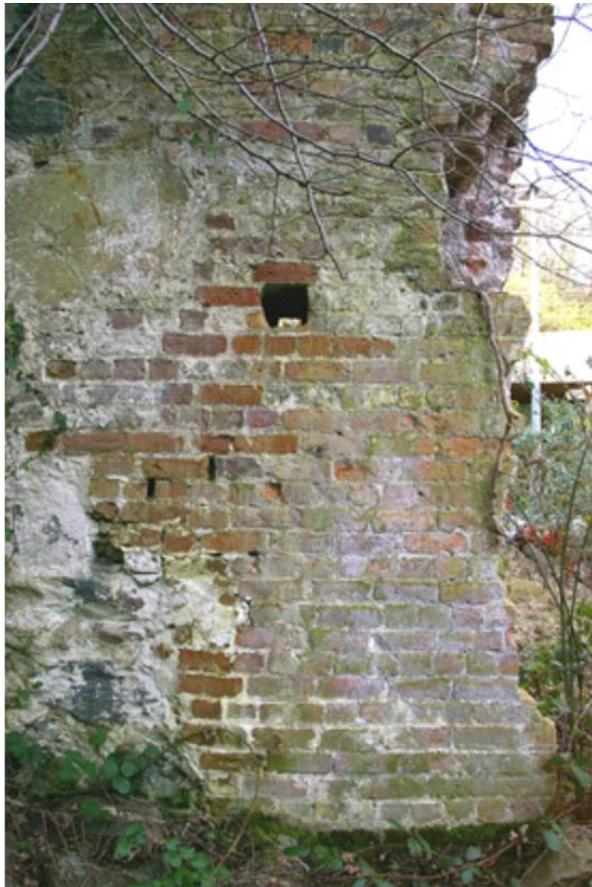
Fig.3.3.37 (left): The south face of the north wall in B-C9. (2015)

probably was cut into the brickwork to facilitate a line shaft (Fig.3.3.37); possibly indicating that there was a powered hoist from the ground floor of the warehouse extension to the chute above. There are also a series of niches in the north face which were to house support beams for the upper floors (Fig.3.3.38).

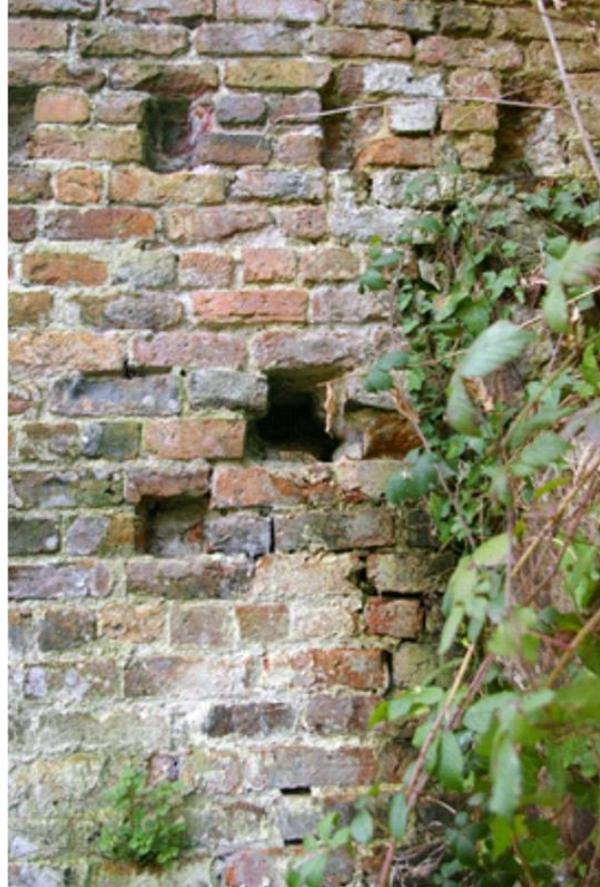
Fig.3.3.38 (right): The north face of the wall in A-B9.
Hole for line shaft in centre, notches for floor joists above. (2015)

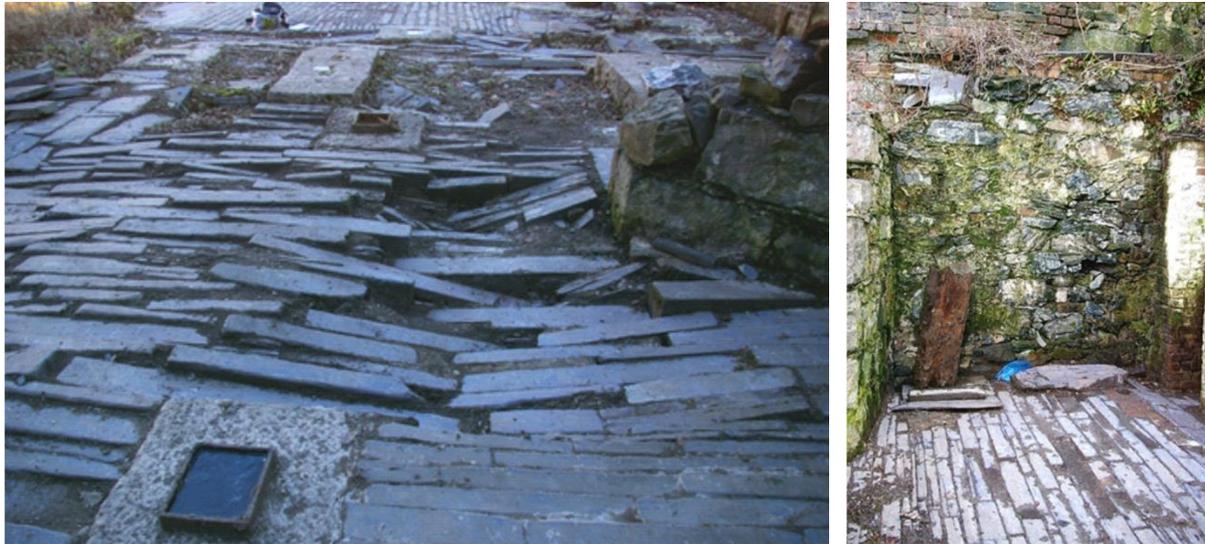
Fig.3.3.39 (left): The depressed section of slate floor in C5-F5, facing east. (2010)

Fig.3.3.40 (right): The south wall revetment with the opening to the chamber in C1. The start of the retaining wall is to the left and the slate slab to the right. (2010)

Although throughout the floor generally is well laid there are a number of disturbed areas, notably the central section from C5 to F5. The slates in this area are depressed inwards (downwards), as though the ground beneath has subsided. The depressed area of floor is in line with the arch that lies

at the base of the stone revetment stonework to the west wall (Figs.3.3.7 & 3.3.39). One possible explanation for this area of floor having collapsed is that there was a cellar beneath it. The existence of a cellar is suggested by one of the items listed in an inventory attached to the 1883 lease document, which refers to '1 shaft in cellar floor 10' x 2 inches square'. While this hints at the possibility of a cellar, there is no specific evidence in terms of a recognizable entrance to support this theory.

In C1, at the junction of the south wall revetment and the stone retaining wall, there is an irregular shaped hole in the floor where the slate has collapsed and beneath this in B-C 1 & 2 there is a small chamber. There does not appear to be a formal entrance to the chamber, the hole only becoming evident when during the course of excavation loose debris began to pour into it. Because of the amount of debris that has fallen into the chamber it is not possible to see what the floor surface looks like, or whether there is a tunnel running from it beneath ground level. There is what possibly could

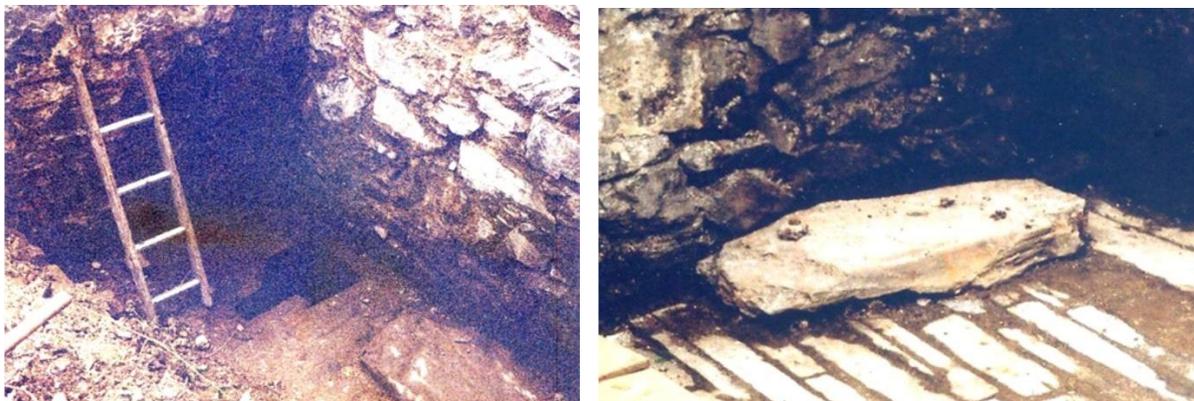
Fig.3.3.41 (left): The outline of the opening to the chamber can be seen adjacent to the foot of the ladder. The retaining wall is to the left of picture, south wall revetment to the right. (2005)

Fig.3.3.42 (right): The slate slab in A-B1&2. The nut is shown at the left and the two holes to the right. (2005)

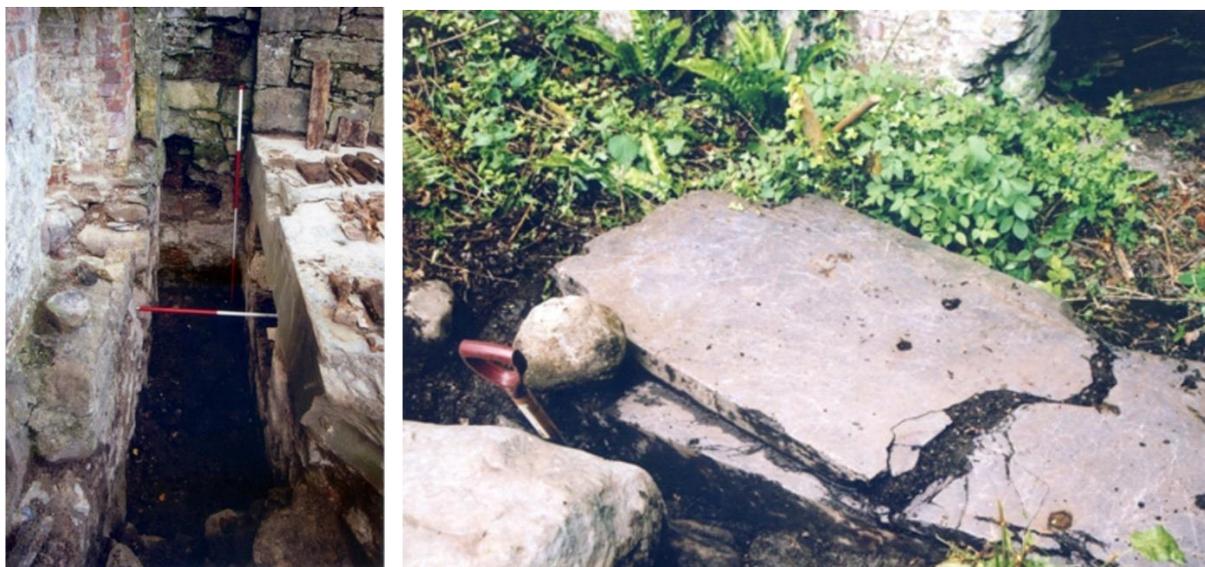
Fig.3.3.43 (left): The (pit)wheel pit in D-F1. (2009)

As previously described, adjacent to the chamber entrance there is a retaining wall (see the description of the south wall), which in turn is adjacent to the first of the two wheel pits. The pit is 3m in length and it was excavated to a depth of 1.5m below ground level. Based on this it would seem safe to assume that the pit wheel would have had a diameter of approximately the same size, i.e. three metres (Fig.3.3.43).

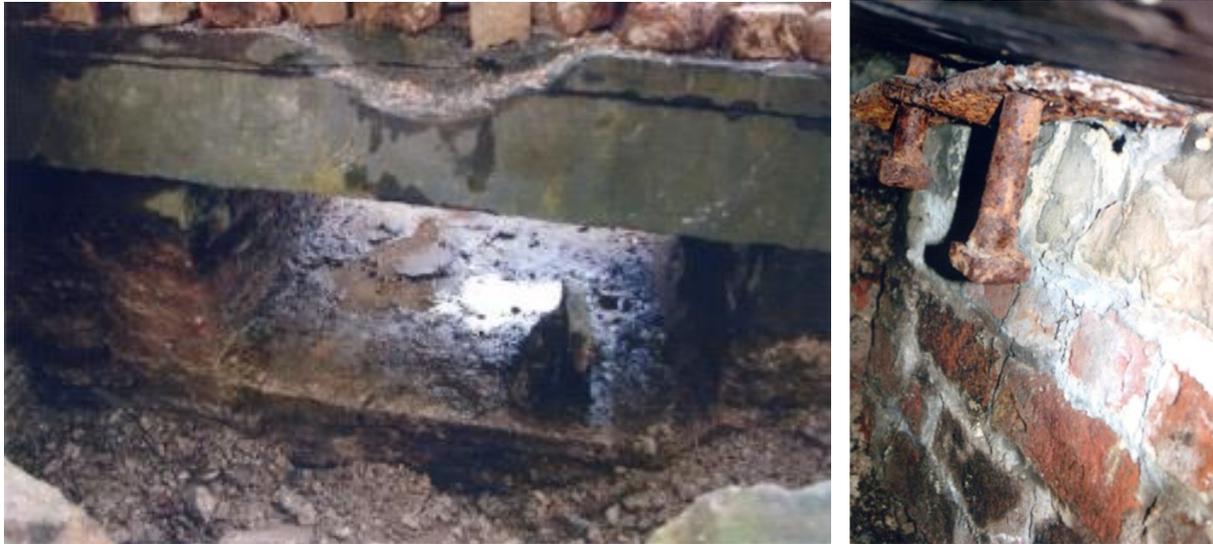
Fig.3.3.45 (left): The chamfered edge to the rear of the slate mounting slab.
The bricks on top of the slab are not related. (2009)

Fig.3.3.46 (right): The retaining bolts in situ to underside of the slab. (2009)

Immediately in front of the wheel pit there is a large slate mounting slab (D-G2) on which originally the axle housing was seated. The location of the four holding bolts can still be clearly seen on the upper surface (Fig.3.3.44). The slab had been badly damaged, probably during the removal of the

mounting plate, but has now been restored to its original position. The inner edge, facing the wheel pit, has been chamfered to accommodate part of the axle mounting (Fig.3.3.45). During excavation one pair of the bolts that originally anchored the axle housing was found to be in-situ to the underside of the slab, together with their spacing bar (Fig.3.3.46). A second pair was found lying in the spoil beneath it (Fig.3.3.47).
