**Richard Pennant, Samuel Worthington and the mill at Penlan
a history of the Penrhyn Mills on the Lower Ogwen**

Richard Pennant, Samuel Worthington, and the Mill at Penlan

A History of the Penrhyn Mills on the Lower Ogwen

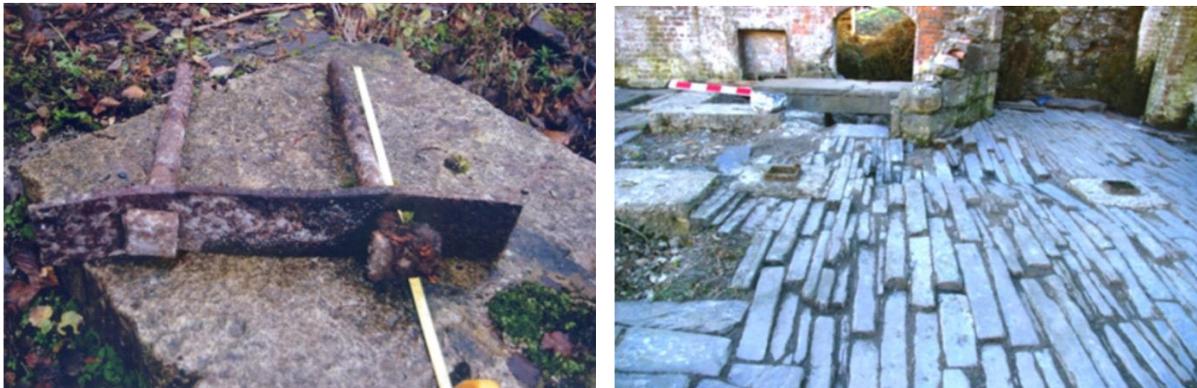
Fig.3.3.47 (left): Retaining bolts and spacing bar found beneath the slab. (2009)

mounting plate, but has now been restored to its original position. The inner edge, facing the wheel pit, has been chamfered to accommodate part of the axle mounting (Fig.3.3.45). During excavation one pair of the bolts that originally anchored the axle housing was found to be in-situ to the underside of the slab, together with their spacing bar (Fig.3.3.46). A second pair was found lying in the spoil beneath it (Fig.3.3.47).

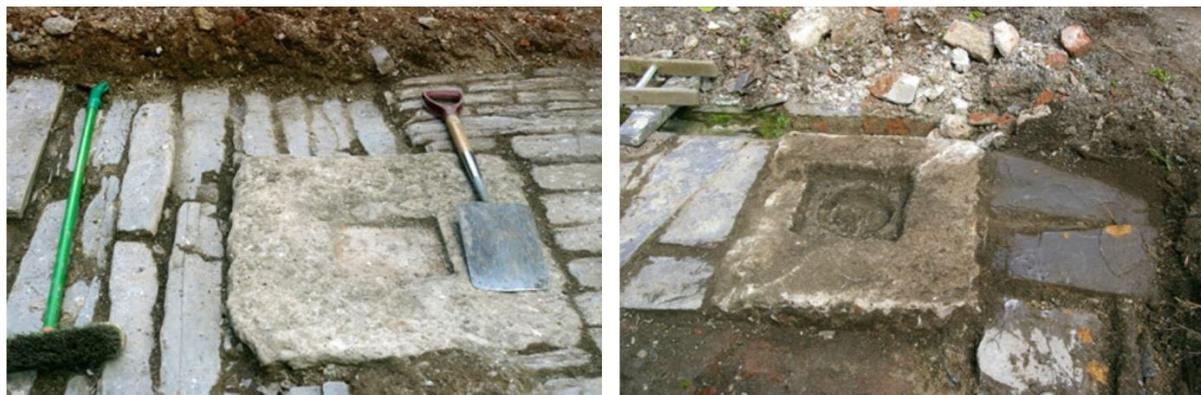
Fig.3.3.49 (left): The limestone block in I5. (2006)

Fig.3.3.50 (right): The limestone block in G/H7. The north wall is top of picture and the small wheel pit to the left, beneath ladder. (2006)

Running west to east, more or less across the centre of the mill, there are four small limestone bases located in C5, F5, I5, and L5, and these appear to be for housing vertical support columns. There is a fifth base in H7, which is located adjacent to a small flywheel pit that abuts the north wall. The bases in C5 and F5 on average measure 78cm square overall, with a 23cm square metal cup in the centre (Fig.3.3.48). The bases in I5 and L5 do not have a metal cup but instead have a 34cm square recess approximately 4cm deep; although it is likely that originally cups were inserted (Fig.3.3.49). The base in G/H7 is the same except that it has a 25cm diameter by 4cm deep round hole in the centre (Fig.3.3.50).

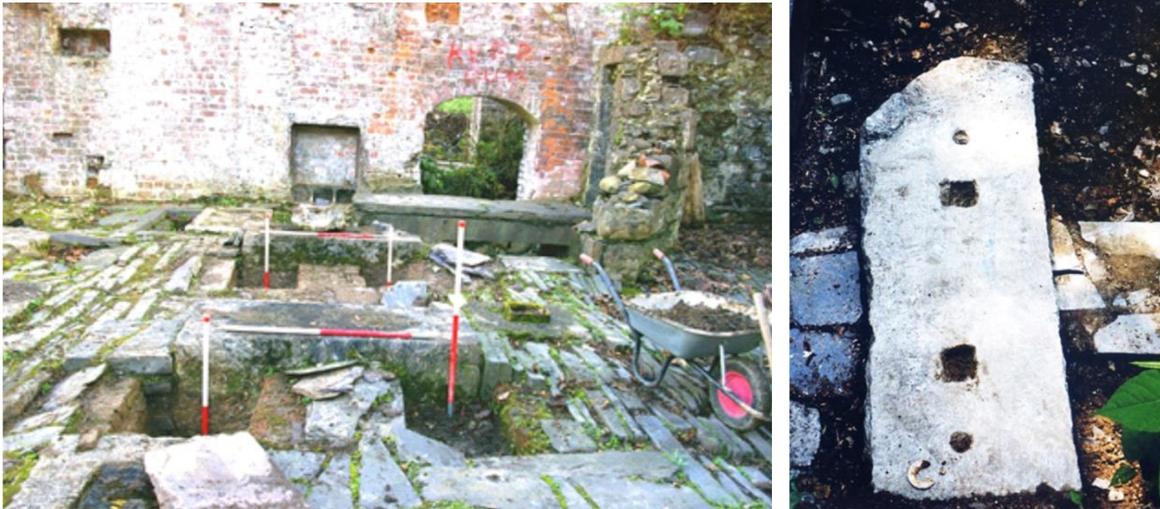
Fig.3.3.51 (left): The two limestone blocks are marked by the horizontal ranging poles, and the access pits by the vertical poles. (2011)

Fig.3.3.52 (right): The limestone block in F-G3. (2005)

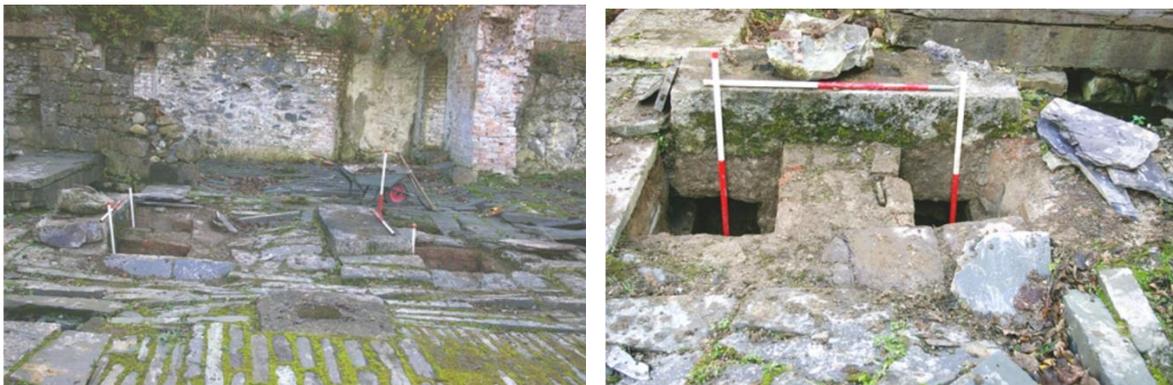
Fig.3.3.53 (left): The location of the limestone blocks, facing west. The slate mounting slab and retaining wall are to the left, with the brick column and water chute showing to the top left. (2011)

Fig.3.3.54 (right): The limestone block in F-G3 with its two access pits, AP3 to the right and AP4 to the left. (2011)

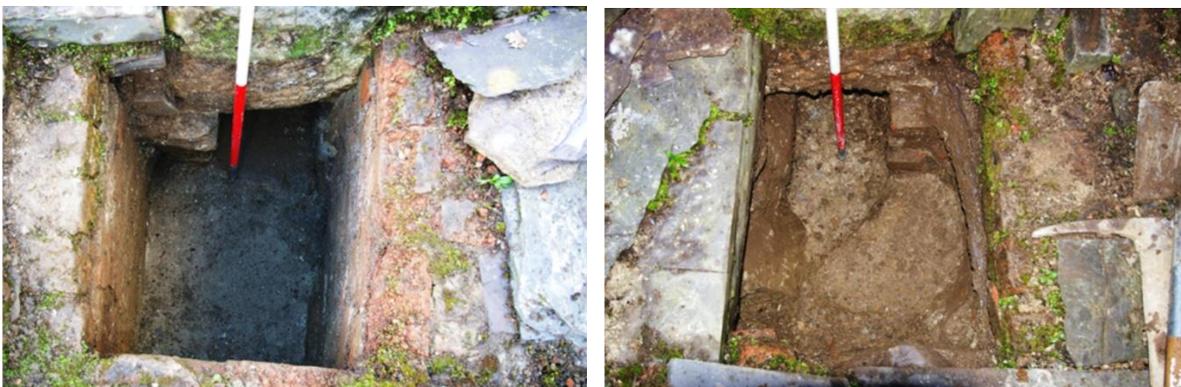
Fig.3.3.55 (left): Access pit AP1. (2011)

Fig.3.3.56 (right): Access pit AP2 (2011)

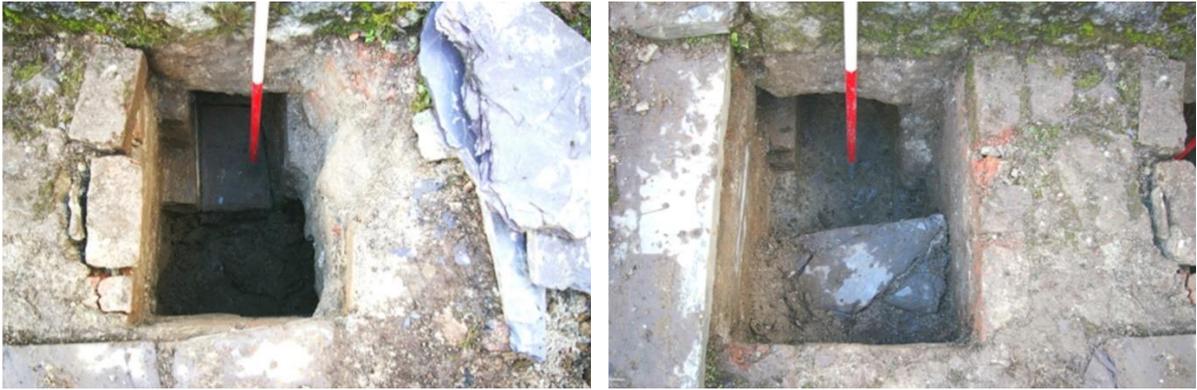
Fig.3.3.57 (left): Access Pit AP3 (2011)

Fig.3.3.58 (right): Access Pit AP4 (2011) The small tunnel at the rear of each of the pits allows access to the mounting bolts located in the stone block above.

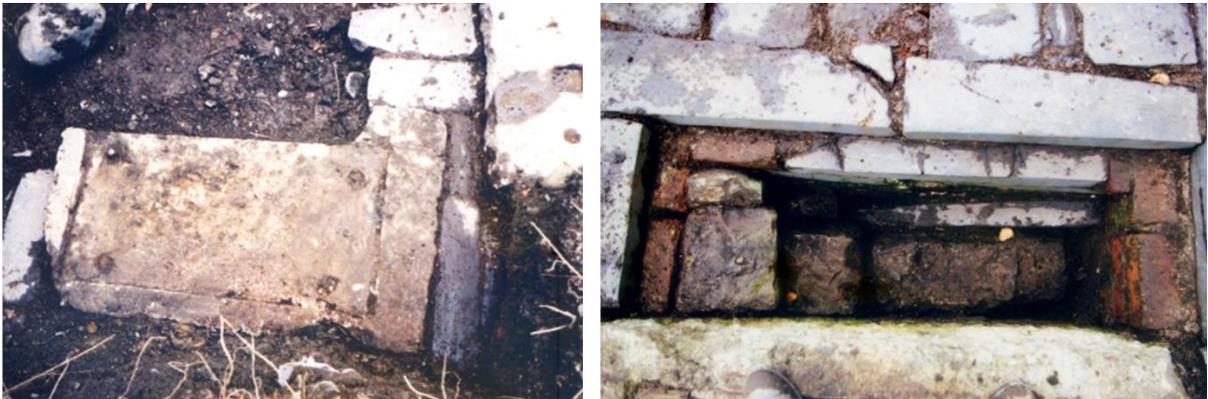
Fig.3.3.59 (left): The limestone block in H2. (2005)

Fig.3.3.60 (right): The Pit AP6 in I2. (2009)

There is another block in H2, running in line with the slate mounting slab. It is 1.45m long by 76cm wide by 60cm thick, with a retaining bolt in each corner. It is orientated north-south, and again there is an adjacent pit (AP6). (Figs.3.3.59 & 3.3.60) Whether this is an access pit or a small fly wheel pit is not clear, although as there is no obvious access to the underside of the stone block the latter is the more likely.

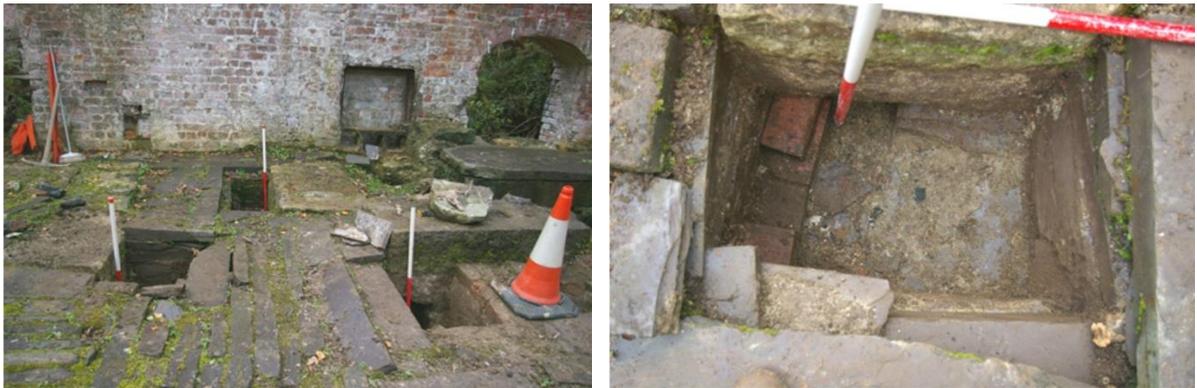
Fig.3.3.61 (left): The limestone blocks in (from L-R) J3, H2 and F-G3, together with their respective access pits (AP5, AP6 and AP4). The metal beam is inset to the south wall at J0 (top left of picture); the metal housing is at G0; and the slate mounting bed is to the right. (2011)

Fig.3.3.62 (right): Access pit AP5, located in I3. (2011)

The fourth block is in J3. It has an irregular shape and at its maximum measures 80cm by 60cm by 55cm thick. It has a single bolt inserted in the centre, and one access pit (AP5). (Figs.3.3.61 & 3.3.62)

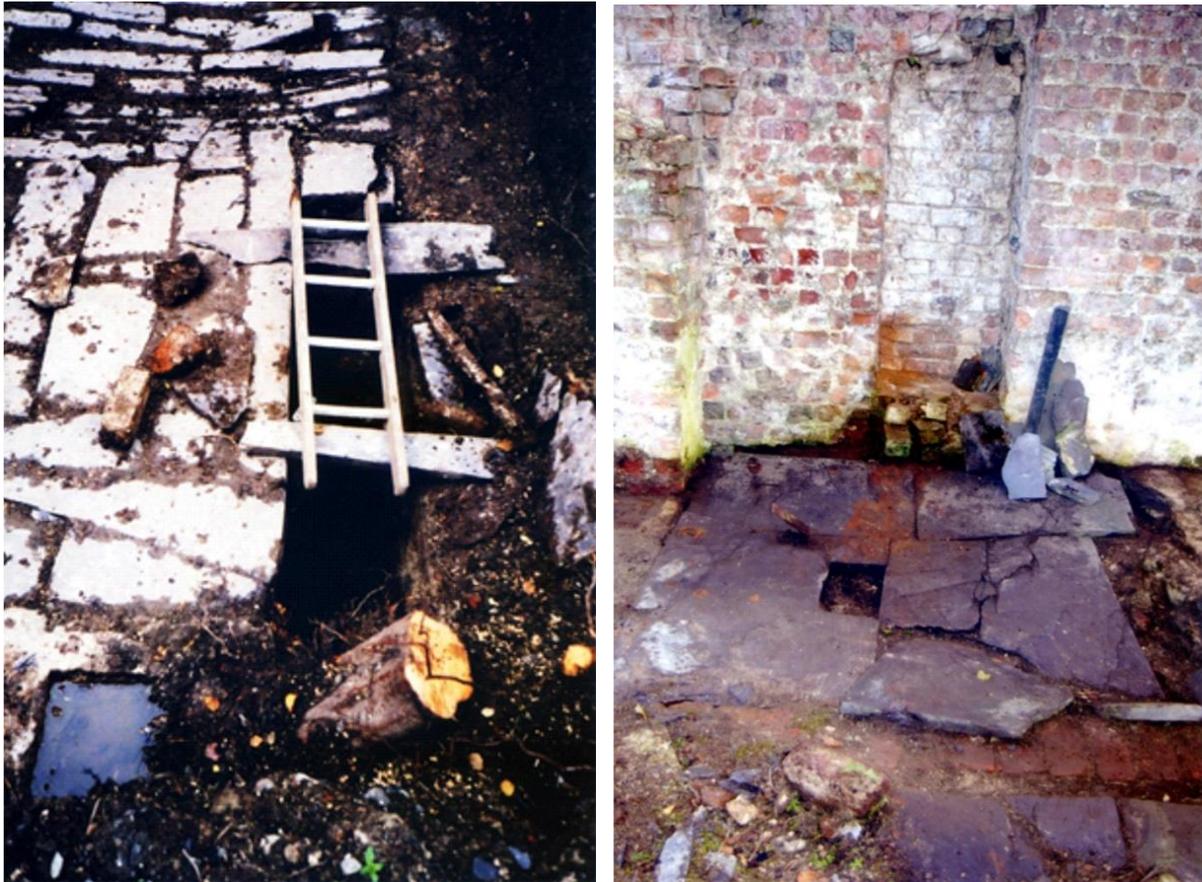
Fig.3.3.63 (left): The flywheel pit in F-H8 in course of excavation. The small limestone block in H7 is shown at bottom left adjacent to the tree stump, and the north wall is to the right. (2005)

Directly in line with the blocks in F-G3 and F-G6 and the metal housing inset at G0 there is a small fly wheel pit, immediately adjacent to the north wall of the mill in F-H8 (Fig.3.3.63).

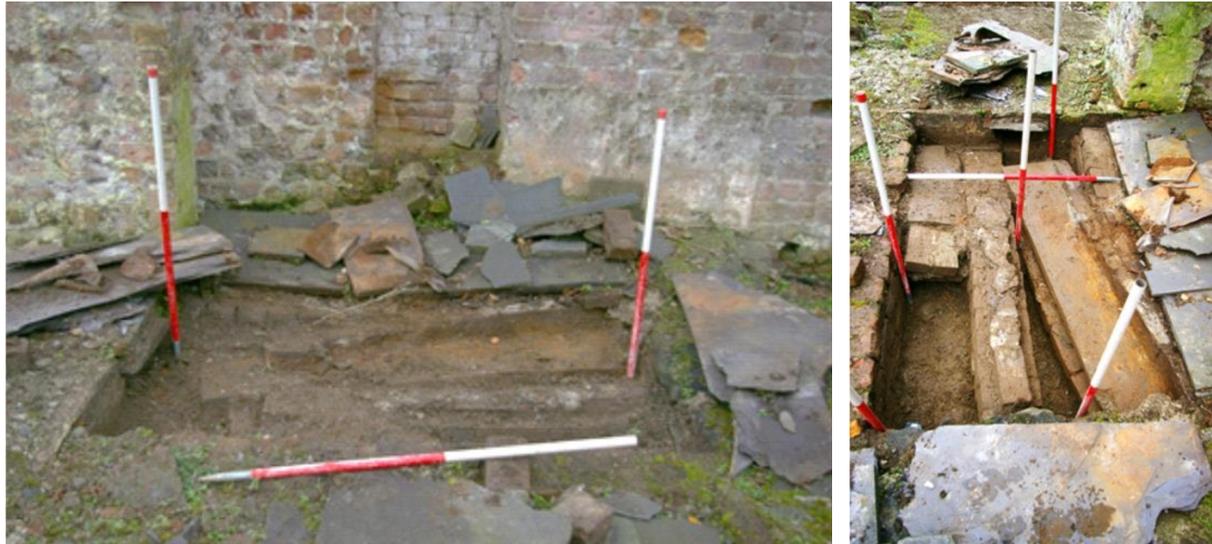
Fig.3.3.65 (left): The pit in N&O 1&2 after the cover was removed, but prior to excavation. (2011)

In the extreme south east corner of the mill in N&O 1&2 there are four large slate slabs that together form a cover. There is a square hole located centrally between them, and a flat metal bar protruding upwards from the surface (Fig.3.3.64). Beneath the slabs there was found to be a pit measuring some 1.8m east- west by 1.0m north-south. When first uncovered it was backfilled with soil and rubble (Fig.3.3.65), but after excavation it was found to be approximately 90cm deep and have a central row of bricks some 23cm wide running along its length. As this is only three bricks deep and not supported underneath, evidently it is not designed to be load bearing; perhaps other than to support the slate cover. In addition, there is a slate slab, laid flat and running at an angle from the south west corner of the pit towards the row of bricks; and beneath the slab there is a further row of bricks. These do not appear to support the slab as there is a gap between them. There is a second, much shorter, slate slab that occupies the other half of the pit, to the north side (Fig.3.3.66). The sides of the pit are lined with brick.

In the east wall of the pit, facing the end of the slab, there is the opening to an exit channel 40cm wide which feeds into a pipe beneath the base of the wall in O1. After approximately 1.0m the pipe turns through ninety degrees to the north and continues beneath the concrete base of the hearth area to a point where it exits into the space between the east wall of the mill and the stable (Figs.3.3.67, 3.3.68 & 3.3.32). The possible purpose of this pit is discussed later.

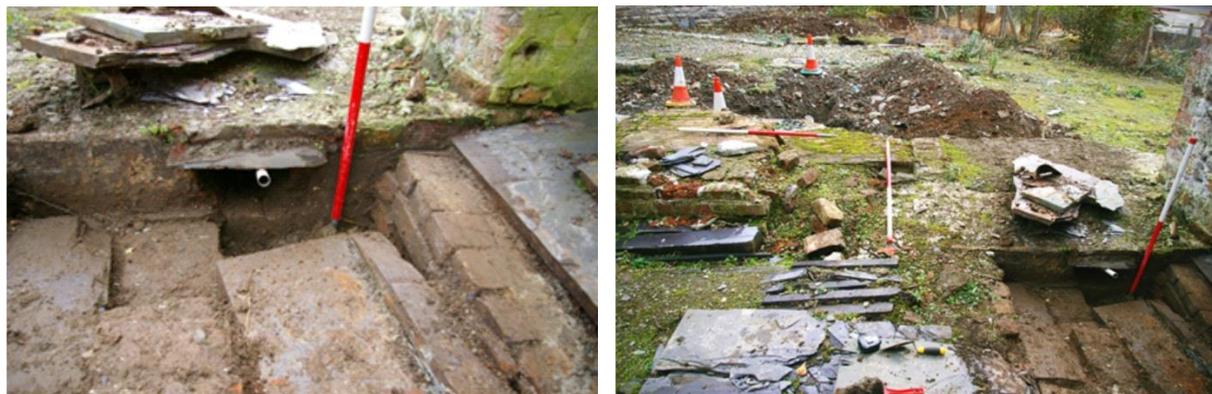
Fig.3.3.67 (left): The opening to the exit channel with horizontal pole inserted to full length. (2011)

Fig.3.3.68 (right): The horizontal poles show the direction of the water flow from the pit to the exit pipe in P6. (2011)

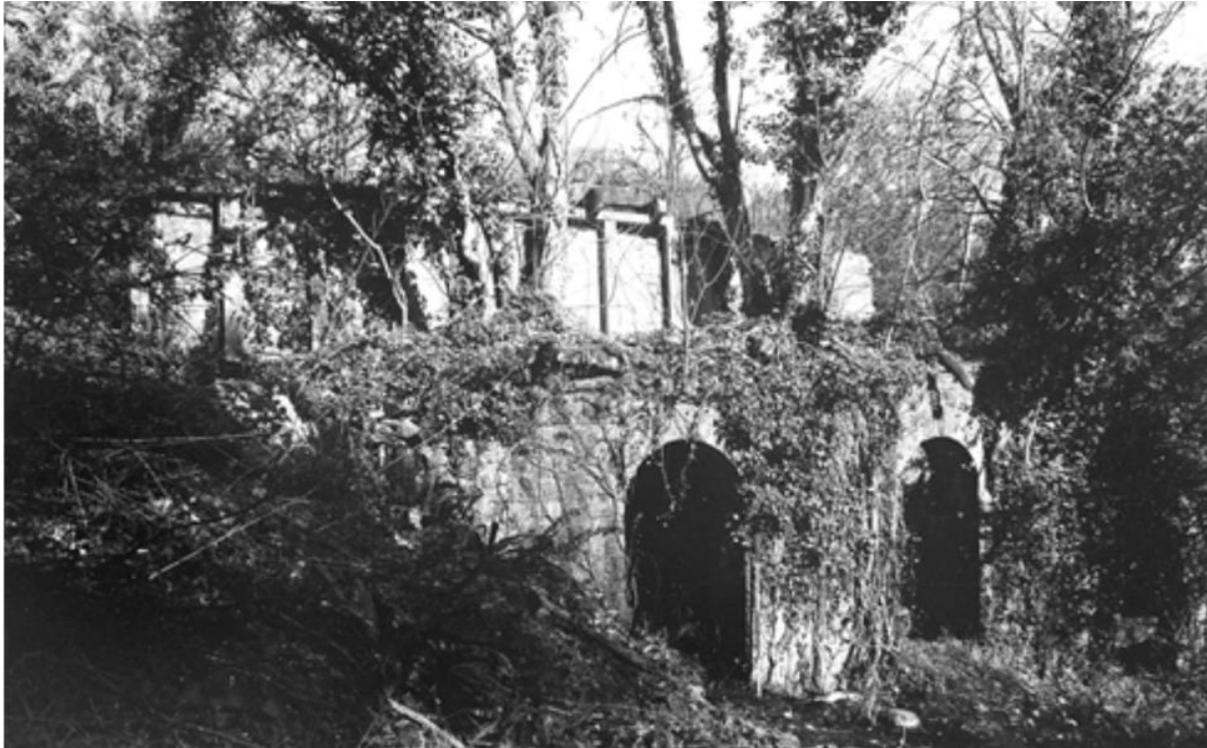
Fig.3.3.69: The south outer wall of the water wheel pit as it appeared in 1980, with original wooden launder above.¹⁷¹

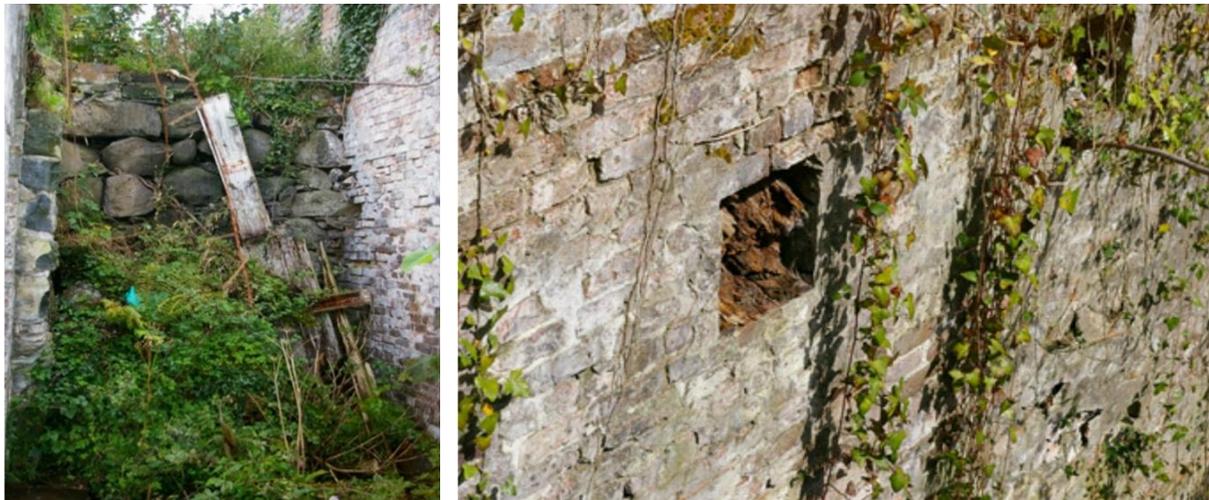
Fig.3.3.70 (left): The inner west wall of the water wheel pit and remains of the launder. (2011)

Fig.3.3.71 (right): The remains of a support beam in the north face of the inner wall of the water wheel pit. (2006)

The inner north and east walls of the water wheel pit are constructed in brick on a stone base,¹⁷² whereas the west wall is constructed from heavy rough stone, as shown in Fig.3.3.70 above. It is this wall that carried the main weight of the water as it passed to the launder. Externally the south wall is more decorative and mainly constructed from dressed limestone blocks on a stone base, although there is some brickwork to the inside face, possibly inserted during repair. The wall has three symmetrical arches, albeit the easternmost (arch 1) is larger. The central arch (arch 2) appears to be purely decorative as unlike the other two it did not house any working machinery; whereas the axle mounting slabs for the water wheels were housed in arches 1 and 3. While the dressed stone face continues for almost the full length of the water wheel pit there are two exceptions. At the western end where it abuts the earth embankment it is constructed from rough stone; and at the eastern end

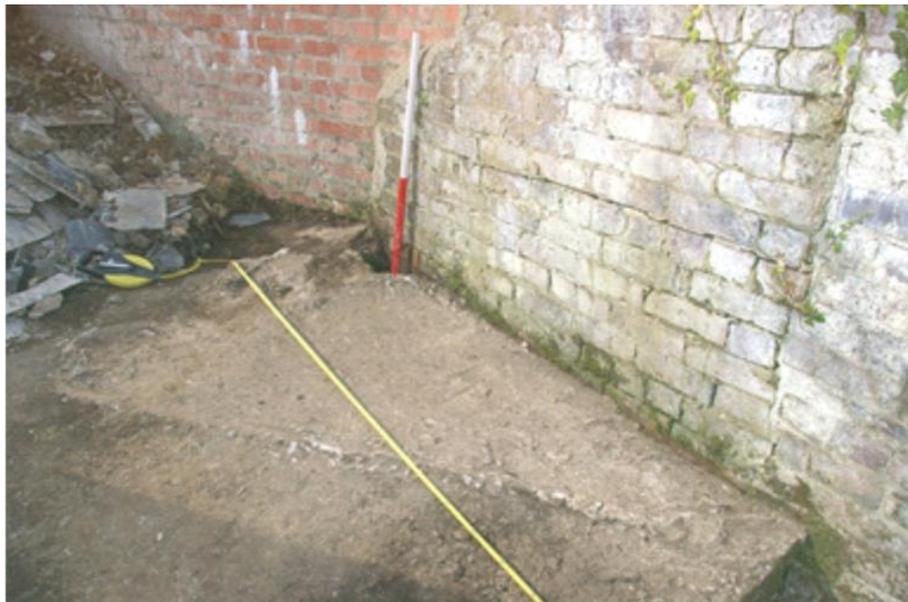
Fig.3.3.72: The concrete step in the headrace and the location of the post hole. The joins between the three sections of brickwork are clearly visible. (2011)

The brickwork that forms the inner wall of the headrace appears to have been raised in three distinct stages. The section nearest the water wheel pit (the east end) appears to have been built first. It is 4.15m long, runs to the front of the concrete step, and forms part of the original south wall of the mill. The second section is 2.19m long and runs from the front edge of the concrete step to the point where the race bends towards the leat. In both cases the change in brickwork is defined by a straight edge. This section of wall appears to have formed part of the 1885 extension in the upper yard. At the end of this section of wall the headrace turns roughly west-south-west as it joins the leat proper, and at this point there is what appears to be a post hole; probably the location of a sluice gate.

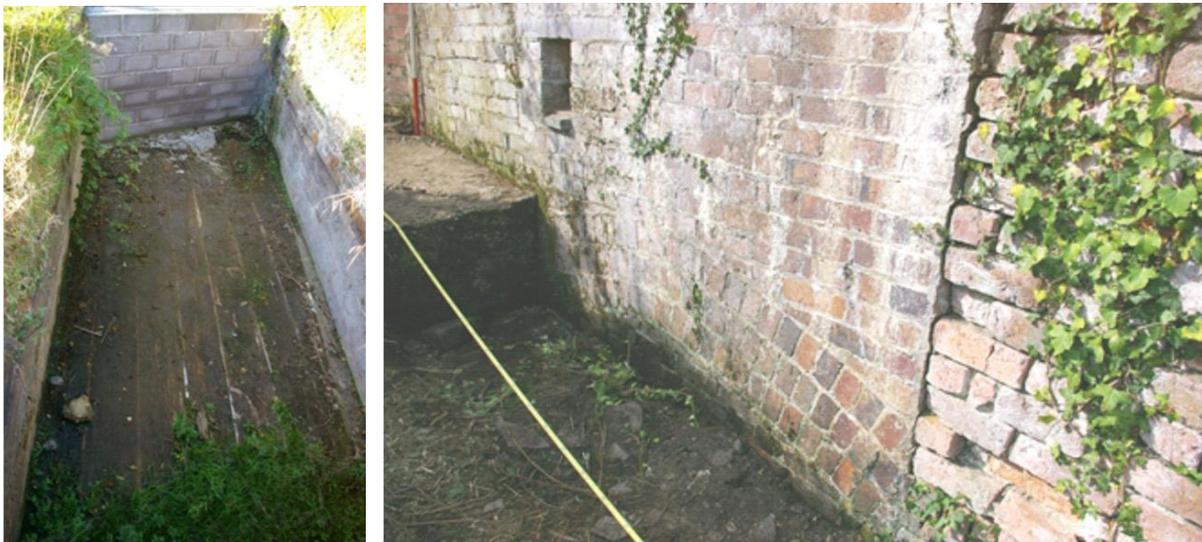
Fig.3.3.73 (left): The base of the leat above the head race, between the two retaining walls. (2009)

Fig.3.3.74 (right): The chute entrance and arch in the headrace wall, adjacent to the join between old and new brickwork. (2011)

The third section runs from this point into the main leat channel, and it is constructed in a more modern hard red brick. Just beyond the turn the leat is divided by two retaining walls that have been constructed to cut off the flow of water to the mill. The first of these is built in the same hard red brick as the side wall in section three, and it is likely that it was built in around 1955 when the mill building was demolished. The second wall has been built using modern breeze blocks and was constructed in around 2008 or early 2009. Subsequently the area between the two walls has been completely backfilled with building waste. While no longer visible, the bottom surface of the leat between these two walls comprises quality timbers closely joined together and caulked (Fig.3.3.73).

Immediately in front of the concrete step there is an arched section of brickwork that is located at ground level. It seems unlikely that there would have been an opening at this point as the area behind the wall is solid ground. Coupled with this, the arch is located at the junction of what appears to be old and newer brickwork. The old brickwork marks the west end of the inner mill, whereas the new marks where the extension in the upper yard once stood (Fig.3.3.74).

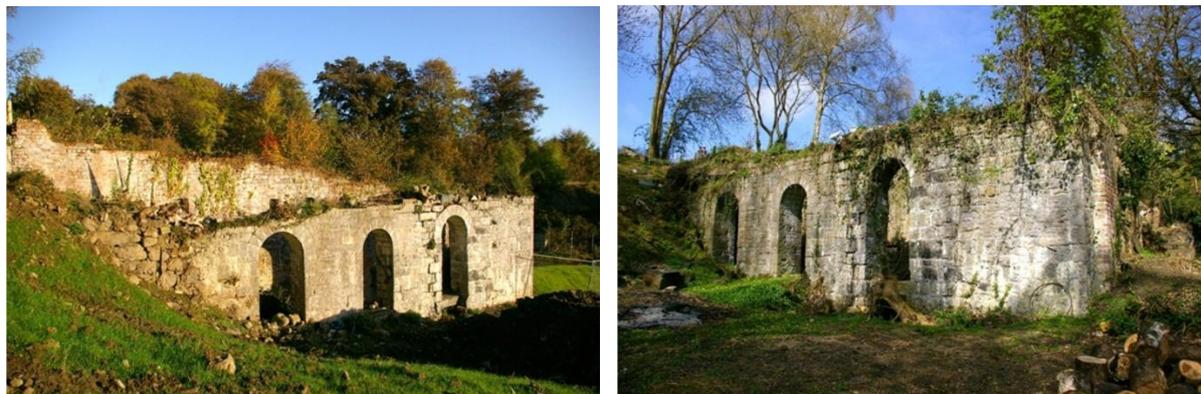
Fig.3.3.75 (left): The contrasting stonework in the outer wall of the water wheel pit, with the rough stonework visible adjacent to the embankment. (2009)

Fig.3.3.76 (right): The outer wall of the water wheel pit, showing the stepped-back brickwork at the east end. (2006)

it finishes just short of the end of the pit, giving way to brick that in turn is slightly stepped back from the stonework (Figs.3.3.75 & 3.3.76).

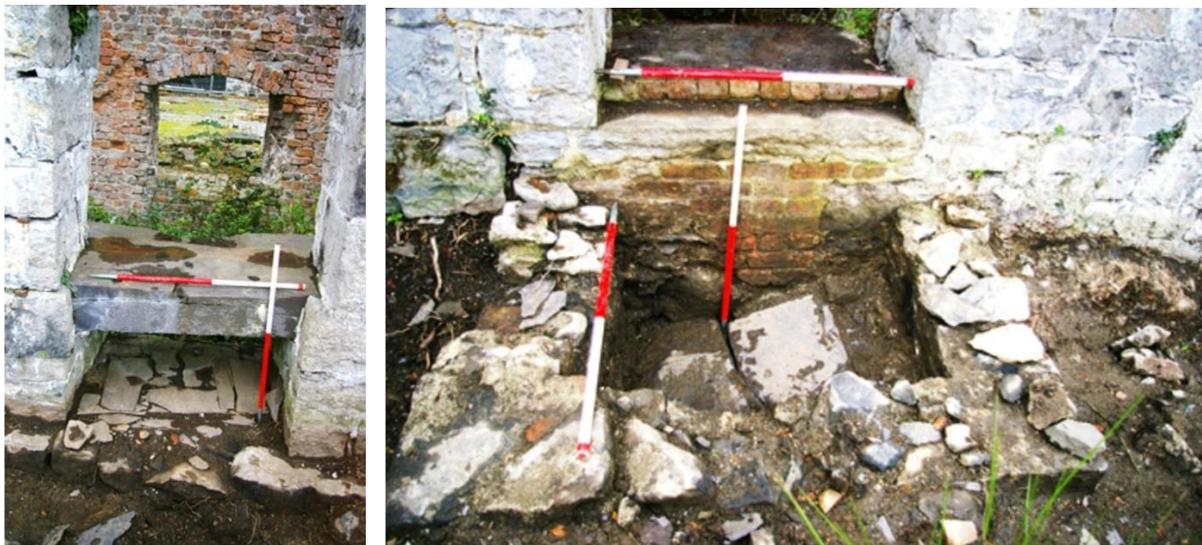
Fig.3.3.77 (left): The area in front of Arch 1, without a pit. (2011)

Fig.3.3.78 (right): The pit in front of Arch 2. (2011)

The pit in front of arch 2 (Fig.3.3.78) is not totally symmetrical. Internally it measures 1.12m at the rear (immediately adjacent to the wall), and 1.18m at the front. The west side wall measures 86cm and the east wall 82cm. The maximum external dimensions are 1.9m at the rear and 2.02m at the front, while on average the walls are 38cm wide. The pit had been backfilled with waste material and contained several pieces of honeycomb tile from a drying floor, fragments of ribbed jam/marmalade jars, and miscellaneous pieces of broken bottles, wood and metal (all listed in Section 8, Finds).

There is no pit in front of arch 1 and, unlike with the other two arches, the area beneath the axle mounting slab has not been bricked in. Why this should be so is not at all clear, although one possible explanation is that as this arch is lower down the slope than the other two, the ingress of unwanted

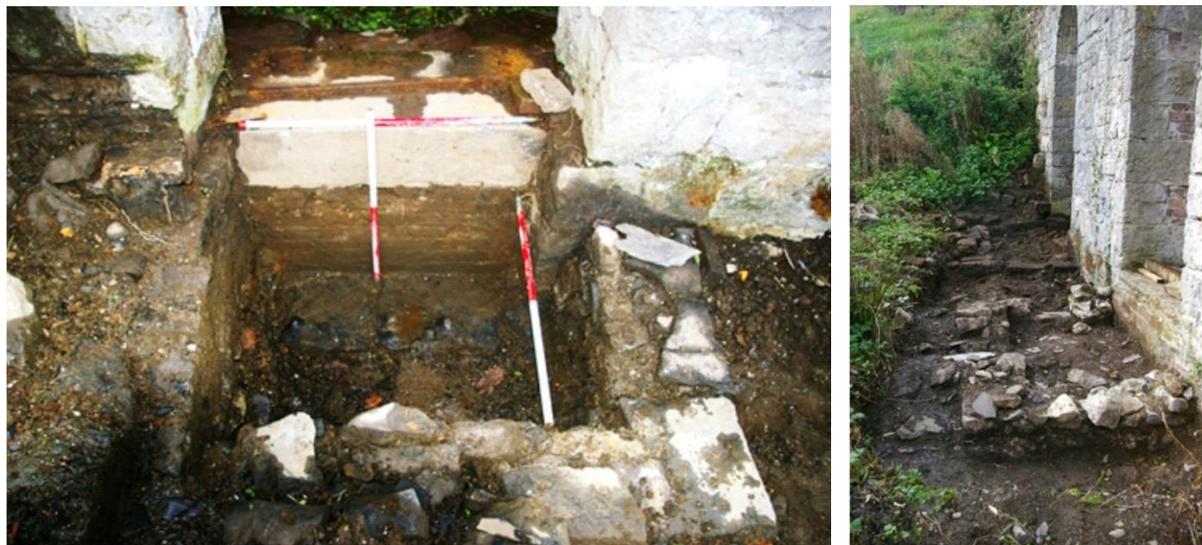
Fig.3.3.79 (left): The pit in front of Arch 3. (2011)

Fig.3.3.80 (right): First view of the pits in front of Arches 2 & 3 before they were excavated. (2011)

There is nothing directly linking pits 2 and 3, and there is only rough ground between them (Fig.3.3.80). When and why they were built is not clear, especially as they do not appear to have a defined inlet or outlet. Nor is it clear whether they were bricked in from the outset or whether this work was undertaken at some later date. The fact that they are not uniform in size and are relatively crudely constructed by comparison with the rest of the building possibly indicates that they were a later addition, perhaps in response to a newly apparent need. One possible explanation is that they were built to stop material from the adjoining embankment passing through into the water wheel pit, although this is highly unlikely as the same result would have been achieved simply by bricking in the wall beneath the cills, which they did anyway. Similarly, having noted during excavation work that water from the embankment seeps quite freely into them, they could have been built to stop the unwanted inflow of water into the water wheel pit. Once more this seems unlikely as again bricking in the base of the wall would prevent this from happening; unless the pits were built first, were found to be inadequate, and therefore the bricking in took place later. The position of the pits, outside the mill and in line with the water wheel axles, precludes them having any processing function.

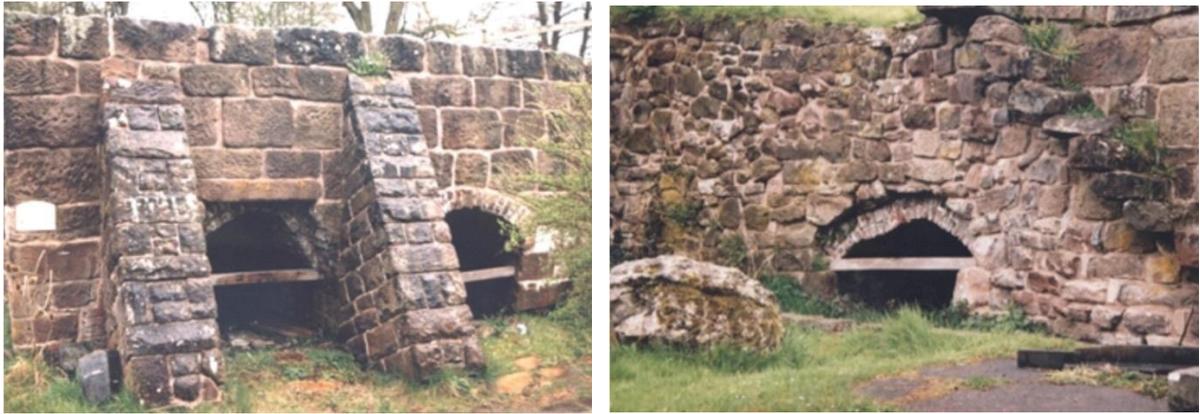
Fig.3.3.81 (left): The flint kiln at Cheddleton Mill (2005)¹⁸⁴

Fig.3.3.82 (right): Draw vent for the flint kiln at Cheddleton Mill. (2005)

Flint mills developed in order to provide a raw material for the production of fine pottery, being used to improve both the whitening and strengthening qualities. Before the flint can be mixed with the other materials it has first to be rendered to a fine particulate, which is where the milling or grinding process comes in. As flint is a naturally hard material, before it can be ground generally it has first to be calcined (burnt) in order to make it easier to crush. This is done in a brick-lined kiln that is filled with alternate layers of flint and coal slack, usually in the proportion of about one ton of slack to twenty tons of flints.¹⁸³ The mixture is then fired from the base of the kiln and allowed to burn naturally (Fig.3.3.81 & 3.3.82). Usually the calcined flint is then crushed, typically in some form of stamp mill or, more recently, a granulator, before passing to the grinding pan. Not all flint mills have a kiln but instead rely on the flint being reduced by crushing alone.

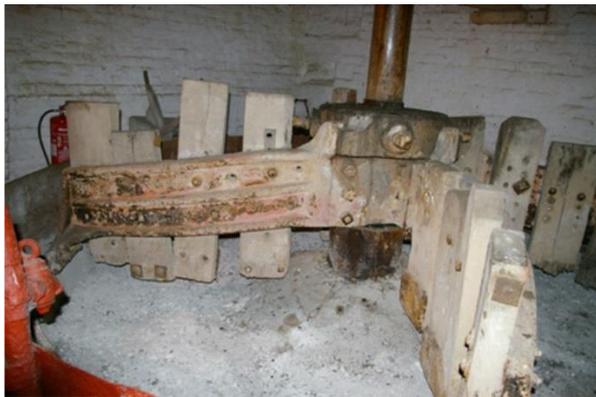
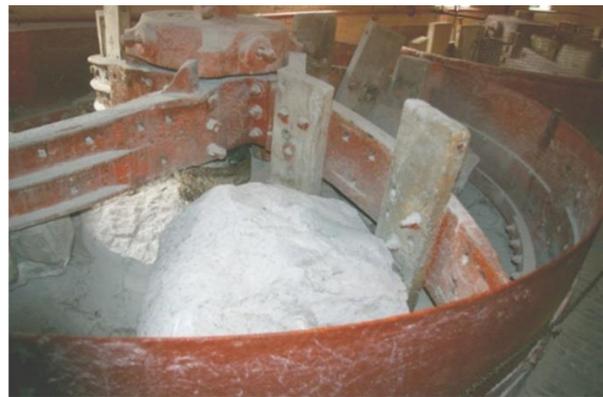
Fig.3.3.83 (left): A typical grinding pan showing the drive shaft, sweep arms, and hanging arms. The brake drum is also visible on the shaft.¹⁸⁶ (2011)

Fig.3.3.84 (right): A runner stone inside the grinding pan. The weight of the runner stone can vary between 1-30cwt (2011)

The grinding pan consists of a circular wooden or metal structure, typically around three feet high. Inside this outer surface, that is known as 'staffing', there is a continuous band of iron called a 'slug iron'; designed to ensure that the runner stones do not fall against the staffing, and that the sweep arms are kept at their correct distances. The base or floor of the pan is paved with a level layer of chert stones known as 'pavers', that typically are between nine and fourteen inches thick: the equivalent of the lower mill stone in a corn mill. They are grouted in with broken pieces of flint, and then sealed with clay to ensure that water does not percolate through (Figs.3.3.83 & 3.3.84).

In the centre of the pan there is a vertical shaft to which are attached either three or four metal paddles or 'sweep arms', that usually are made of cast iron. To each of these arms there is attached a number of heavy wooden hanging arms that are designed to protect the sweep arms from abrasion. Typically, these hanging arms are made of oak and are fitted with metal toe plates for protection against wear. They also have slots that enable them to be adjusted up or down. The shaft is driven from beneath the pan by a large horizontally mounted cog wheel that is known as a 'wallower', and this in turn is driven by a vertically mounted pit wheel that is driven by the main shaft from the water wheel (Fig.3.3.85). Typically, the shaft extends vertically above the grinding pan in order to provide power for additional ancillary machinery, such as pumps or hoists. The sweep arms can run freely on the shaft, where they are tightened by a brake strap or drum. The brake drum is designed to provide a slip mechanism in case a paver stone becomes jammed and causes damage. The speed of the drive shaft will depend on the diameter of the pan, and typically this will be between 12-18 revolutions per minute.

As the central shaft is rotated by the power source, in the case of Penlan Mill the water wheel, so the paddles rotate heavy runner stones that then grind the crushed flint to a fine powder. Usually the runner stones are a form of chert which, being softer than the pavers, wear more quickly. During the grinding process the flint is mixed with water in order to minimise the amount of dust produced. Prior to Benson's patents of 1726 and 1732 the flint was ground dry, resulting in silicosis and a reduction in the working life expectancy of the operative to around two years: the result being that it became virtually impossible to find people willing to perform this task.¹⁸⁵

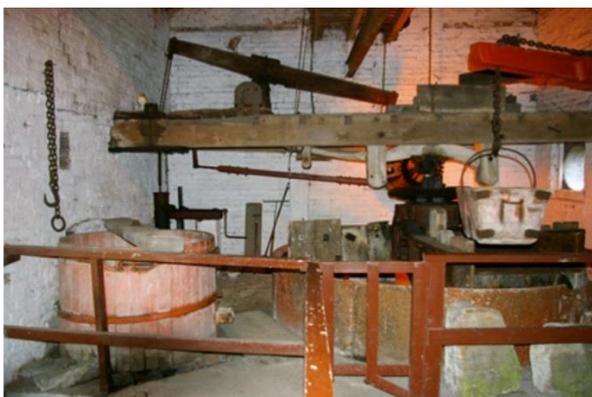
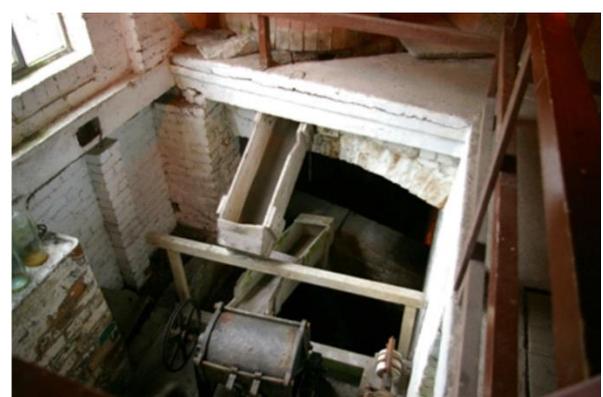
Fig.3.3.85 (left): The first floor at Cheddleton Mill. The grinding pan is to the right and the wash tub to the left. The beam engine and pump are in the background. (2011)

Fig.3.3.86 (right): Cheddleton Mill. The ground solution passing via a chute from the wash tub (top of picture), into the settling ark below. (2011)

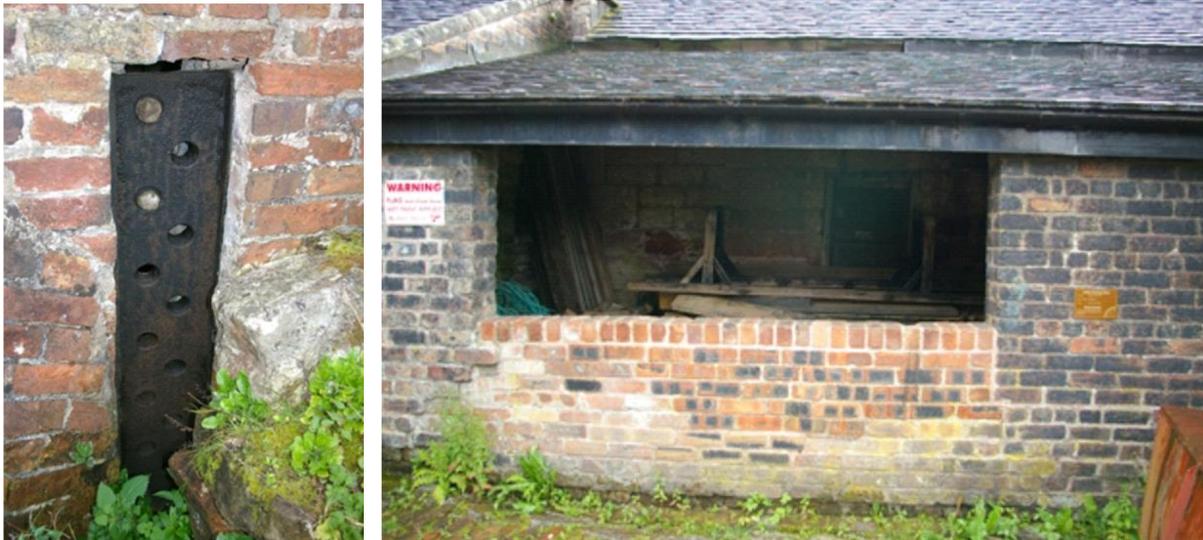
Fig.3.3.87 (left): A typical 'plugplank'.

Fig.3.3.88 (right): The slip kiln at Cheddleton Mill where the material from both of the mills is channelled for drying.

In the side of the wash tank there are a series of vertical holes in each of which is a wooden plug through which the water is drawn off from the top downwards, (hence the name 'plug-plank'). The top layer of very fine flint is run off into a drainage channel and the intermediate layer is run into a settling tank or 'ark'. The remaining layer of heavy coarse material is pumped from the wash tank back into a grinding pan where it is mixed with fresh material for re-grinding. The material in the ark is allowed to settle before the plugs in the side of the ark are removed and any remaining water drained off. The material is then pumped into a drying (slip) kiln where it is heated via a form of hypocaust. When sufficiently dried it is packed into tubs or blocks ready for shipment.

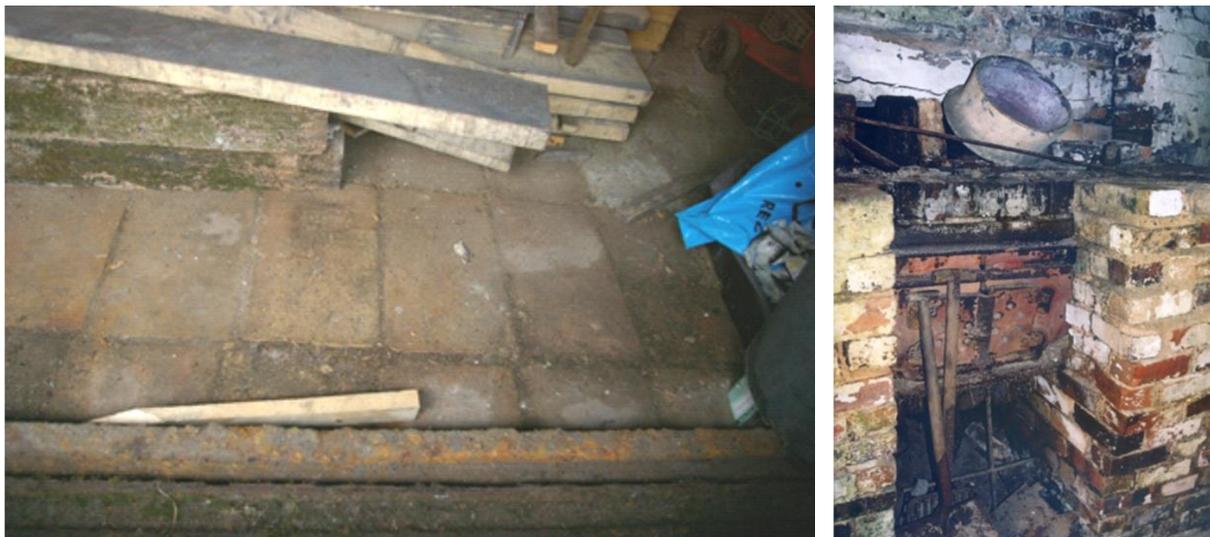
Fig.3.3.89 (left): The tiled base of the slip kiln.

Fig.3.3.90 (right): A slip kiln oven.

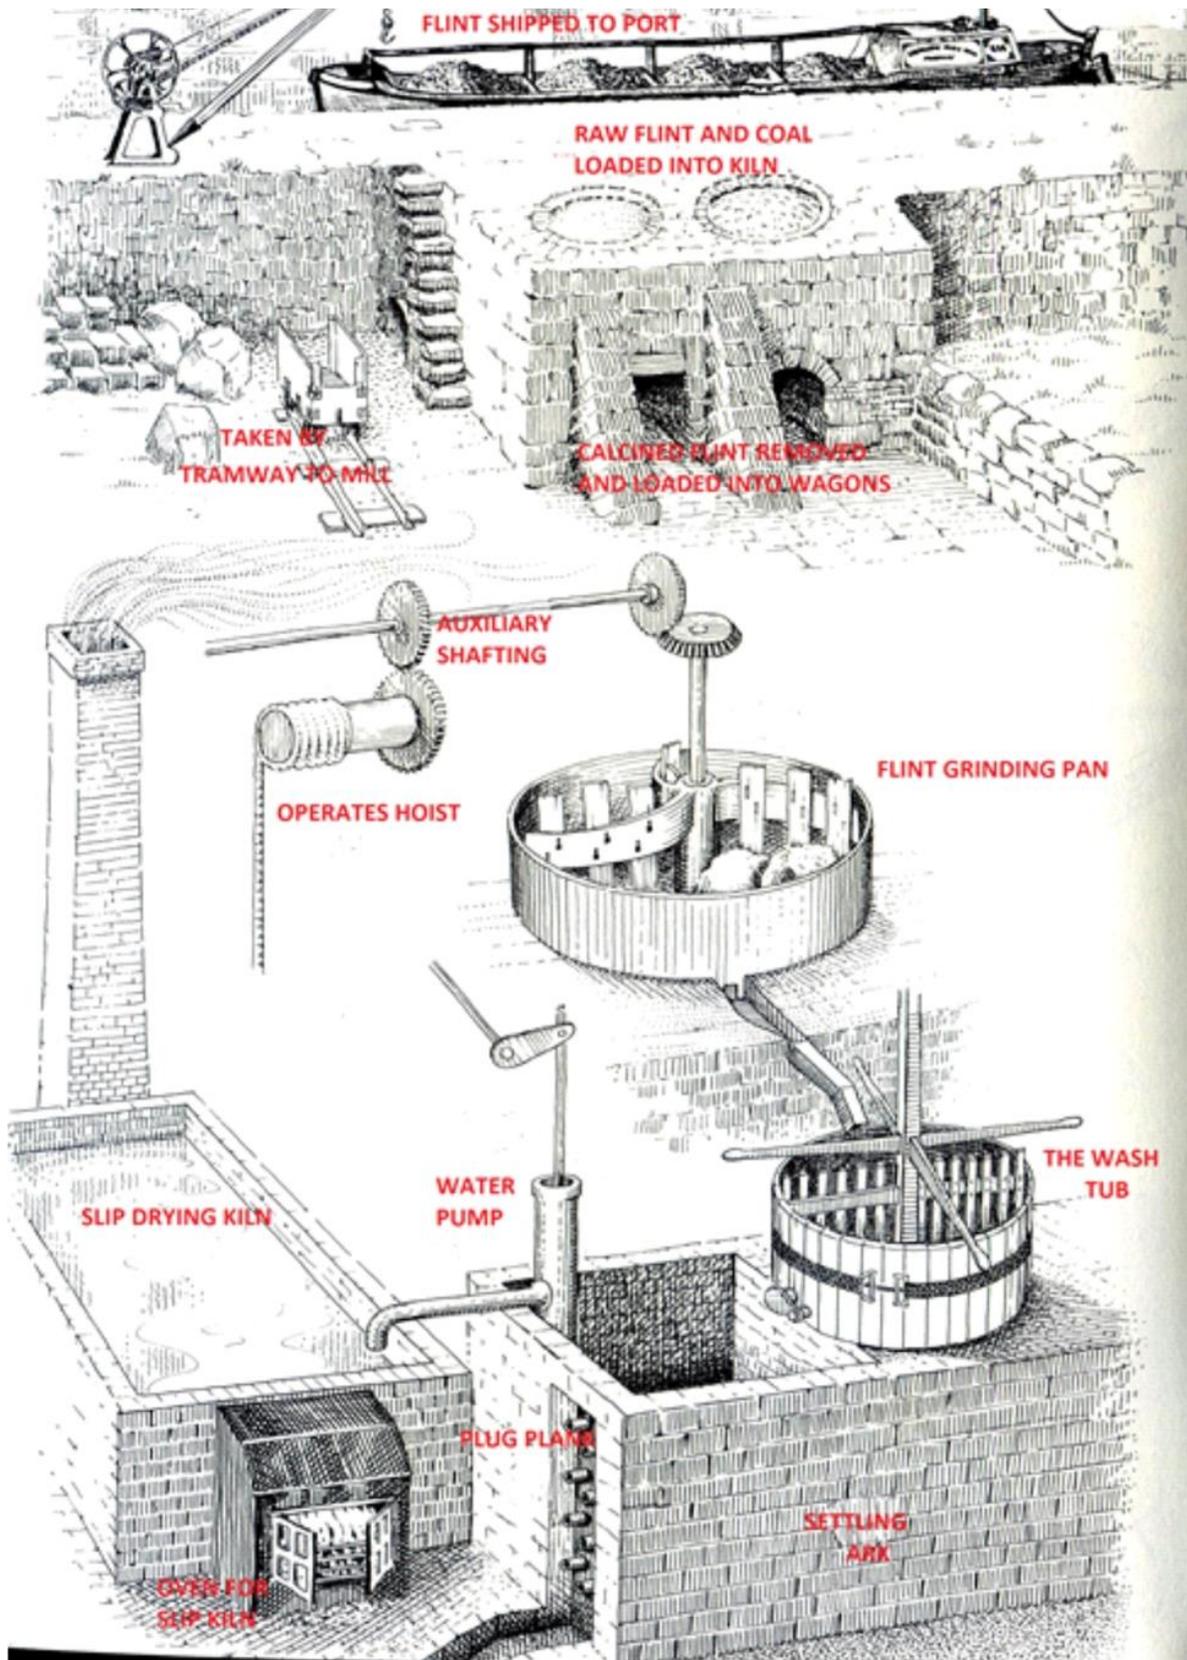
Fig.3.3.91): The flint grinding process.¹⁸⁷

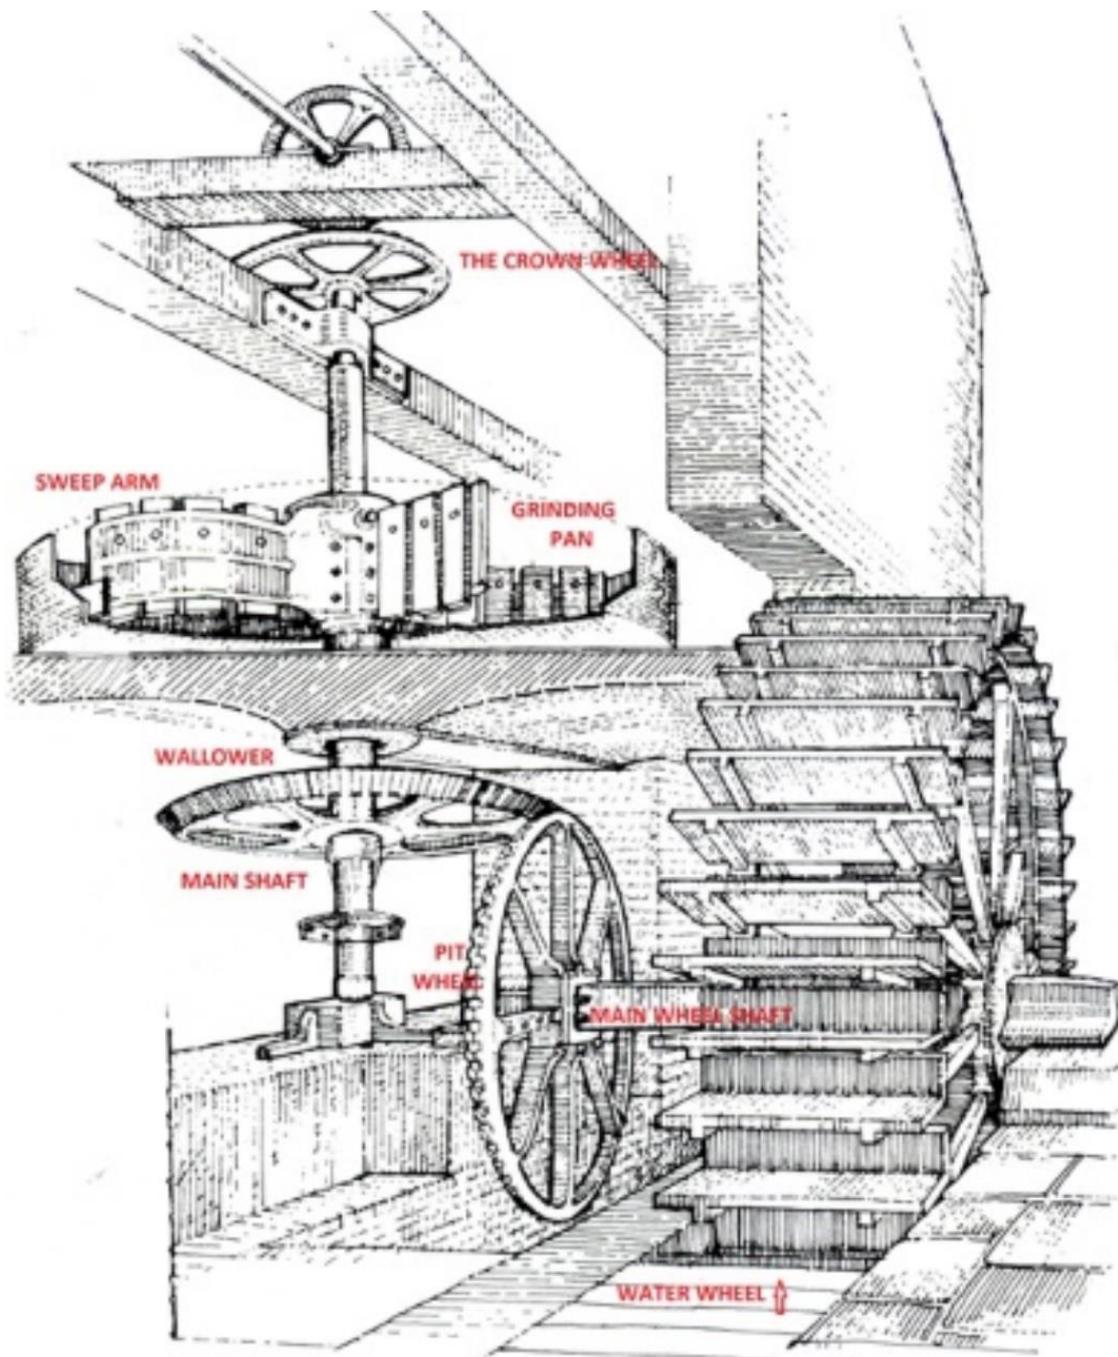
Fig.3.3.92: Typical gearing at a flintmill.

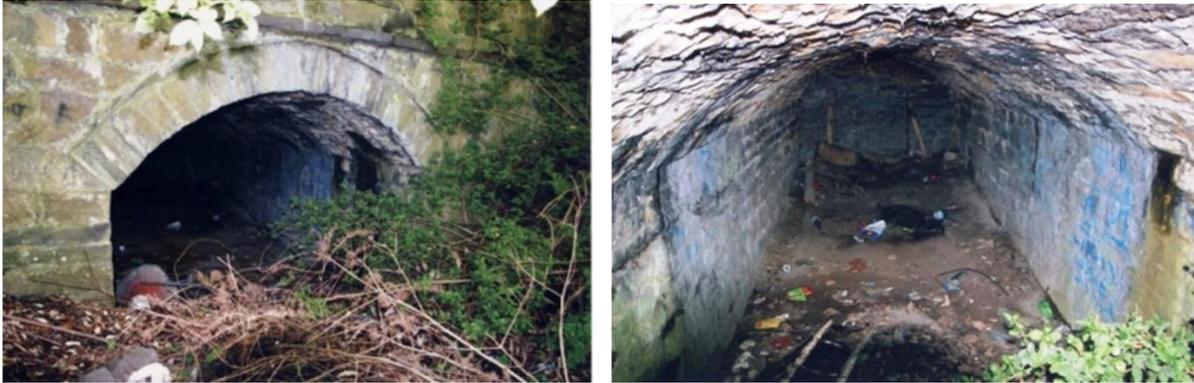
Fig.3.3.93 (left): The tunnel entrance beneath the road at Llandegai. (2006)

Fig.3.3.94 (right): Inside the tunnel, which is now bricked-up at one end. (2006)

front of what is now the mill cottage, to the chute above the west wall. Apart from the tunnel some additional evidence of the tramway still exists. For example, the bed is evident in the garden to the rear of Tanygraig in Llandegai; and the winding house cottages at the Marchogian incline, that runs parallel to the A5 trunk road into Bangor, opposite the Crematorium. Originally Incline Cottage had been two separate buildings with the tramway passing between them, but subsequently they have been converted to a single private dwelling today known as Incline Cottage (Fig.3.3.95). The route taken by the tramway is shown at Fig.3.3.96.
