**Richard Pennant, Samuel Worthington and the mill at Penlan
a history of the Penrhyn Mills on the Lower Ogwen**

Richard Pennant, Samuel Worthington, and the Mill at Penlan

A History of the Penrhyn Mills on the Lower Ogwen

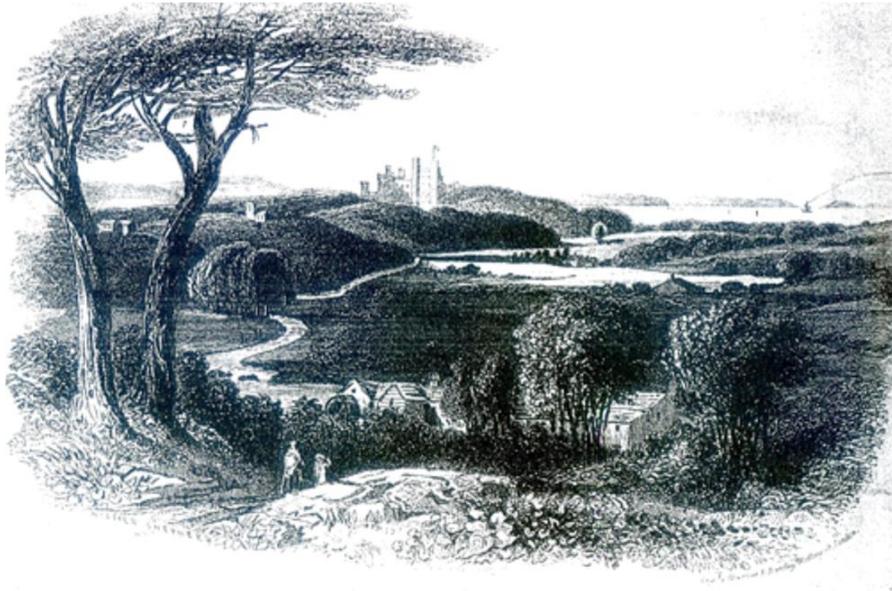
Fig.3.3.97: The picture depicts Penrhyn Castle in the background, viewed from Penlan. The building to the left in the foreground appears to be Penlan Mill as there is a water wheel shown to the south side, whereas the river is behind it. Based on its relative location, possibly the building to the right depicts Felin Isaf. (c.1840s)²⁰¹

None of the roof has survived and the only evidence we have comes from the lithographic print, shown below in Fig.3.3.97, in which it is shown running east-west, with twin gables facing south and possibly a chimney against the east wall; although the accuracy of this print cannot be relied upon. The only reliable data is that from the number of broken slates found on the site it is safe to assume that the roof was slated, and this is borne out by an entry dated 2nd May 1798 in the Account headed 'Expenses for Building Flint Mill', that states 'Settled with Lord Penrhyn for Slates used at the Flint Mill £38-12-0'.¹⁷³ A small piece of rounded slate ridging tile was also found (see under 'Items found on site' item 11/007/001), although it cannot be assumed that it actually came from the mill itself. The use of slate would also have been consistent with contemporary mills such as those at Cheddleton and Higher Washford. Based on the evidence furnished by (Finds) Item 06/06/007, which is a line shaft mounting still affixed to timber, it would appear that the roof trusses measured 85mm deep x 70mm wide.

All subsequent documents issued by the Penrhyn Estate make reference to there being ‘wheels’, plural. In May 1823, when discussing the possible conversion of the mill, Mr Baxter refers to ‘*the repairs and alterations to the wheels*’. There is nothing to indicate what was meant by the word alterations, although conceivably it could have referred to the enclosure of the water wheel pit. In the lease dated 28th December 1859 between Roger Evans, miller, and Lord Penrhyn the reference is to ‘*the repairs of the water wheels attached to the mill & the driving wheels thereon*’.¹⁹⁷ In the plan attached to the lease of 10th December 1883 between Thomas and Henry Lewis and Lord Penrhyn, the mill is shown as having two wheels in tandem,¹⁹⁸ and in a 1912 report for the Silurian Iron Ore Company the surveying engineer describes the mill as having ‘*two powerful Water Wheels, measuring each 20 feet diameter and 6 feet wide, also both are “over shot” with plenty of water all the year round*’.¹⁹⁹ Finally, as part of his assessment as to the use of the mill as a power source in connection with his iron mining venture, in 1924 E. J. Morris wrote ‘*a water power of about 100 H.P. is available at this old mills, - two water wheels 20’ x 6’ is already there*’.²⁰⁰ Whereas the physical evidence is both inconclusive and contradictory the documentary evidence is not; the exception being that somewhat frustratingly the c.1840 lithographic print only clearly shows one wheel, although the second wheel may be obscured by the trees (Fig.3.3.97).

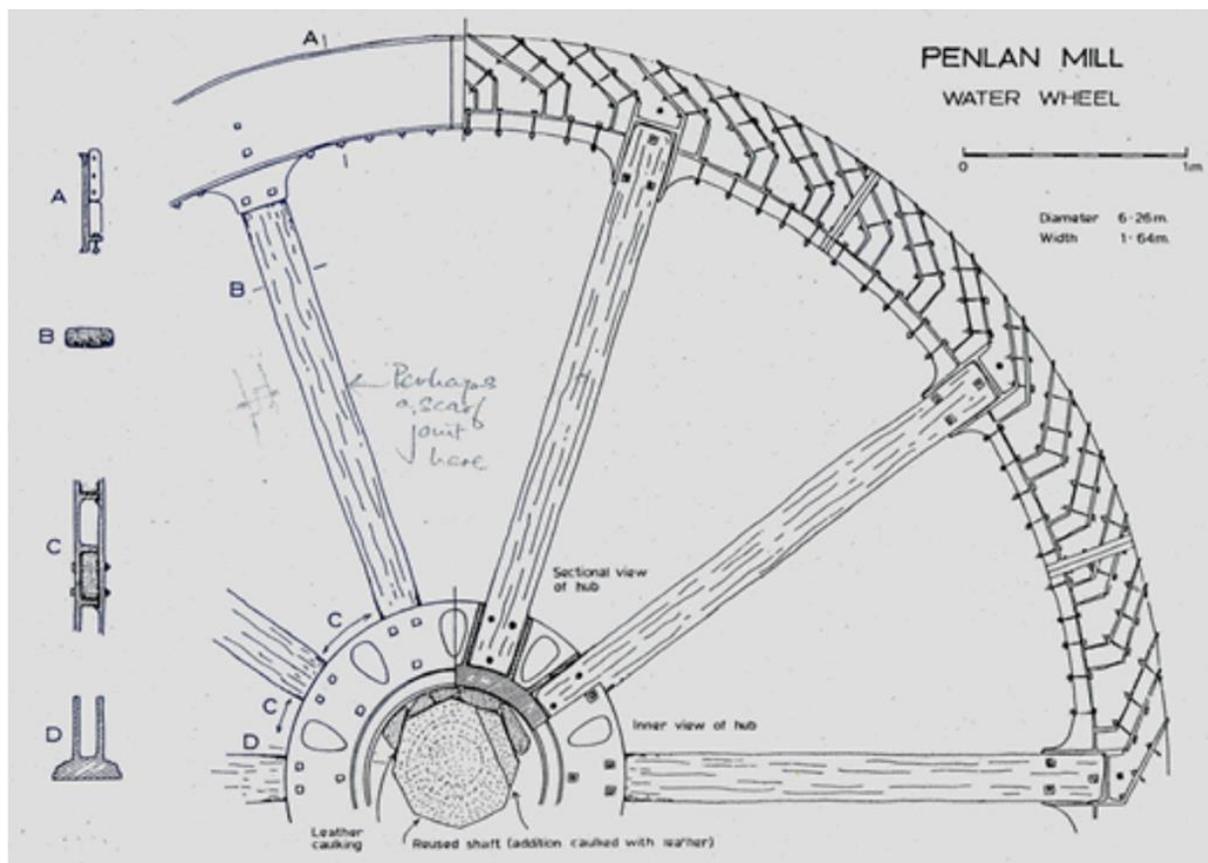
Fig.3.3.98: The water wheel at Penlan Mill as recorded in 1980.²⁰⁶

the tail-water from the first wheel would be in opposition to the water flow of the second, thus causing a 'drag' effect (Fig.3.3.99). A more efficient option would be that if the first wheel (the westerly) was a true overshot wheel, and the second was a backshot wheel (also known as a pitch-back wheel). With an overshot wheel the water from the head race is deposited on the top of the wheel, slightly beyond the axle, thus moving the wheel in a clockwise direction. With a pitchback wheel the water is still deposited on top of the wheel, but slightly in front of the axle and thus moving the wheel in an anti-clockwise direction. The result is that instead of the tail-flow from wheel one impeding wheel two it would assist it by providing additional thrust applied to the bottom of the wheel (Fig.3.3.100). The third option, and undoubtedly the most efficient, is that both wheels were pitchback, and thus both wheels would rotate in an anti-clockwise direction, with the tail-water from the first wheel adding impetus rather than impedance to the second.

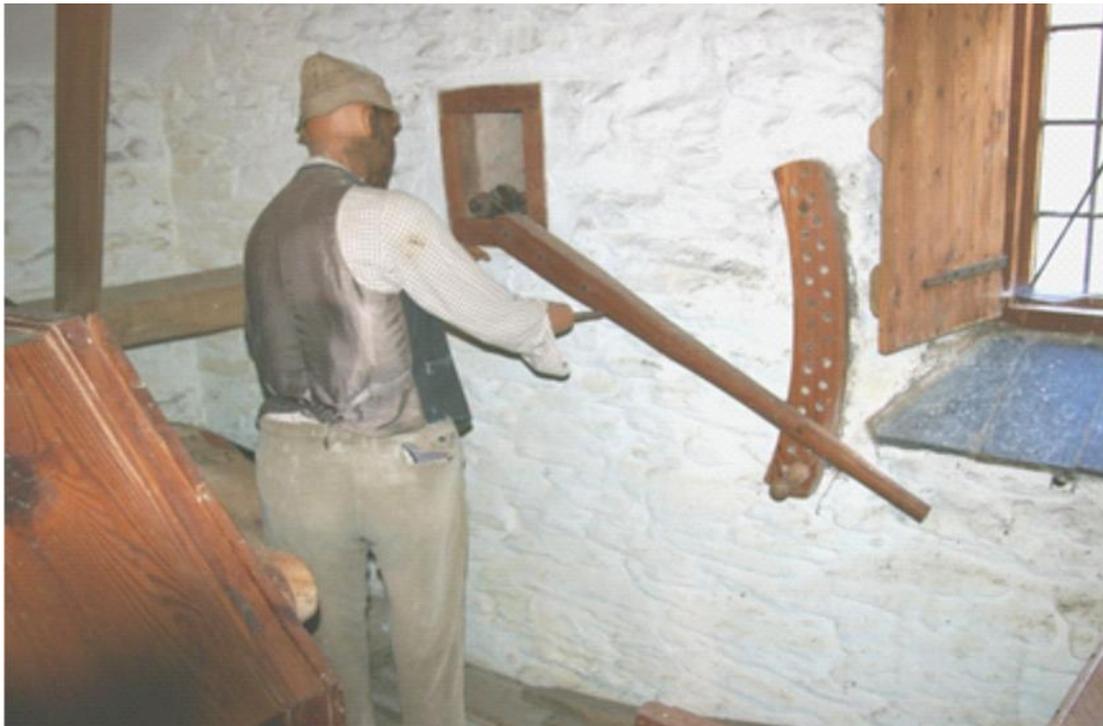
Fig.3.3.101: The control lever inside the mill, held in place by the peg board. The lever is connected to a shaft that goes through the wall and connects with the shutter control mechanism.²¹⁰

To operate the first wheel a shutter in the launder is depressed by means of a series of inter-connected rods that are operated via a long wooden lever inside the mill building. The degree to which the shutter is held open is controlled by a simple peg board, the peg holding the lever in place at the desired point, as shown below (Fig.3.3.101). As the shutter is depressed the water drops through the resulting aperture and on to a chute, from which it then drops onto the water wheel (Figs.3.3.102 to 3.3.104). The water is guided to the aperture by means of a wooden board sitting adjacent to it in the launder. When power is no longer required the aperture in the launder is closed simply by moving the lever in the opposite direction. To operate the second wheel the shutter to the first wheel is closed and the water passes over it to a similar arrangement at the far end of the launder (Fig.3.3.105).

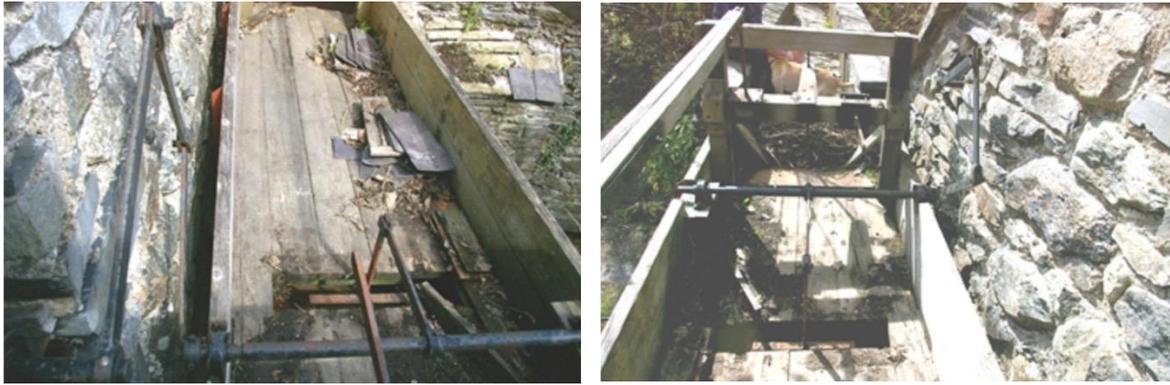
Fig.3.3.102 (left): The control levers operating the shutter in the floor of the laundry.
In this illustration the shutter is depressed to the open position.

Fig.3.3.103 (right): Reverse view of the control levers with the open shutter in the foreground.
The laundry is visible in the background.

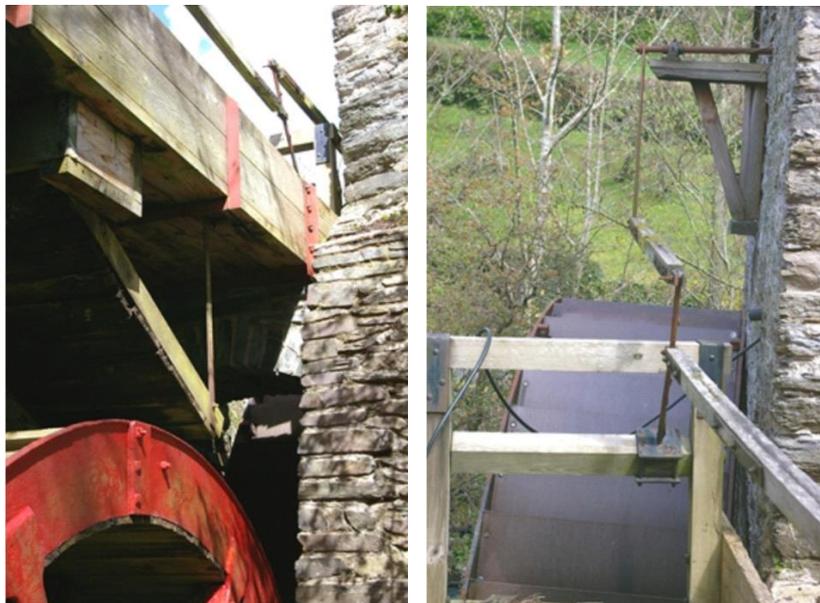
Fig.3.3.104 (left)

As illustrated in Fig.3.3.104, with the shutter depressed water falls onto the chute beneath the launder, where it passes onto the wheel. The control levers for the second wheel are visible top right. The control levers for the second wheel (Fig.3.3.105) are operated from inside the mill.

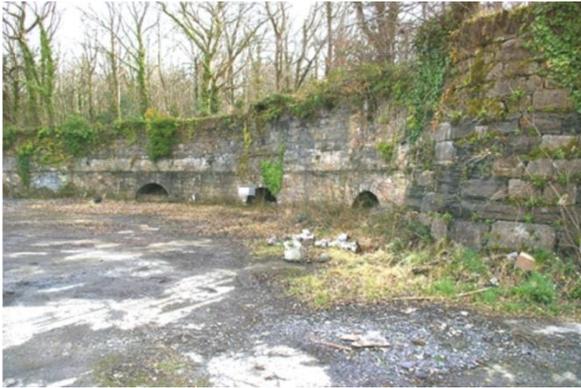
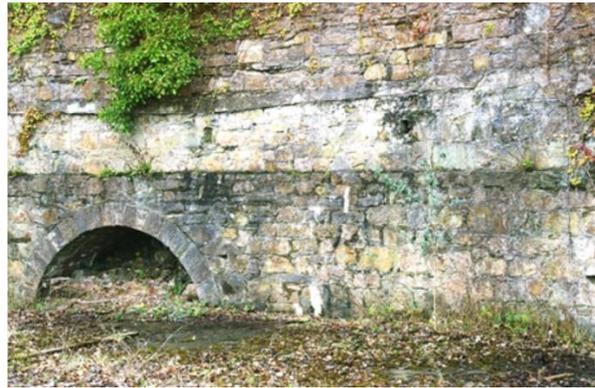
Fig.3.3.106 (left): The kilns at Port Penrhyn. (2010)

Fig.3.3.107 (right): The kilns at Port Penrhyn, showing the draw vent and different strata of stonework. (2010)

Port Penrhyn remains a strong contender, even though the construction of the new kilns was not directly related to the development of the Penlan Mill site, but rather for the purpose of producing lime for the Estate's new building programme, as well as to support the improved agricultural methods introduced by Richard Pennant and Benjamin Wyatt. Also, this location would ideally have suited Worthington & Co. as not only did they hold the lease on the port but also had an office there. In addition, their transport link to and from the mill and the slate quarry passed close by. Being astute business men, they also would have seen the opportunity afforded by having easy access to the raw materials required for their newly acquired pottery, as well as the means of processing them without incurring the disfavour of their neighbours at the Toxteth site in Liverpool.

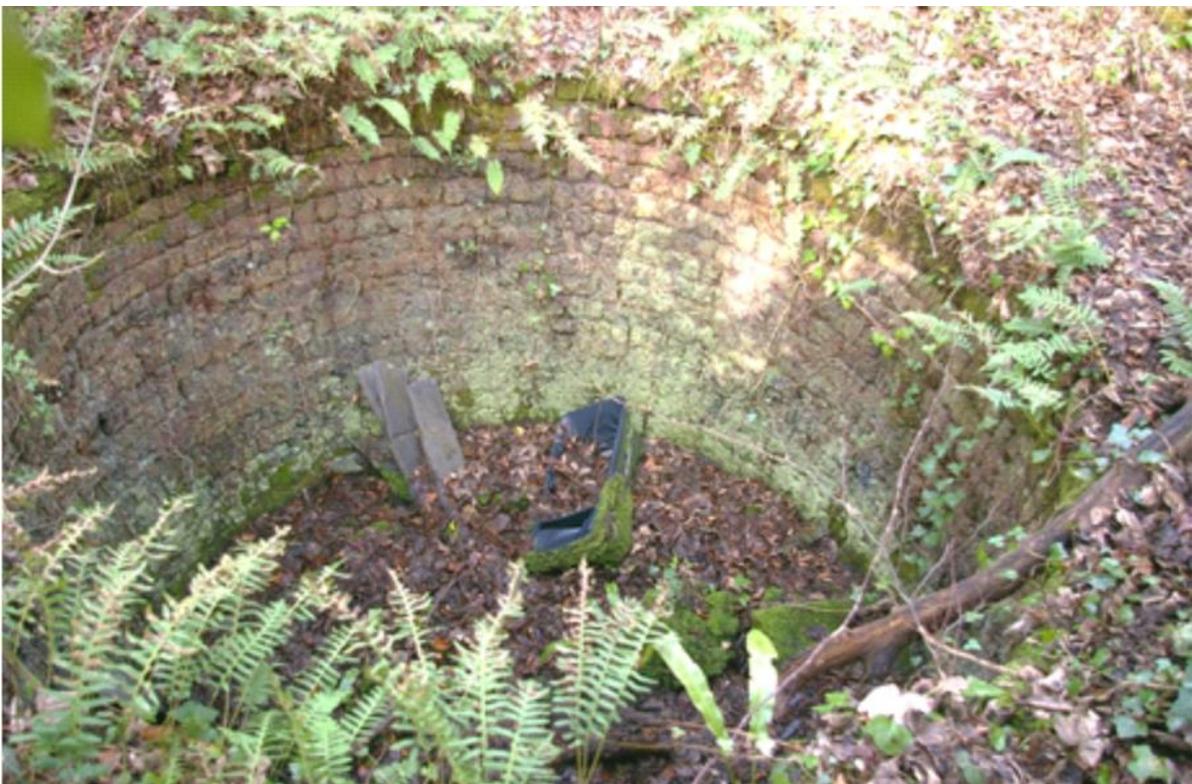
Fig.3.3.108: The interior of one of the kilns. (2010)

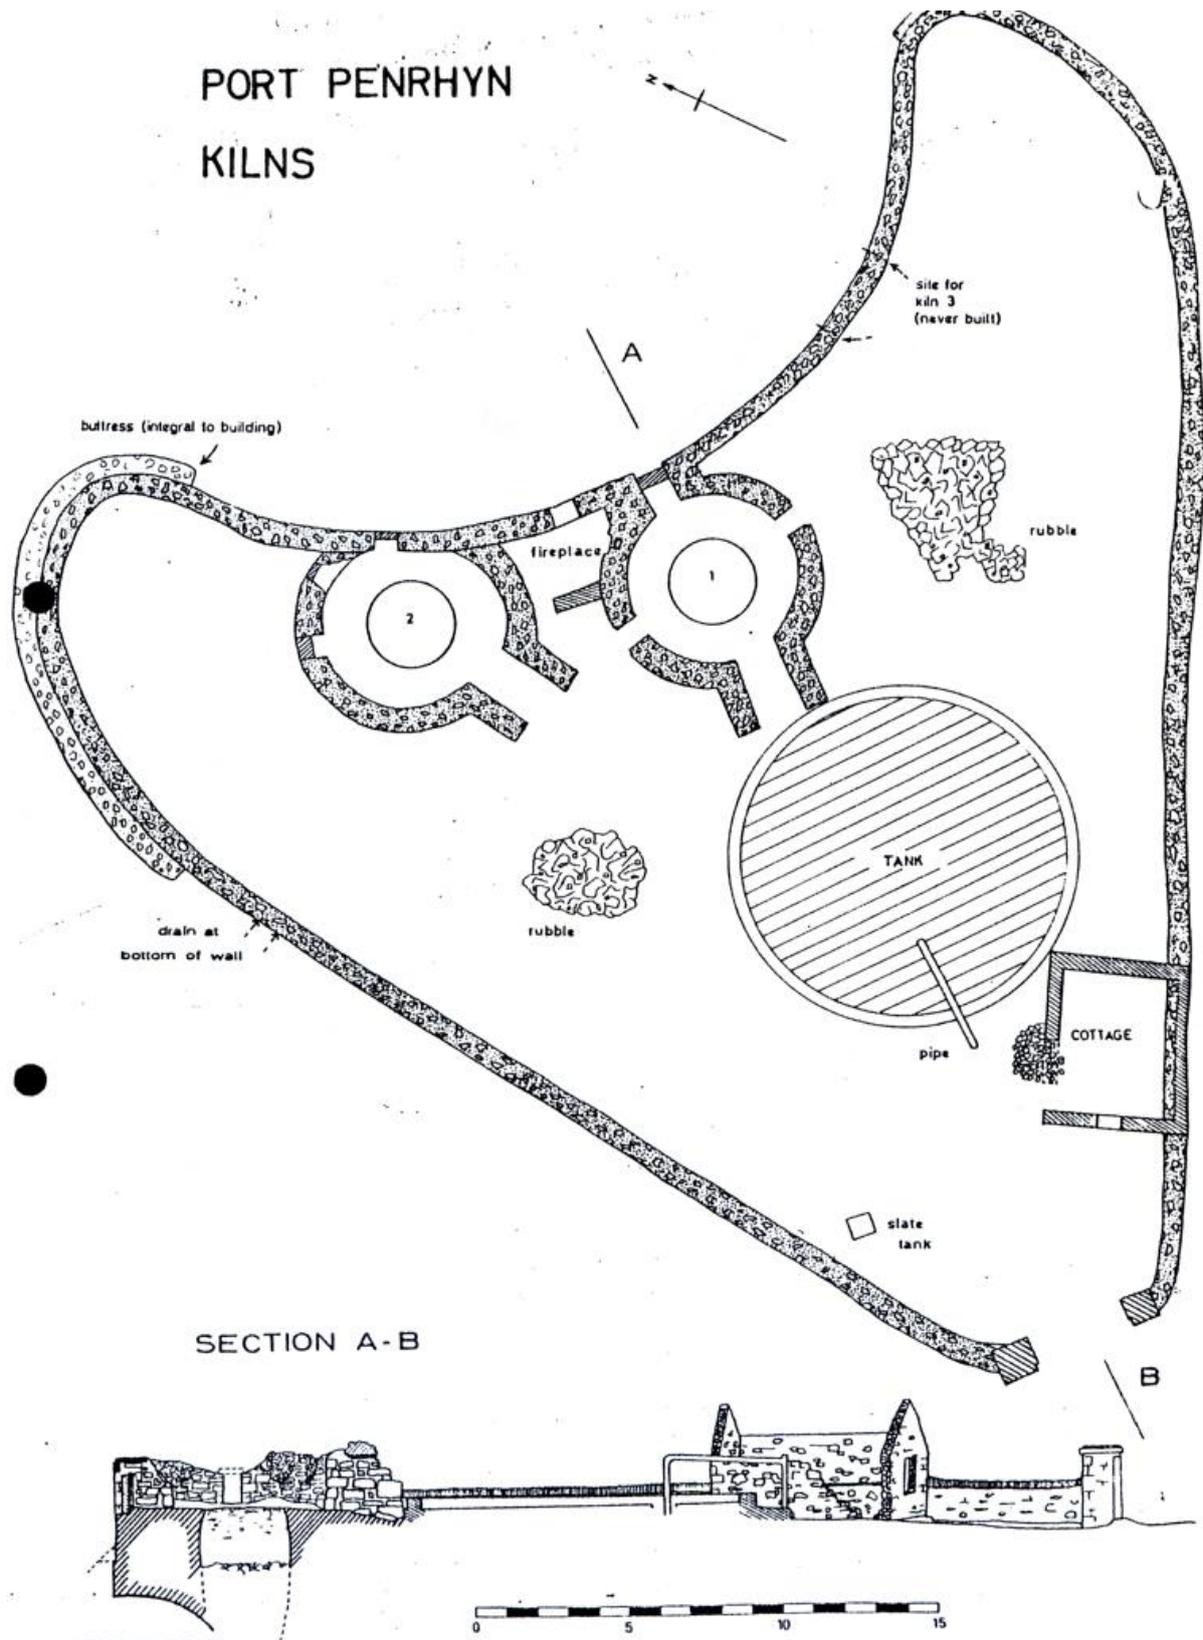
Fig.3.3.109: Plan of the Port Penrhyn kilns. (1980)²²⁹

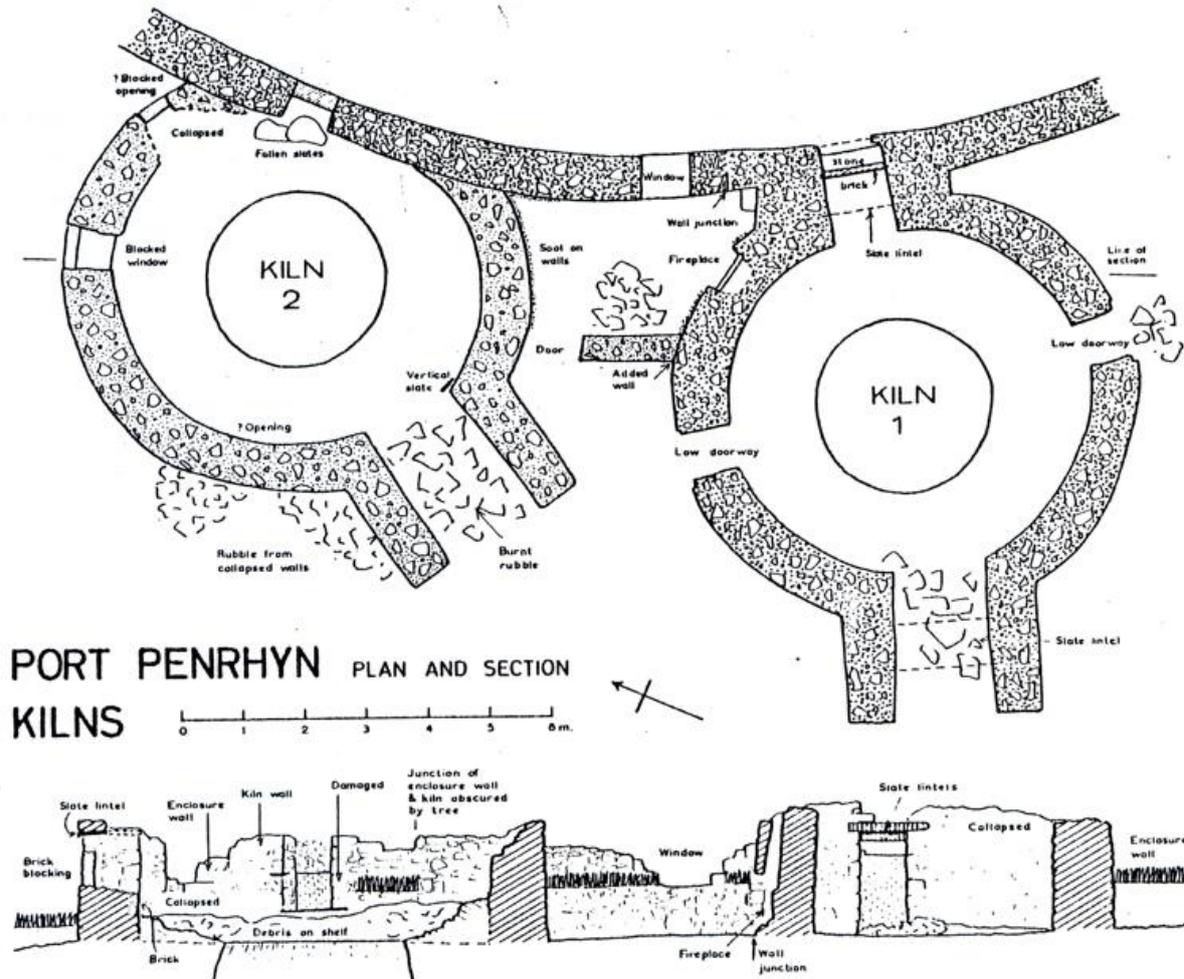
Fig.3.3.110: Plan and section of the Port Penrhyn kilns. (1980)

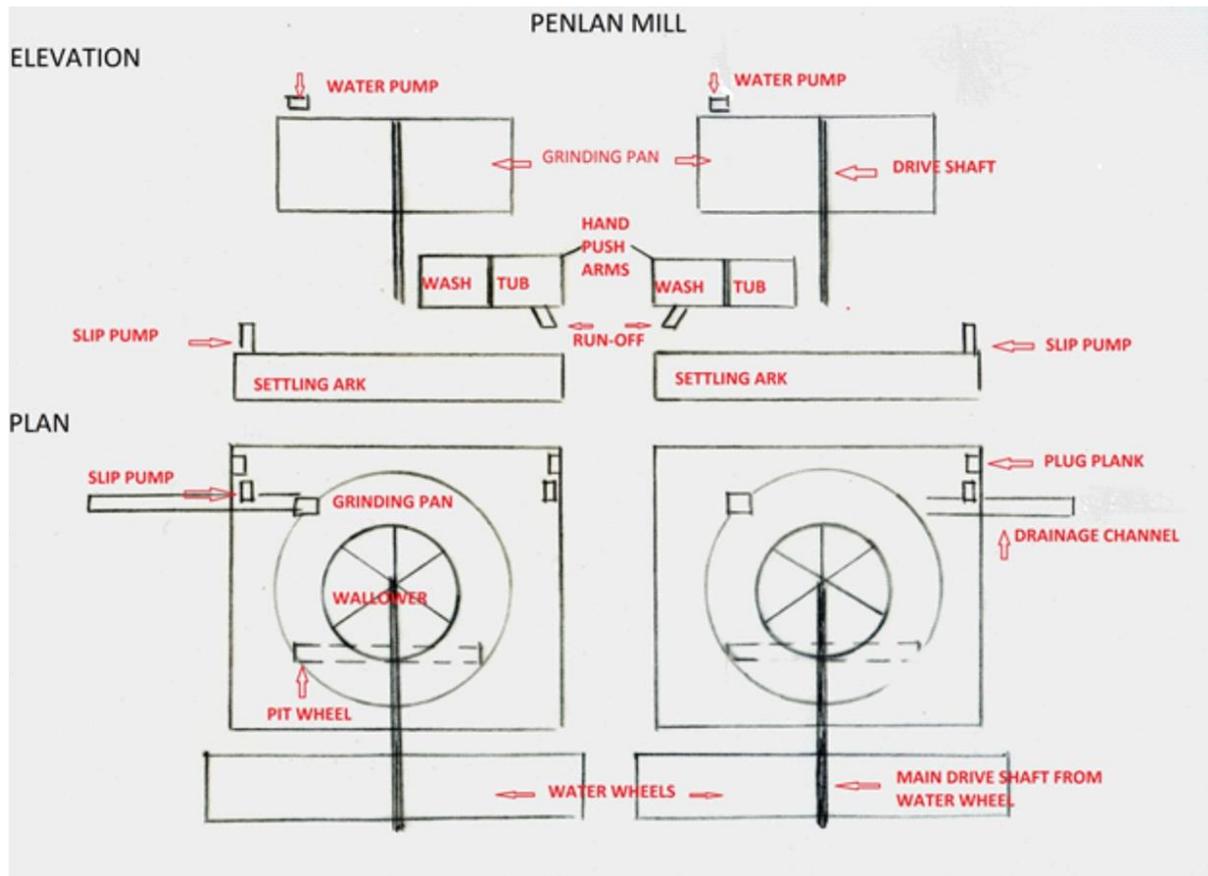
Fig.3.3.112: Schematic of the flint grinding process.²⁴⁴

Although none of the above scenarios offer any conclusive evidence it is likely that the second wheel could have been used in the same way as the first, i.e. for grinding flint, but with the power being delivered through an alternative gearing arrangement.

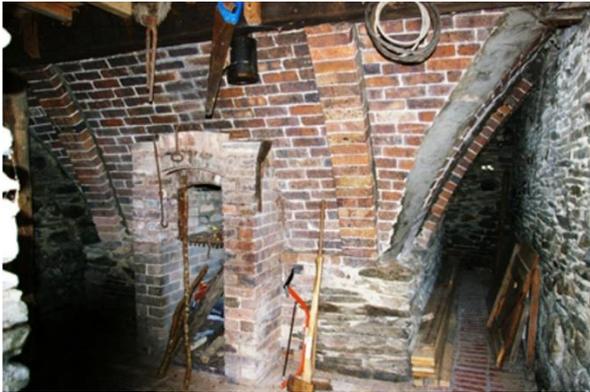
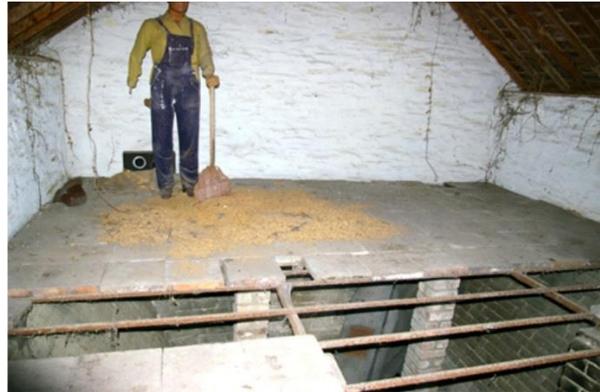
Fig.3.4.1 (left): The oat drying kiln at Felin Isaf, Glan Conwy, with the oven to the front side and the drying floor directly above. (2015)²⁴⁹

Fig.3.4.2 (right): Part of the drying floor at Felin Isaf, Glan Conwy, showing the brick support columns and metal frame. (2015)

Typically, the grain is dried on a purpose-built drying floor which is supported by pillars, and which is heated by a kiln or oven located immediately beneath it. Generally, the kilns are fairly large structures and together with the drying floor form what essentially is a form of hypocaust (Figs.3.4.1 & 3.4.2). The pillars can be brick, slate, or even metal. Typically, the drying floor comprises a large number of flat tiles that have a honeycomb surface to the underside, and a pattern of very small round holes on the top surface (Fig.3.4.3). The tiles are supported on a metal frame, with the heated air being circulated to the underside. As the type of kiln required for heating a grain-drying floor is fundamentally different to that used for calcining flint, a completely new kiln would have been required.

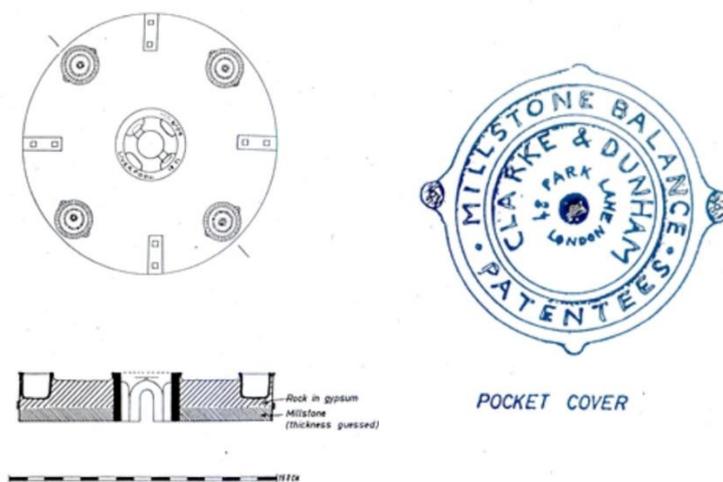
Fig.3.4.4 (left): Plan and elevation of the millstone found at Penlan Mill in 1980.²⁵¹

Fig.3.4.5 (right): The pocket cover.

When in 1980 Mrs Llewellyn and her students carried out their recording exercise they uncovered one of the original millstones, which she describes as being late 19th Century (1871) and originating from Liverpool. It had four balance pockets, which was a system patented by Henry Clarke and William Dunham of 48 Mark Lane, London. In this type of stone weights were installed in the wheels in vertical holes spaced at 90-degree intervals. The height of each stack of weights was adjustable by a screw, by which means the wheel could be made to rotate in balance and without wobble. Typically, the holes were covered by plates showing the patent date of 1859. The partnership dissolved by mutual consent in 1868, although William Dunham continued the business while retaining the partnership's name.²⁵⁰

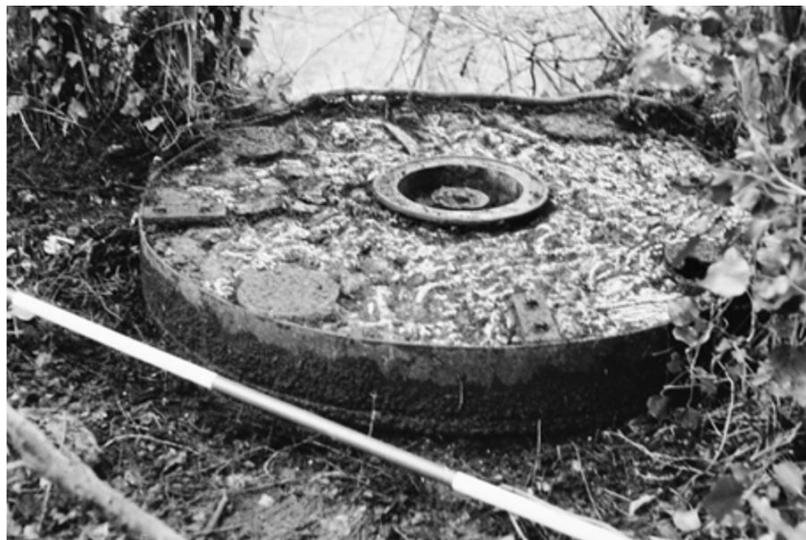
Fig.3.4.6: The millstone found on site at Penlan Mill in 1980.²⁵²

In 2006 the stone was still on site in the upper yard, covered by undergrowth. It appears that subsequently it may have been removed when the yard was cleared, although alternatively it may still be there but inaccessible due to the extensive shrubbery that has been planted. The drawings of the stone which Mrs Llewelyn completed in 1980 are included above (Figs.3.4.4 & 3.4.5), together with a contemporary photograph (Fig.3.4.6).

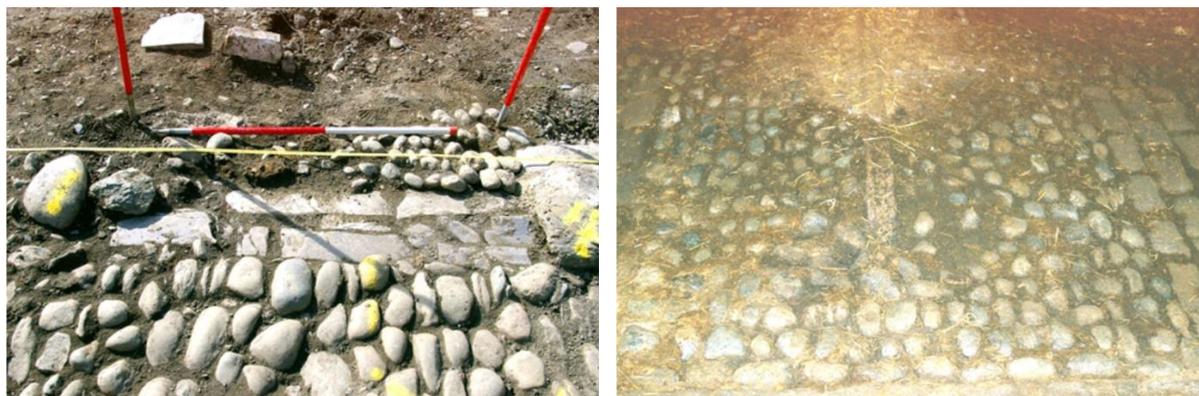
Fig.3.5.1 (left): The slate threshold in W/X 4 & 5. (2011)

Fig.3.5.2 (right): An example of a typical Penrhyn cobbled stable floor from the mid-1840s.

Mid-way along the east wall in W/X4-5 there is what appears to be a doorway, sufficiently wide to provide access for a horse. The opening is 1.4m wide and what remains of the slate threshold is 34cm in width (Fig.3.5.1). This compares with the stable doorway at Glan y Mor Isaf Farm (Glan y Mor) which is 1.05m wide. There are only two small areas of the floor surface still intact; those in the north east and south west corners being brick. The remaining floor area adjacent to the north wall is cobbled which again is in common with other Penrhyn stables; an example being the floor at Glan y Mor which is from the same period (Fig.3.5.2). There is no remaining evidence of either the southern half of the east wall or the south wall.

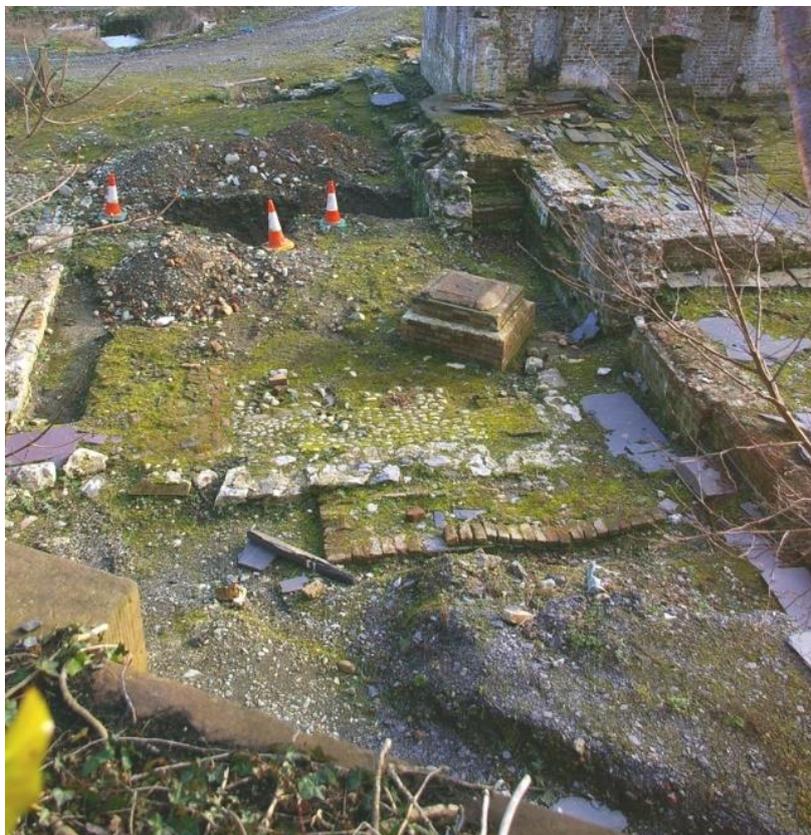
Fig.3.5.3: The stable area and cobbled road viewed from the north, with the possible harness room in the foreground. (2012)

Immediately adjacent to the outside of the north wall in P-T12-13 are the brick footings of a small rectangular structure that measures 3.3m east to west and 1.03m north to south. There is no evidence of an entrance although it could have been at the west end, which has been demolished. Alternatively, or perhaps additionally, there could have been an entrance from inside the stable itself. There is nothing to suggest what this structure may have been, although based on its size and location it is likely to have been a tack or harness room.

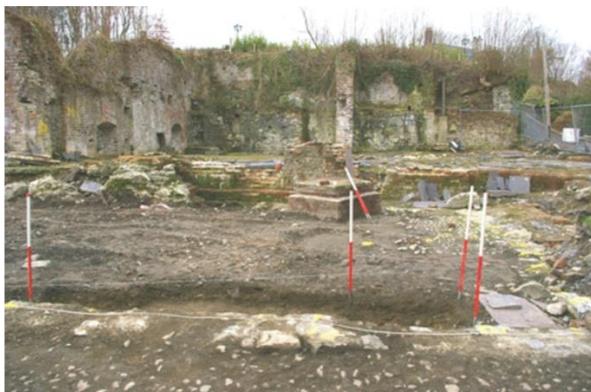
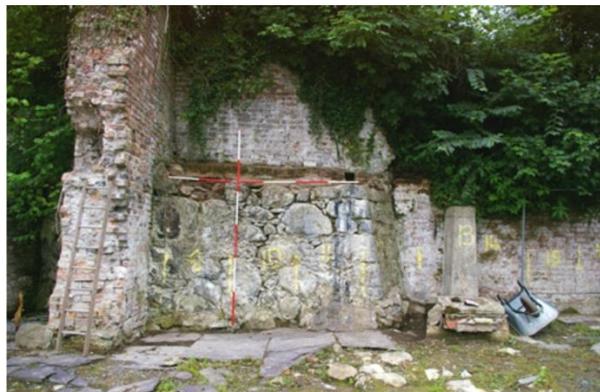
Fig.3.6.1 (left): The inner mill is to the left and the outer mill to the right.

The chute is located top right, immediately below the cottage. The stable area is in the foreground. (2011)

Fig.3.6.2 (right): The revetment to the west wall of the outer mill.

The chute is at top right, beneath the foliage. (2010)

In front of the brick wall, in B9-12, there is stone revetment that protrudes one metre from the embankment wall (Figs.3.6.2 & 3.6.3). The back surface is thirty centimetres wide, flat, and is constructed from brick covered in mortar. The centre section is approximately forty centimetres wide, slopes downwards, and is constructed from mortar over rough brick and stone (Fig.3.6.4). To the top right-hand side of the revetment there is an aperture 21cm wide and 32cm tall that extends for 20cm into the brick wall (B11). Some small pieces of timber were recovered from here, suggesting that it once housed a floor joist. At the front the average height of this section is 2.15m and at the rear 2.5m, giving some indication of the ceiling height.

Sitting above the wall in A13-17 is what looks to have been a chute, possibly for loading/unloading materials between the upper yard and the first floor of the mill; or between the upper yard and railway wagons brought across from the siding. The wall at this point is three bricks wide (Figs. 3.6.2 & 3.6.5). The side walls of the chute are constructed from dressed stone, with the north side being part of the high outer wall that runs parallel to the inclined track leading up to Penlan Mill Cottage and the upper yard (formerly part of 'Occupation' Road). The south wall of the chute tapers inward with the end furthest from the mill wall being narrower; although as it was not possible to remove the large roots and tree stumps from within this area it has not been possible to fully ascertain accurate dimensions. Projecting at a right angle from this wall, below surface level, is a broken section of vitreous clay pipe that prior to the sewage pipe being installed possibly fed into the cast iron pipe that ran to Trefelin (Figs.3.6.6 and 3.6.7). It is likely that originally the bottom surface of the chute had a sloping wooden base.

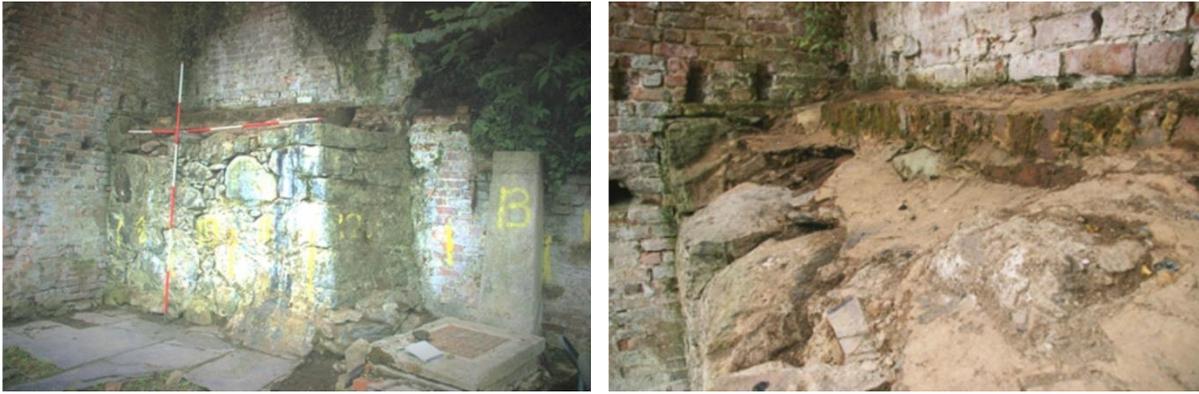
Fig.3.6.3 (left): Side view of the stone revetment showing the location of the joists in the central (south) wall (2010)

Fig.3.6.4 (right): Top surface of the stone revetment to the west wall in A9-11. (2010)

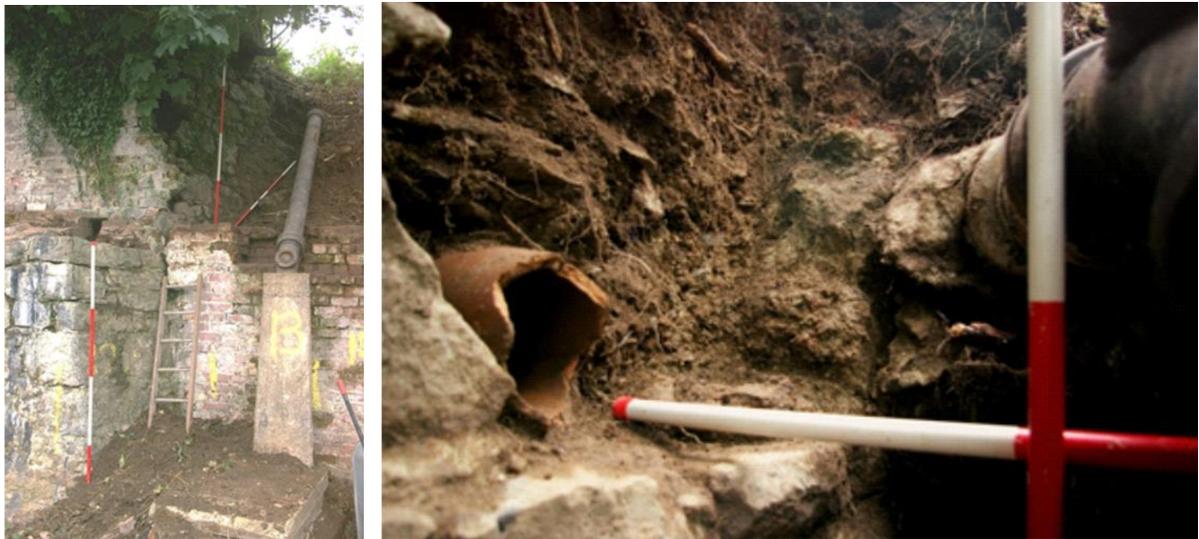
Fig.3.6.5 (left): The Chute above the embankment wall in A12-13. The descending pipe feeding into the manhole is encased in concrete. (2010)

Fig.3.6.6 (right): The junction of the iron and clay pipes. (2010)

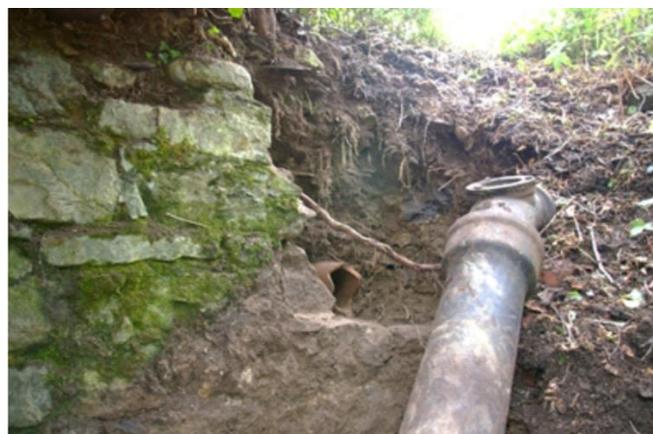
Fig.3.6.7: The iron pipe feeding from the upper yard to the manhole. At this point the pipe is 1.85m above the base of the chute. The end of the clay pipe is visible to the left. (2010)

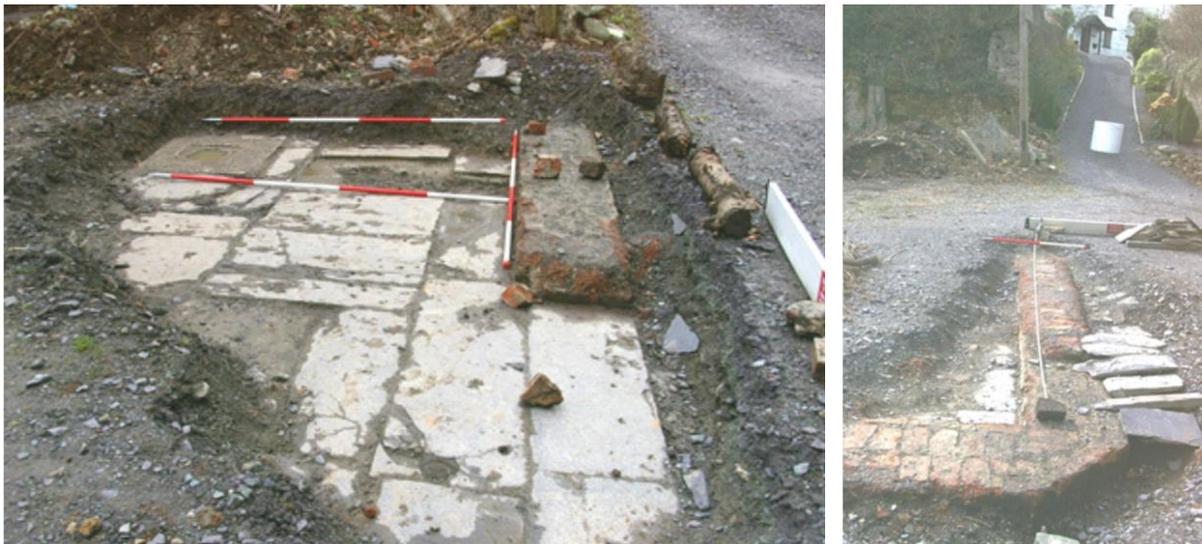
Fig.3.6.8 (left): Slate threshold in J-K18. The drop bolt holder can be seen in the bottom right hand corner of the centre slate (2010)

Fig.3.6.9 (right): Shows the chamfered north-east corner of the outer mill in P18 (2010)

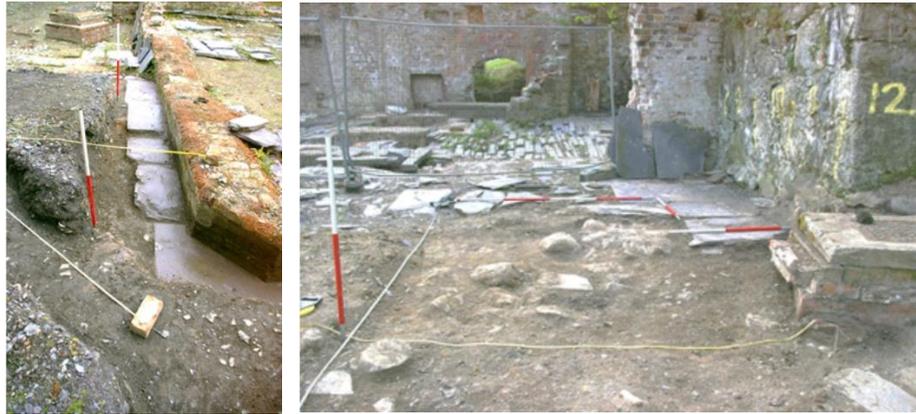
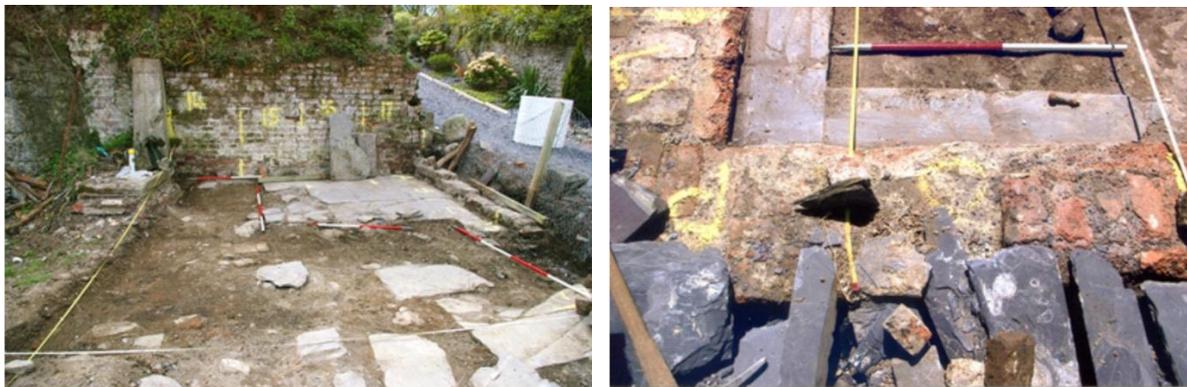
Fig. 3.6.10 (left): shows the slate path running from P18 alongside the east wall, leading to the rear of the stable. The remaining road surface can be seen in the foreground. (2011).

Fig.3.6.11 (right): The remaining floor surface in B-E 10-13. (2010)

Fig.3.6.12 (left): The remaining floor surface in A-E 14-17. (2010)

Fig.3.6.13 (right): The remaining floor surface in O & P 17. (2010)

While it has been greatly disturbed by subsequent ground works the internal floor of the outer mill is essentially level and retains some areas of the original slate surface (Figs.3.6.11 to 3.6.13). Within the floor area limestone bases for vertical support columns are still visible in H11, H15, L15 and M15 (Figs.3.6.14 to 3.6.16). The blocks in H11 and H15 are in line with one in H7, and the block in M15 is in line with one in M4: both M4 and H7 being in the inner mill. Because of the amount of disturbance that has taken place it is not possible to ascertain whether these were the only supports within this part of the building, although it is unlikely because of the need to support the weight of the bridge from the railway siding. The likelihood is that there would have been additional column bases, but that they were obliterated during the course of earthworks by the water authority.

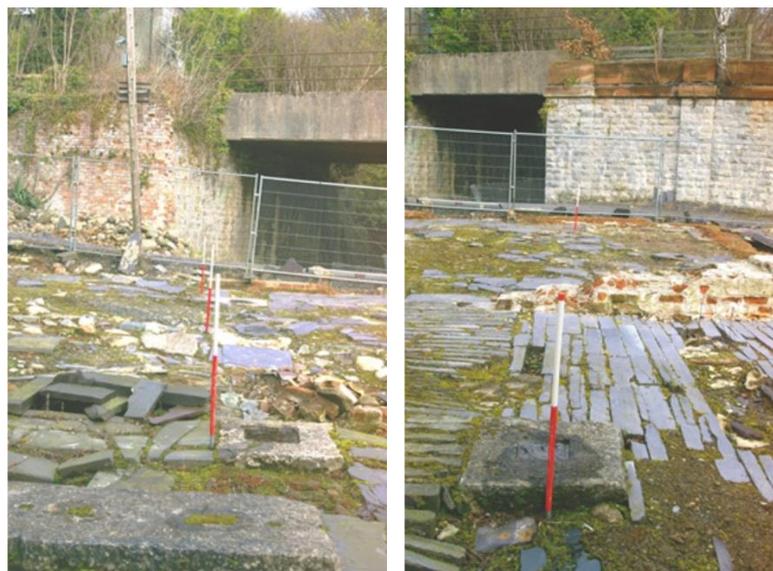
Fig.3.6.14 (left)

In Fig.3.6.14 the poles mark the location of the limestone blocks in (front to rear) H7, H11 & H15. Fig.3.6.15 Shows the limestone blocks in M4 (nearest) and M15. (2011)

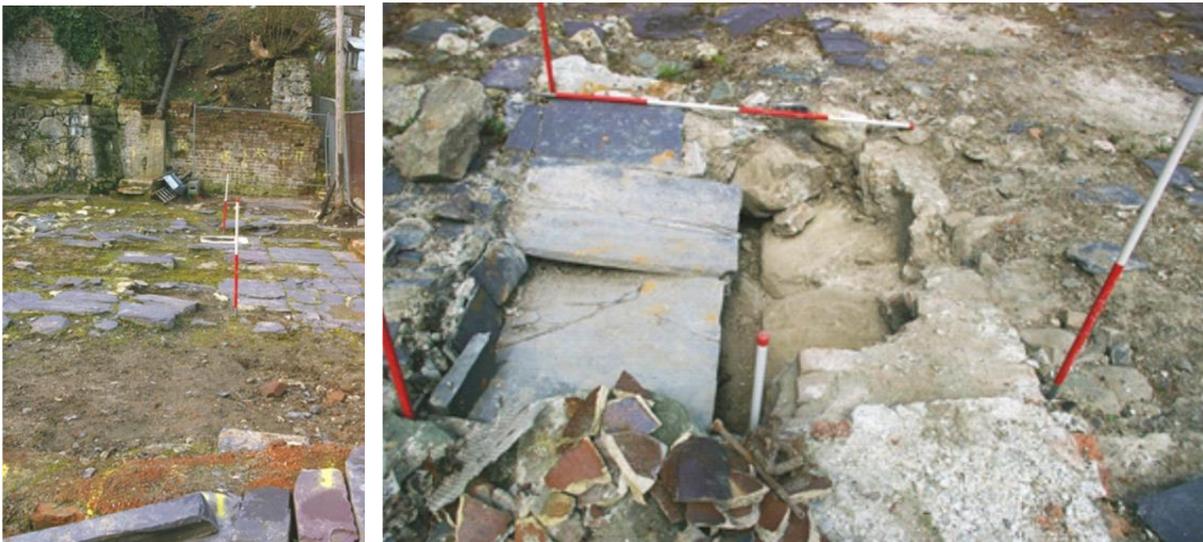
Fig.3.6.16 (left): The limestone blocks in H15 and L15 (nearest). (2011)

Fig.3.6.17 (right): The hole in H9-11, I9-11, viewed facing north. (2011)

One prominent feature is a sizeable hole in H-I9 and H-I 11, lying adjacent to the west side of the south wall (Fig.3.6.17). There is little to suggest why this feature should be present although the fact that a large cast-iron gully trap (Item 11/28/005) and some small pieces of glazed clay pipe were found adjacent to it could indicate a drain of some sort, although there is no obvious sign of either an inlet or outlet channel. Whatever its purpose, the gully trap would not have been installed until much later as the material in which it was coated, Dr. Angus Smith's Solution, was not invented until around 1880. Possibly at some stage it connected with the large underground drainage tunnel which from the excavation work that has taken place appears to run from the vicinity of the south-east corner of the outer mill (see site plan). As this section of the tunnel probably pre-dates the construction of the warehouse this certainly is feasible. If it *was* constructed as a drain the obvious question would be why, as there would not seem to be any particular requirement for such a feature in a storage area where no processing took place. There is also the possibility that it was put in place sometime after the warehouse was erected, although had this been the case then to connect it to the underground tunnel would have been a far more difficult task; particularly bearing in mind the very large stones that line the sides of the hole.

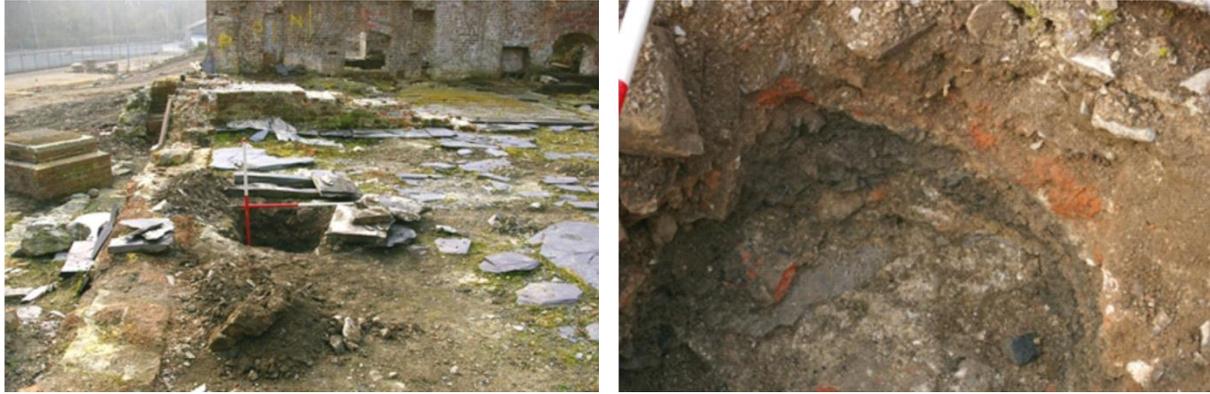
Fig.3.6.18 (left): The hole excavated in O12. (2011)

Fig.3.6.19 (right): The inner surfaces of the hole in O12. Note the layers of slate and brick, perhaps indicative that this may have been the site of a settling ark. (2011)

Yet another possibility is that it pre-dates the construction of the outer mill and was constructed at the same time as the original building. It is also feasible that it was connected with a hole that was excavated in O12, and that both of the holes linked with the main tunnel. While there was nothing distinctive about the hole in O12 it was found to have evidence of both brick and slate surfaces toward the base, although no evidence of inlet or outlet channels (Figs.3.6.18 & 3.6.19). One possibility is that they were in some way connected to the slip kiln or settling arks. However, from the discussion in Section 3.3 this perhaps is unlikely. The only way to provide a more definitive answer would be to excavate a far larger area, although probably this would be inconclusive bearing in mind the large

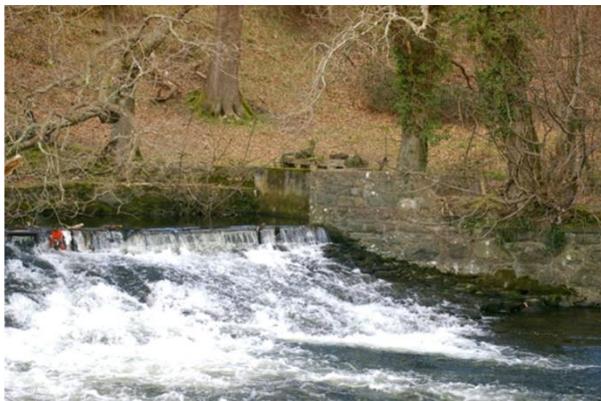
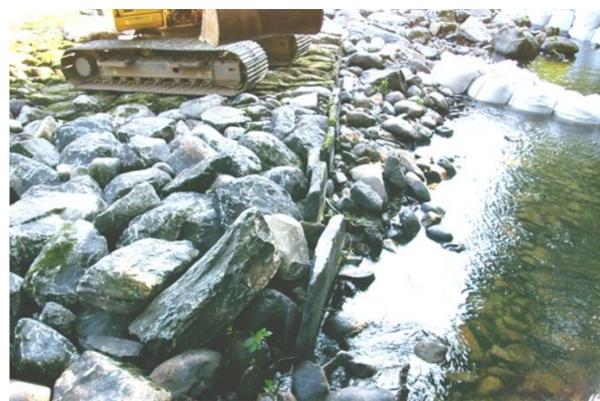
Fig.4.1.1 (left): The weir and leat entrance, south of Shaky Bridge. (2010)

Fig.4.1.2 (right): The vertical slates securing the rear edge of the weir. (2015)

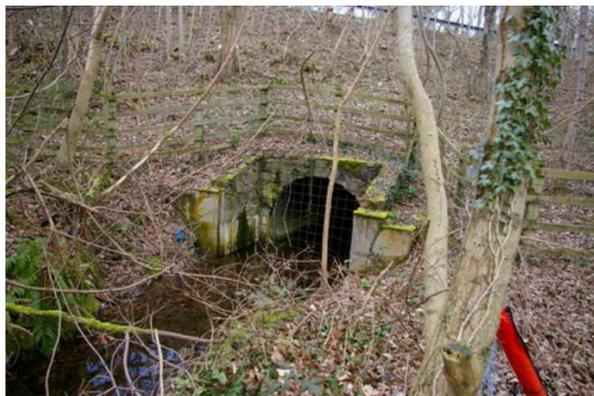
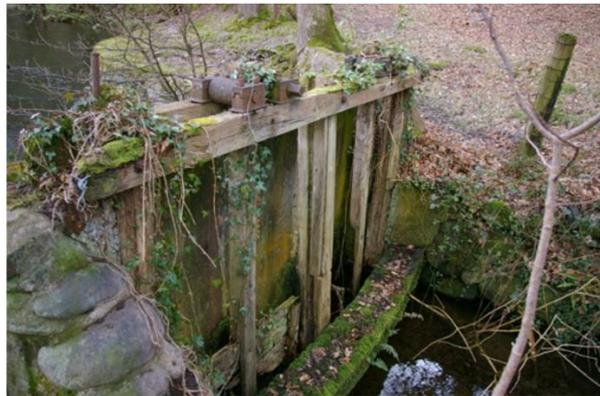
Fig.4.1.3 (left): The leat tunnel beneath the A55 Expressway (south side). This section is no longer visible having been piped and buried during the installation of the hydro-electric scheme. (2010)

Fig.4.1.4 (right): The original sluice gate at the start of the leat. The brick wall is behind it. (2010)
