**Richard Pennant, Samuel Worthington and the mill at Penlan
a history of the Penrhyn Mills on the Lower Ogwen**

Richard Pennant, Samuel Worthington, and the Mill at Penlan

A History of the Penrhyn Mills on the Lower Ogwen

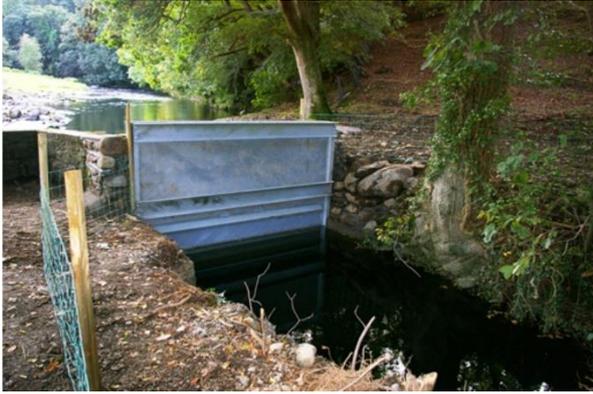
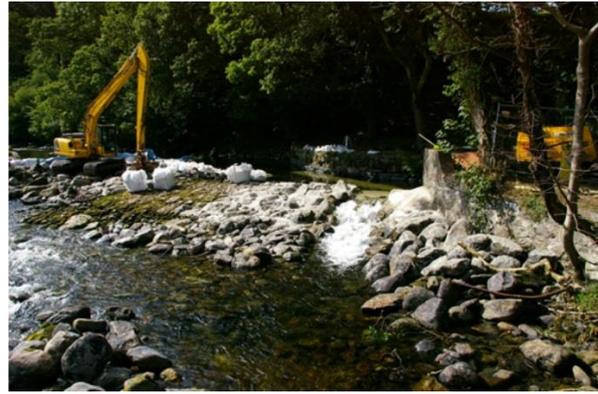
Fig.4.1.5 (left): New sluice at start of the leat. (2013) This now forms a part of the new hydro scheme and is no longer visible.

Fig.4.1.6 (right): Alterations to the weir including the creation of a fish run, shown to the right, adjacent to the leat entrance. (2015)

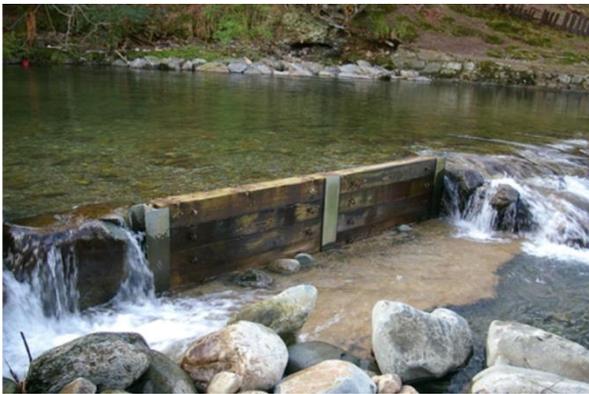
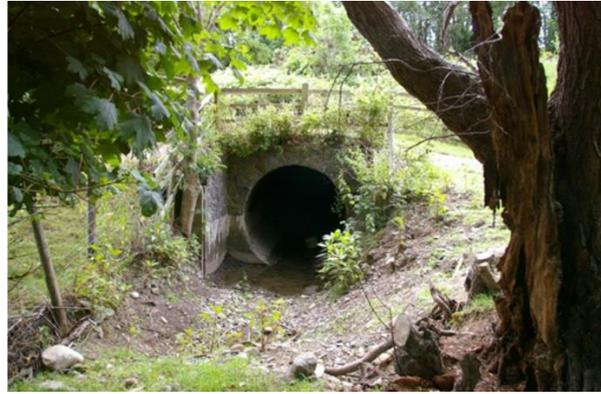
Fig.4.1.7 (left): The new section of the weir at Shaky Bridge. (2016)

Fig.4.1.8 (right): The north end of the leat tunnel as it emerges from beneath the A55 Expressway. (2015)

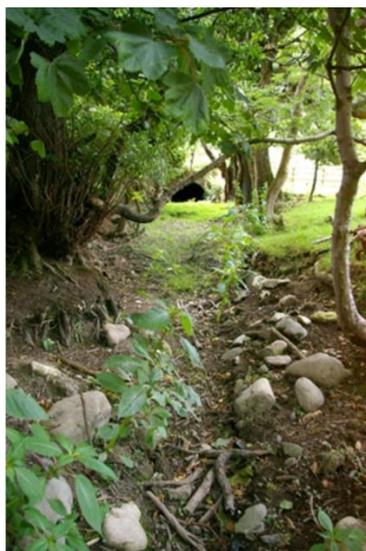
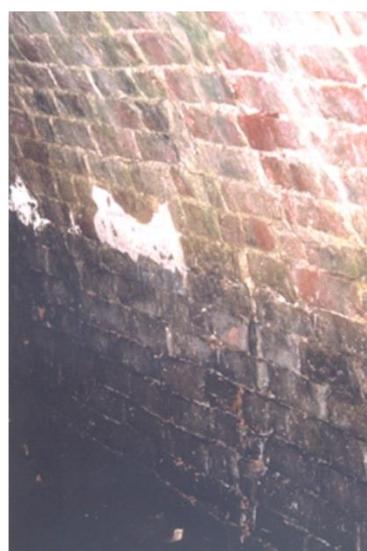
Fig.4.1.9 (left): Bed of the leat between the A55 and the main brick tunnel (2015)

Fig.4.1.10 (right): Inside wall of the original brick tunnel, unchanged since 1797. (2004)

The tunnel is approximately 100m long, brick built and round in shape, but with the floor being slightly flattened (Fig.4.1.10). At the north end of the tunnel, that nearest to the mill, an approximately 30m section of the leat has been completely demolished (Fig.4.1.11) causing the water to flow directly downhill into the River Ogwen, entering the river immediately adjacent to the large industrial shed situated at the south end of the Trefelin site.

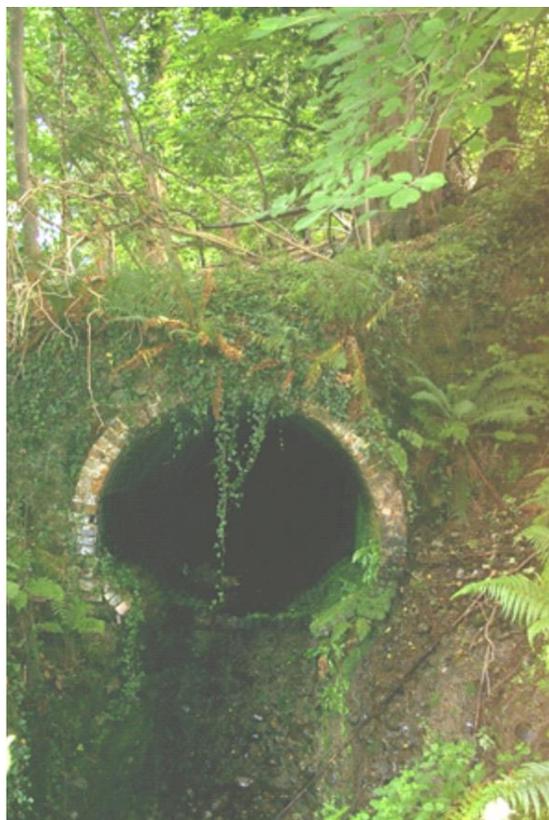
Fig.4.1.11: North end of the tunnel with the demolished section of the leat in the foreground. (2015)

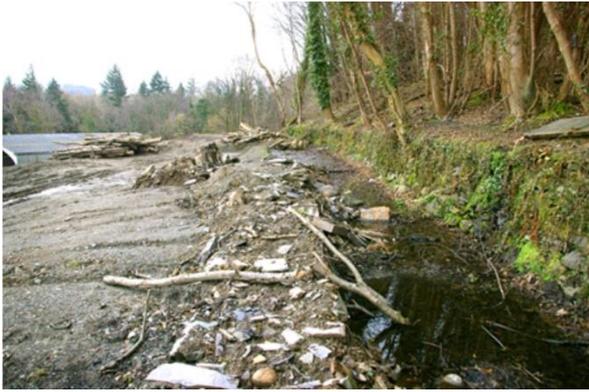
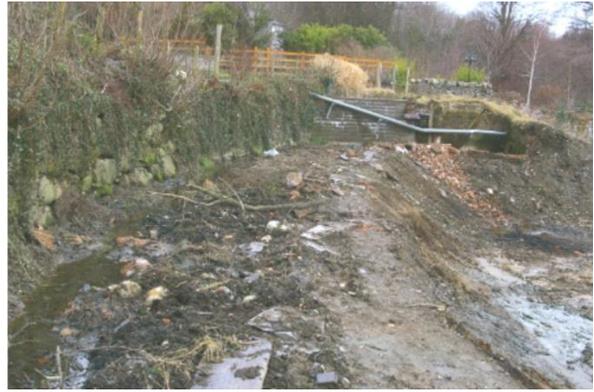
Fig.4.1.12 (left): The remains of the leat with lower (east) wall demolished. (2011)

Fig.4.1.13 (right): Reverse view of the leat with the remains of the demolished sump in the background. (2011)

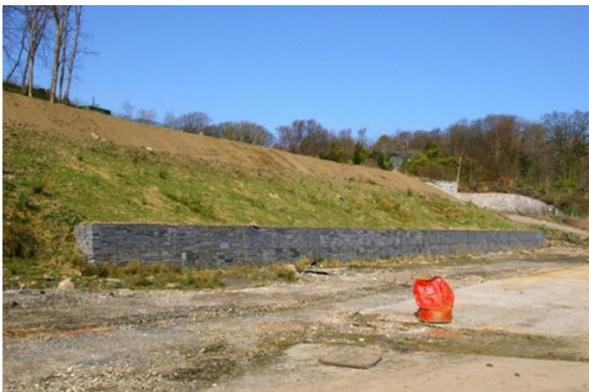
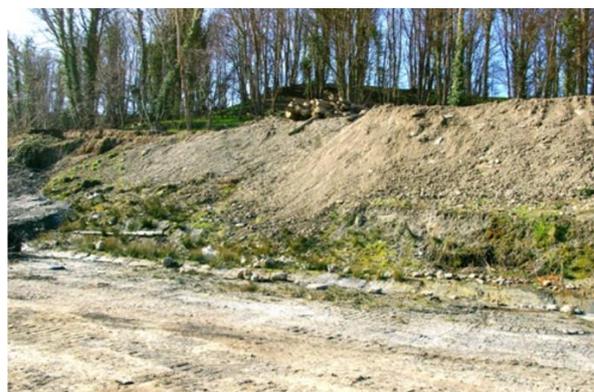
Fig.4.1.16 (left): Lower level of the man-made embankment to the south side of Trefelin Yard, replacing the former woodland. (2011)

Fig.4.1.17 (right): The upper level of the man-made embankment, sitting above and behind the lower level. (2011)

From this gap the bed of the leat continues for the final 200m to the start of the headrace. This entire section of the leat was intact until the end of 2010 at which time the whole of the lower (east) side wall was demolished to facilitate industrial development (Figs.4.1.12 & 4.1.13). Whereas the ground adjacent to it had previously comprised very pleasant woodland it has now been replaced by a large man-made earth embankment (Figs. 4.1.14 to 4.1.17).

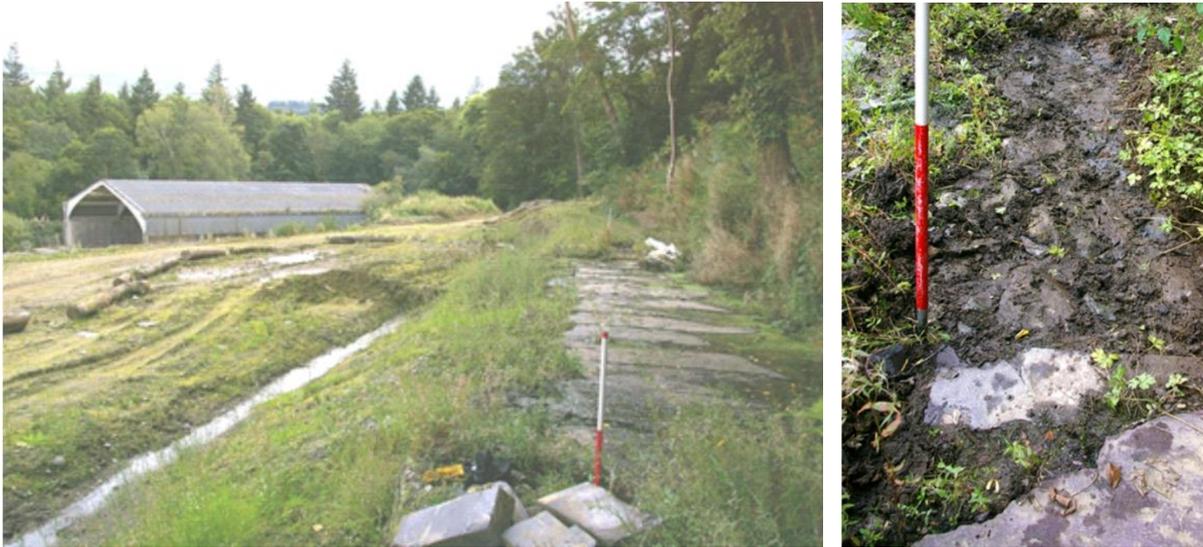
Fig.4.1.18 (left): Location and extent of the slate bed of the Leat. (2011)

Fig.4.1.19 (right): Cobbled base of the leat bed. (2011)

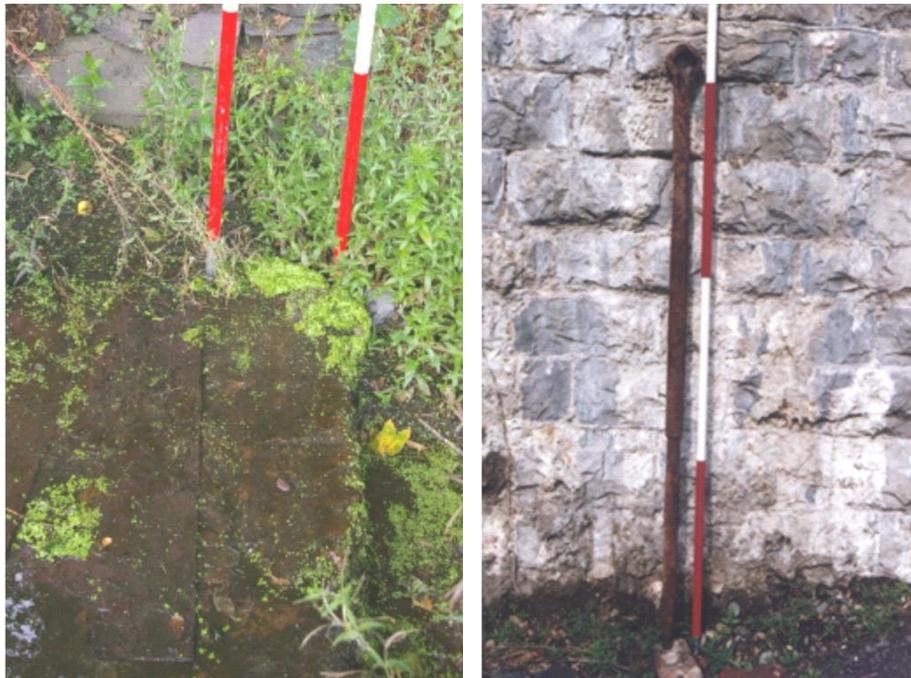
Fig.4.1.20 (left): The brick edge to the slate section of the leat bed is shown between the poles. (2011)

Fig.4.1.21 (right): The sluice key/spanner ('Finds' Item 10/16/001)

By far the most important function of the leat, and the primary reason for it being built, was to provide the water required to turn the wheels at Penlan Mill. The flow of water to the mill was controlled via a sluice at the north end of the leat, as it entered the start of the head race. There is nothing left of this today, although during excavation two small pieces of cement were found there, which from the indentations in their surface appear to show that they once had held in place wooden strips, or something similar.²⁶³ However, as a good deal of waste material has subsequently been dumped into this part of the leat it is not at all certain how much credence can be placed on this. Also found was a large 'key' or spanner that possibly was used for opening and closing the sluice gates (Fig.4.1.21). This appears under the list of 'Finds' as Item 10/16/001.

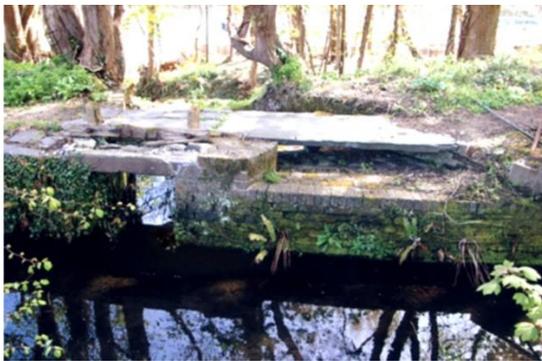
Fig.4.2.1 (left): The sluice and overflow to the spillway. (2006)

As stated above the spillway fulfils three separate functions: to provide water to power the waterwheels in the main Estate Works; to provide a supply of water to the aqueduct; and to carry away any unwanted water from the site, including from the Penlan Mill tailrace. Once Penlan Mill had been demolished and the Estate Works closed the leat was sealed above the headrace, completely cutting off the flow of water beyond this point. After this date any residual water that drained into the leat was channelled directly into the spillway, and from there through pipes beneath Trefelin yard and into the river. Today this remains its sole purpose. Originally water entered the spillway either by means of a sluice located in the side of the leat, or via an adjoining overflow channel (Figs.4.2.1 & 4.2.2). Neither of these features survives following demolition of the leat wall.

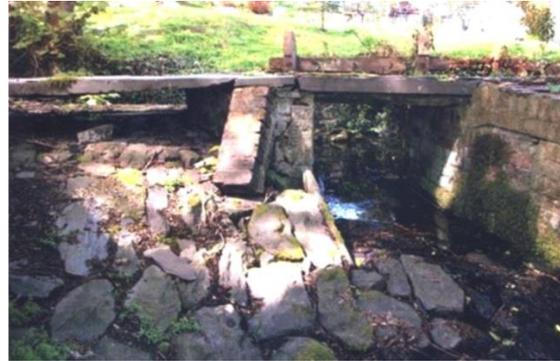
Fig.4.2.2 (right): Rear view of the sluice (right) and overflow (left). (2006)

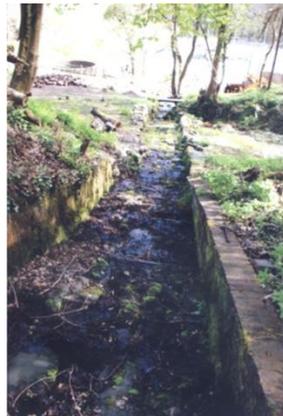
Fig.4.2.3 (left): Top section of spillway, facing downwards. (2006)

Essentially the spillway is one contiguous structure comprising two parts that for ease of understanding are referred to as the upper and lower. The original upper part comprised an open channel that was constructed from stone with the side walls toward the upper end being capped with brick (Figs.4.2.3 & 4.2.4). In 2008 a large concrete pipe was laid within the upper section, the pipe continuing to carry water through to the section below. As a result of this work both the concrete pipe and original stone spillway are now buried beneath the earthworks. At the end of the pipe there is a concrete ledge that causes water to cascade into the lower section of the spillway.

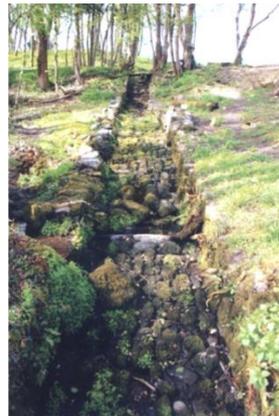
Fig.4.2.4 (right): Top section of the spillway, facing upward. (2006)

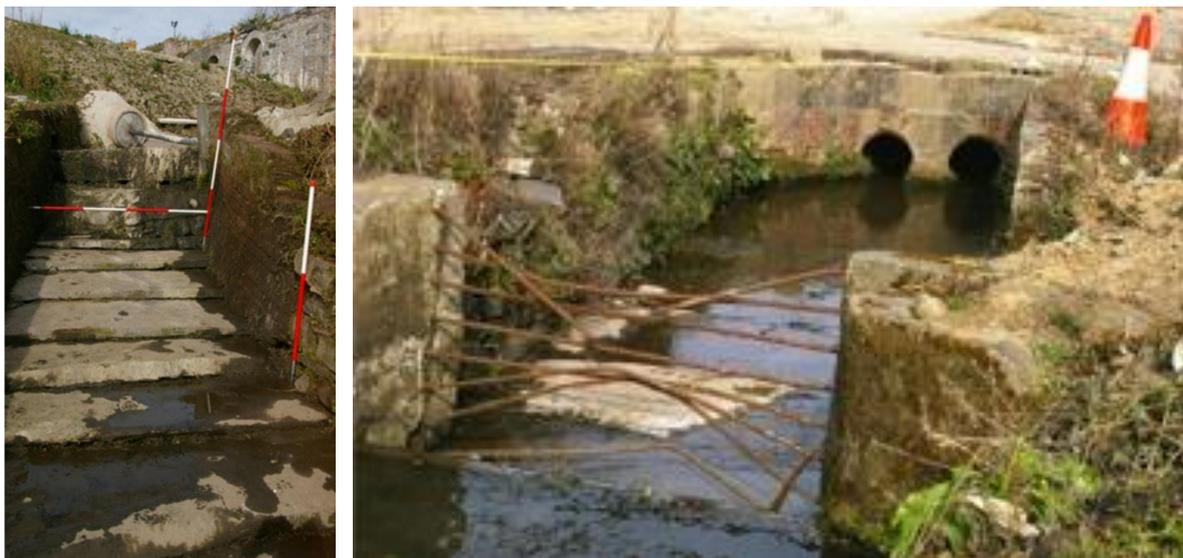
Fig.4.2.5 (left): The lower section of the spillway showing the exit pipe from beneath the earthworks, the concrete ledge, and the slate steps. (2010),

Fig.4.2.6 (right): The lower end of the spillway from the gate to the culvert pipes. (2010)

The lower section of the spillway is part of the original c.1797 construction and still remains in use. It is constructed from large slate slabs that form a series of steps, some 27 in total. They are laid laterally across the width of the channel and are of variable size, being 2m wide, between 60-95cm in depth, and 7-9cm thick. At step 18 there is a rendered pillar at each side and between these there is a badly damaged gate or trap, designed to stop large items passing through and blocking the entrance to the piped culvert that carries water beneath the lower yard. The height of the gate is 95cm and it comprises 8 round horizontal metal bars, each 2cm in diameter and 145cm long (Fig.4.2.6).

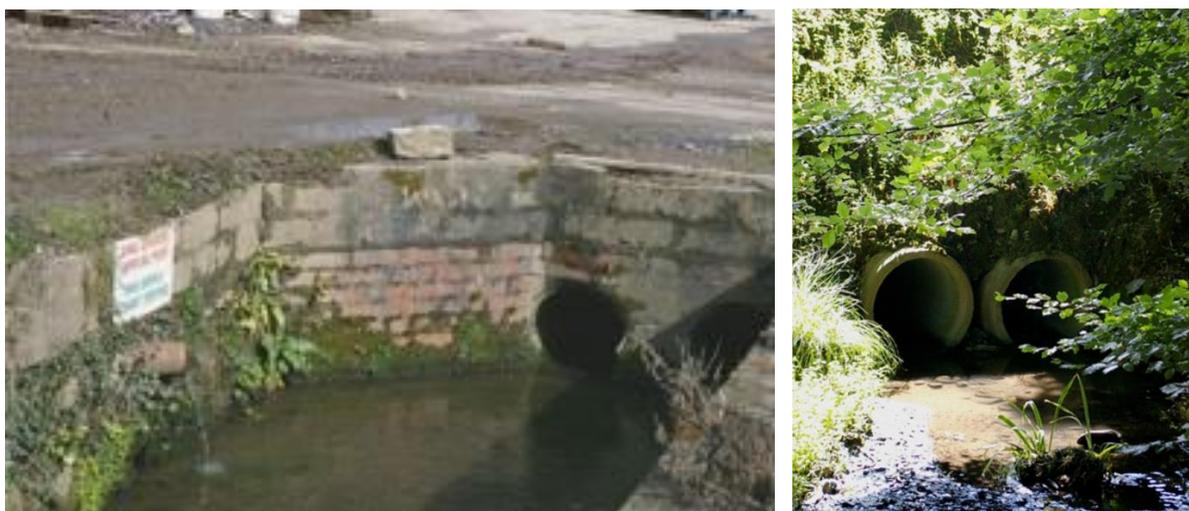
Fig.4.2.7 (left): Location of the water sampling point, left of picture. (2010)

Fig.4.2.8 (right): Outlet from the culvert pipes where they join the river. (2010)

To the left-hand side (descending) between slabs 24 and 25 there is an outlet pipe from the adjacent sewage filter bed, from which daily samples are taken by the water authority (Fig.4.2.7). The end wall is 0.8m high, built of brick, and has two large round pipes inset that together form the culvert that passes beneath Trefelin Yard to the river (Fig.4.2.8). Originally this had been an open channel that has only been culverted in recent times.²⁶⁸ Originally the channel branched with two separate channels leading to the Estate Works. It would also appear that at one time it merged with the original race for Felin Isaf, which originally had received its water directly from the river (Fig.4.4.2).

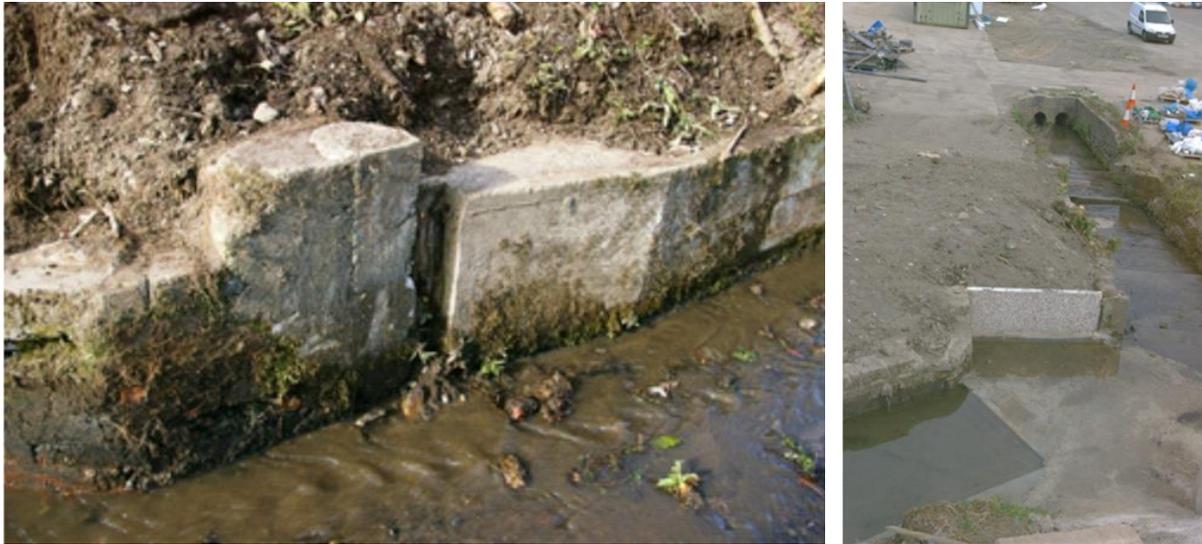
Fig.4.3.1 (left): The location of the sluice gate at the start of the aqueduct, prior to it being sealed. Remains of timber support post still embedded in the channel. (2010)

Fig.4.3.2 (right): The sealed-off entrance to the newly buried aqueduct, the concrete slab having been inserted into the sluice gate channel. (2010)

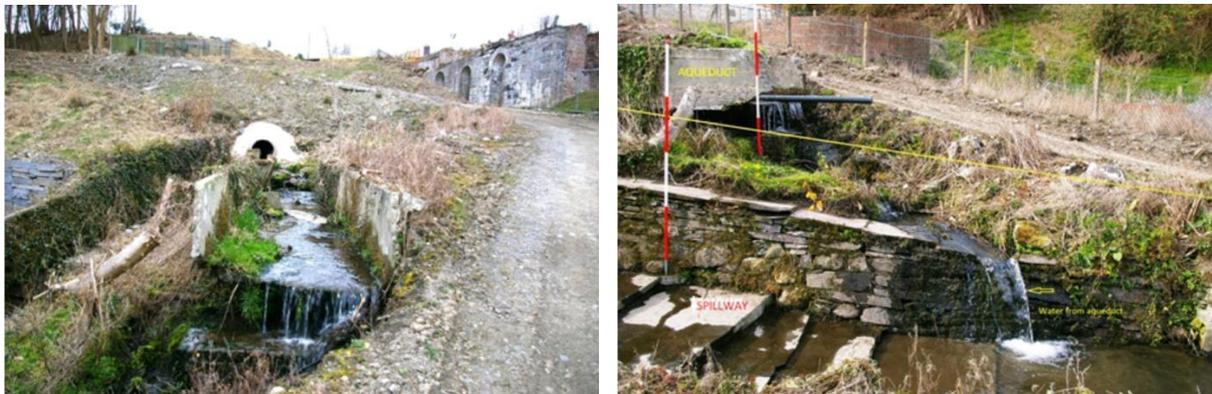
Fig.4.3.3 (left): The aqueduct, facing west, prior to it being back-filled. The spillway is to the left. (2010)

Fig.4.3.4 (right): The aqueduct is the concrete structure top left of picture, sitting above the spillway and with the pipe overhanging. (2010)

The purpose of the aqueduct was to provide a supply of water to the Slate Works and Smithy that were located in Trefelin Yard, adjacent to the main Estate Works. It would appear that initially the water came directly from the spillway, at its confluence with the underground tailrace from Penlan Mill (Fig.4.1.22). From the point at which the three channels merged the flow of water into the aqueduct was regulated by a sluice gate (Figs.4.3.1 & 4.3.2). It was an open-topped channel constructed from wood, but as was evident at the time it was recorded on the site plan it had been coated in cement: probably added for reinforcement, protection, sealing, or all three. It was located adjacent to the slated lower section of the spillway, running parallel with and slightly above it (Figs.4.3.3 & 4.3.4). It is not entirely clear whether the aqueduct was part of the original site design or

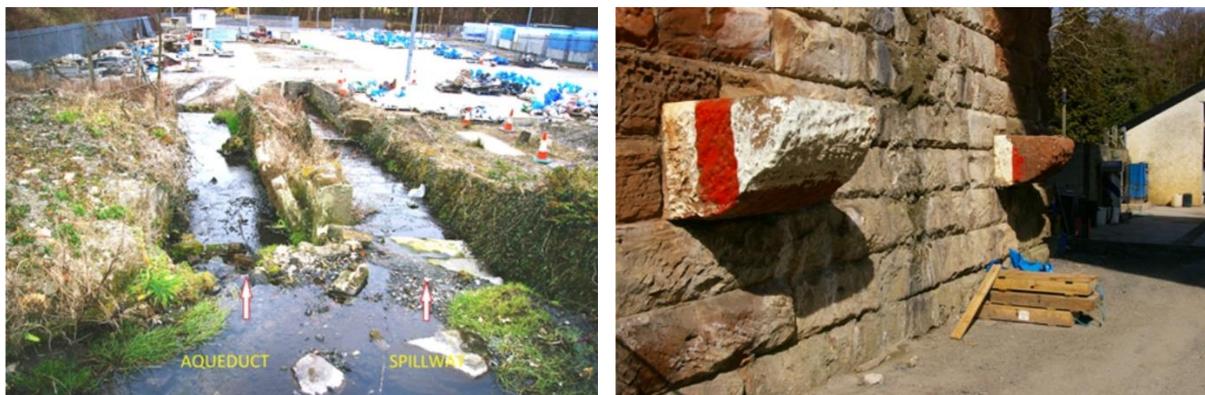
Fig.4.3.5 (left): The junction of the aqueduct and lower section of spillway.
The outlet from the tail-race tunnel joins from the left-hand side. (2010)

Fig.4.3.6 (right): Sandstone aqueduct support arms beneath viaduct arch. (2010)

Smithy had become demolished. At the same time the three water channels were merged into one (Fig.4.3.5).

As the aqueduct passed beneath the railway viaduct it was supported on sandstone arms protruding from the east side of the third pillar (from the west end) before passing through to the bottom yard at Trefelin (Fig.4.3.6). The top of the support arms stands 190cm above the present ground level and the top surface measures 94cm wide x 72cm deep. They are 62cm thick at their deepest point, which is where they abut the side of the pillar. Generally, it had been assumed that the purpose of the aqueduct was to provide a power source for the saw mill, whereas based on the location of the support arms it would seem that in fact the water passed directly to the Smithy and Slate Works. This is borne out by the c.1906 plan that shows what is described as a 'water trough to slate works' (Fig.4.3.7).

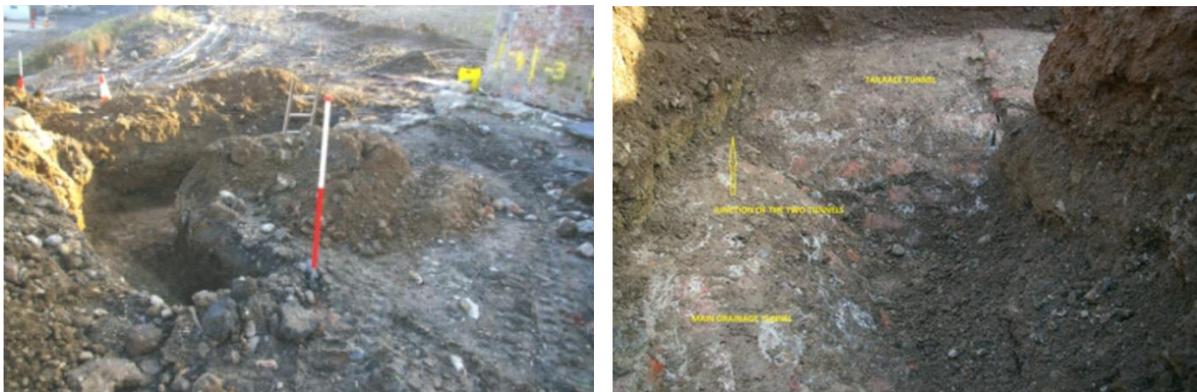
Fig.4.4.1 (left): Junction of the two tunnels, with the main tunnel in the foreground running north-south, and the tail-race tunnel (top of picture) running east-west. (2011)

Fig.4.4.2 (right): Top view of the junction of the two tunnels with the main tunnel in the foreground. The tail-race tunnel with join showing is at top of picture. (2011)

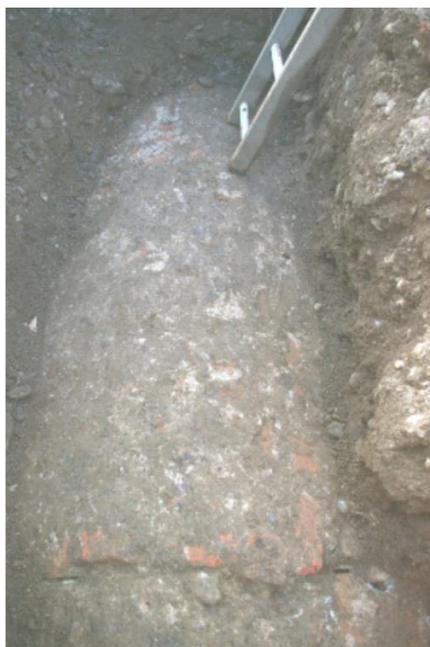
Fig.4.4.3: Top surface of the tail-race tunnel, facing west, with the join showing in the upper surface. (2011)

During excavation top sections of both tunnels were exposed and this provided an indication of their size and condition. They are built of brick and have a curved roof that appears to have some rendering to the outer surface. There is no evidence of damage to the tail-race tunnel, although there is some slight damage to the main one.

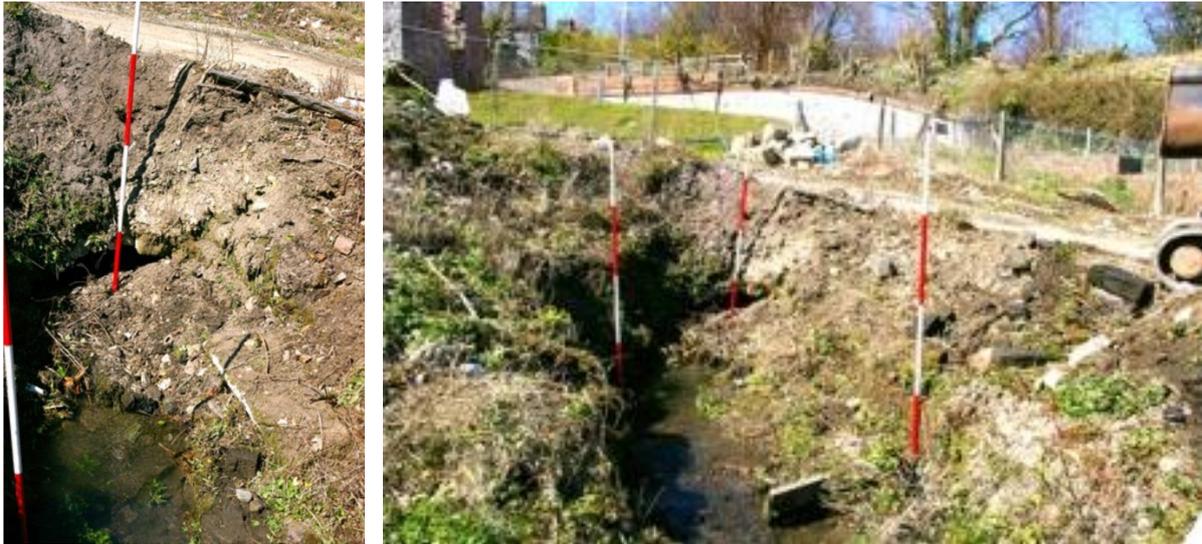
Fig.4.5.1 (left): Blocked entrance to main tunnel, as marked by the rearmost pole. (2010)

Fig.4.5.2 (right): The rearmost pole marks the location of the exit from the main tunnel. (2010)

As the tunnel emerges from beneath the road the last two metres had previously collapsed into the bed of the channel with the sludge and debris blocking the tunnel entrance by as much as seventy-five percent. This severely impeded the water flow and in large part was a contributing factor to the regular flooding that took place when heavy rain caused a back-up of water in the adjoining culvert. Since 2010 when the blockage was cleared the water flow has considerably improved (Figs.4.5.1 to 4.5.5).

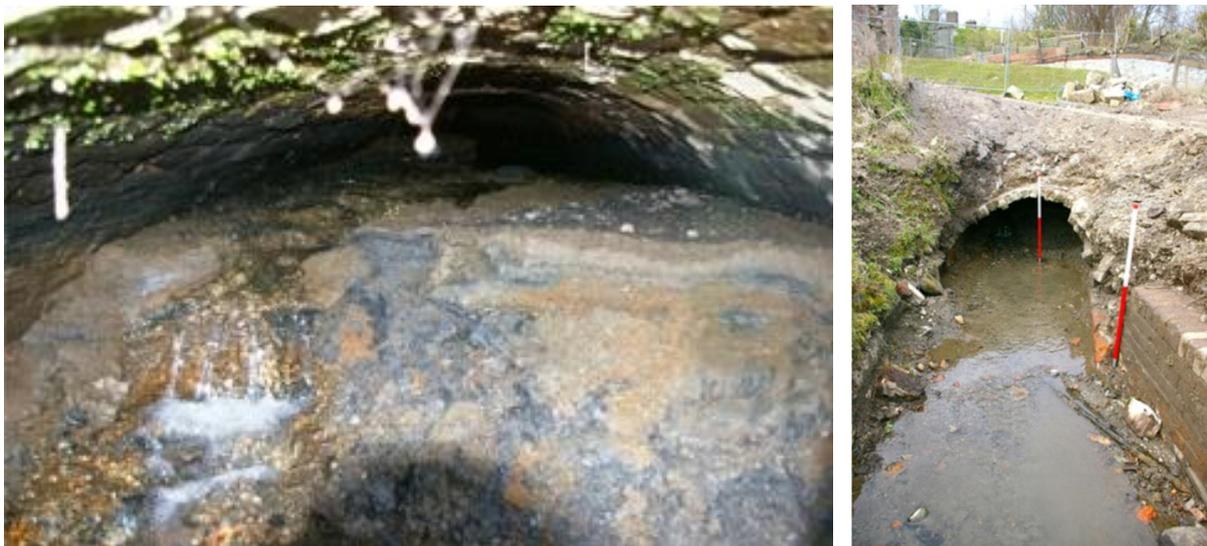
Fig.4.5.3 (left): Depth of sludge inside the tunnel entrance. (2010)

Fig.4.5.4 (right): Tunnel entrance after most of the sludge removed. The near post marks the original extent of the tunnel prior to the roof collapsing. (2010)

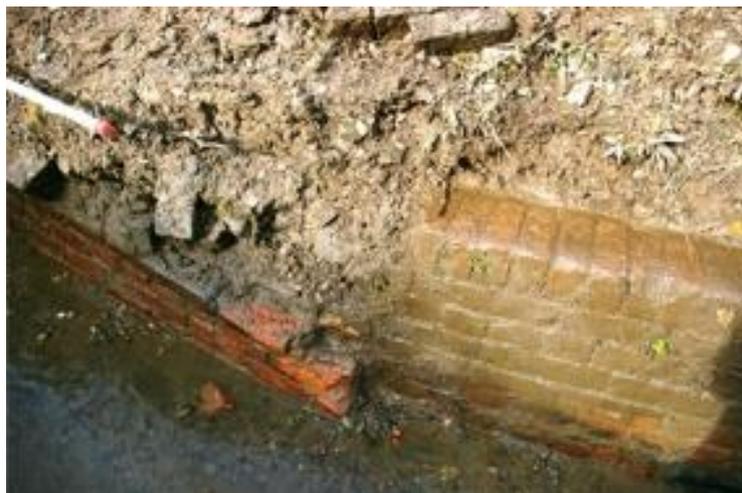
Fig.4.5.5: The join in the brickwork marks the end wall of the tunnel prior to the roof collapsing.(2010)

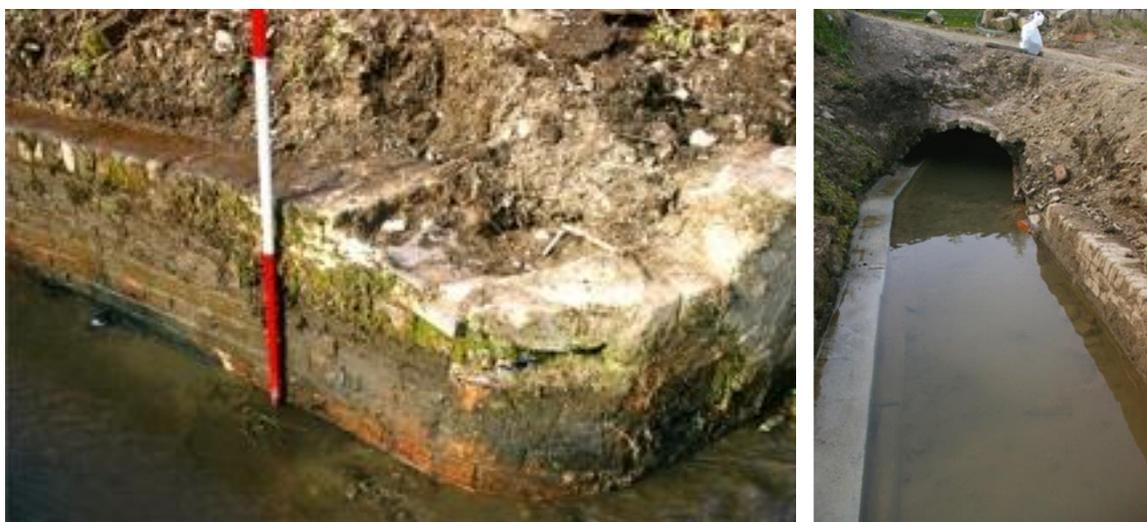
Fig.4.5.6 (left): The junction of the main channel and the entrance to the aqueduct. (2010)

Fig.4.5.7 (right): New concrete edge to the exit channel after being lined. (2010)

From the mouth of the tunnel, looking south toward the spillway, the exit channel has a brick retaining wall to the left-hand side that originally ran for approximately 2.5 metres before it turned through ninety degrees to the left, when it formed the entrance to the aqueduct (Fig.4.5.6): the aqueduct sluice gate being located at this point (see Figs.4.3.1 & 4.3.2). This section of the retaining wall is approximately 0.6 metres high with the brickwork being in very good condition. The wall to the opposite side of the channel lies against the earth embankment that forms the west side of the site (Fig.4.5.4). Originally the wall to this side of the channel was built of stone but as part of the reconstruction work that took place in 2010 it was lined with concrete (Fig.4.5.7). Following the reconstruction work and the closure of the aqueduct water from the tunnel has fed directly into the spillway and from there to the river.

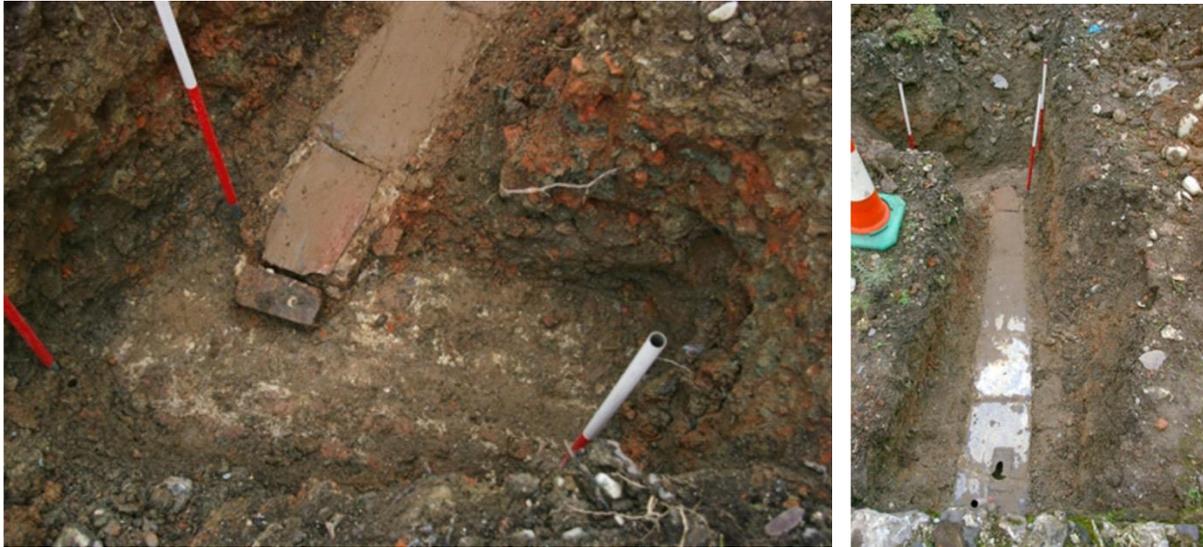
Fig.4.6.1 (left): The junction with the main drainage tunnel at T4, with the red brick deposit very much in evidence. (2011)

Fig.4.6.2 (right): View facing east from R4 to T4. Main drainage tunnel marked by poles at top of picture. (2011)

The third underground channel is a small drain that exits from beneath the area of the former archway in R4 and joins the main drainage tunnel in T4: again, beneath the stable floor. It is 2.7 metres long, has brick edges and a flat slate top, and at the far end has a small square drain hole in the base that drops vertically into the main drainage tunnel. At the point where it exits from beneath the west wall of the stable it is 0.5 metres below the present surface level, sloping down to 0.85 metres as it joins the tunnel: a drop of 35cm over 2.7 metres. It is 42cm wide at the top end decreasing to 32cm at the

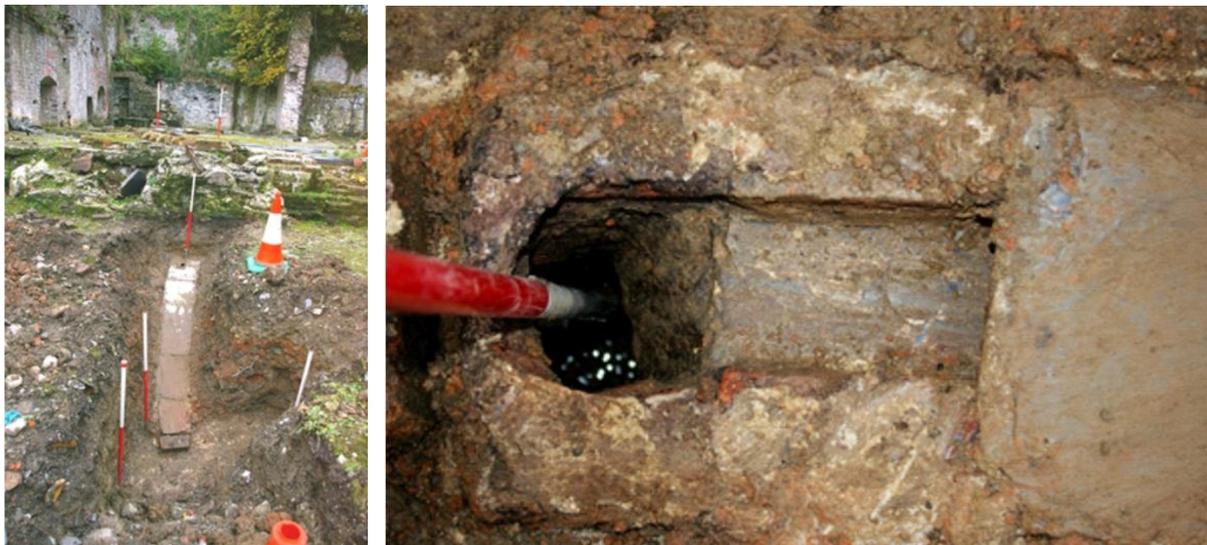
Fig.4.6.3 (left): Reverse view with west wall of stable in the background. Near poles mark the line of the main drainage tunnel.

Fig.4.6.4 (right): The junction with the main tunnel at T4. At this point the depth to the base of the main tunnel is 1.1m. (2011)

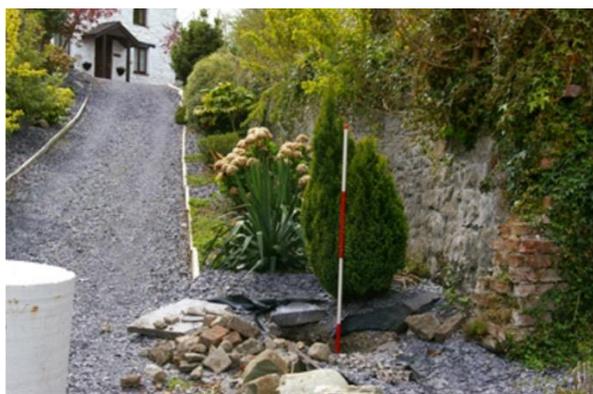
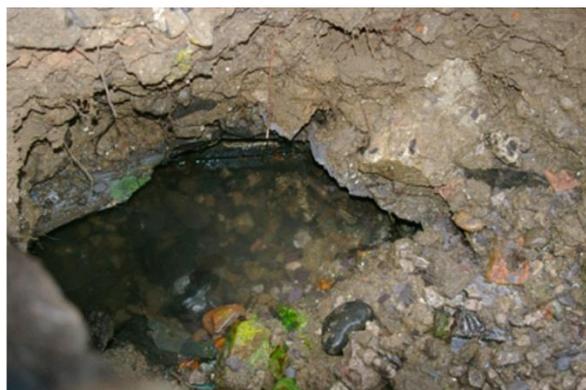
Fig.4.7.1 (left): Location of access point to culvert at Penlan Mill. (2010)

Fig.4.7.2 (right): The inside of the culvert at the access point. (2011)

In order to try and prove the course of the culvert a small trench 1.6 metres deep and 1 metre square was dug at the foot of the slope and adjacent to railway embankment, as shown above. At this point the culvert was found to be lined with slate to all four surfaces (Fig.4.7.2).

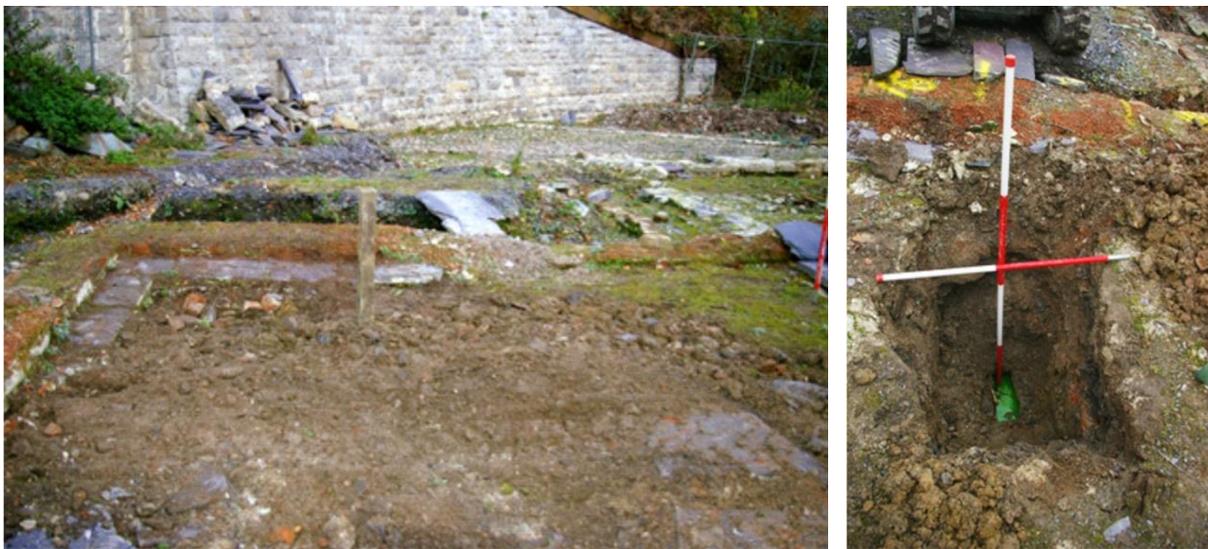
Fig.4.7.3 (left): Marker showing location of culvert in N16. (2011)

Fig.4.7.4 (right): Dye passing through culvert in N16 (2011)

A second trench 1 metre square and 1.1 metres deep was dug in the floor of the outer mill (grid N16), this location having been chosen because there was a round depression in the floor surface that initially led to the thought that there may have been a well there. There was no further evidence to support this and the hole was found to be backfilled with pieces of sandstone, probably from the construction of the viaduct. A channel was found containing an armoured electric cable and tree roots, but no sign of water. However, as flowing water could be heard close by the trench was back-filled and marked, and another trench opened at right angles to it. This was found to contain the culvert (Figs.4.7.3 & 4.7.4).

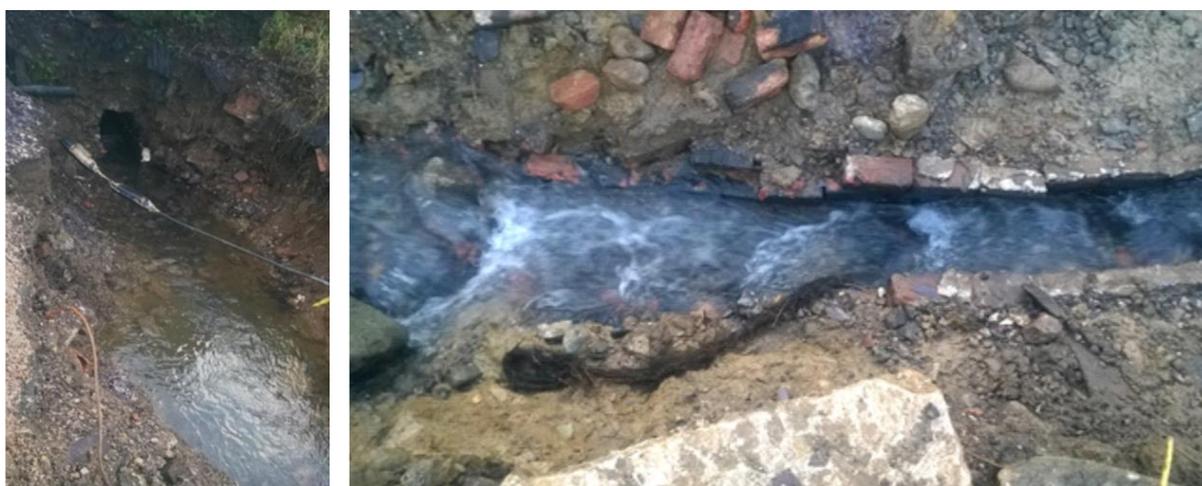
Fig.4.7.5 (left): Channel adjacent to culvert with armoured cable exposed. (2016)

Fig.4.7.6 (right): Inside of the culvert exposed during drainage work, the water flow being from right to left. (2016)

While essentially the report is based on the status of the site at completion of the excavation work, it is perhaps worth noting that as a result of the severe flooding that took place in November 2012 and December 2015, in January 2016 a new drainage system was installed by Celtest Ltd. During the course of this work the access point at the foot of the drive was filled in, a new manhole and drain were installed, and a new pipe was laid to take the water from the manhole to the main underground tunnel, following the line of the existing culvert. Both the manhole and drain are located in the outer mill/warehouse area (Figs.4.7.5 & 4.7.6), although as the new pipe did not extend as far as the tunnel it still has not been possible to ascertain precisely how and where they join.

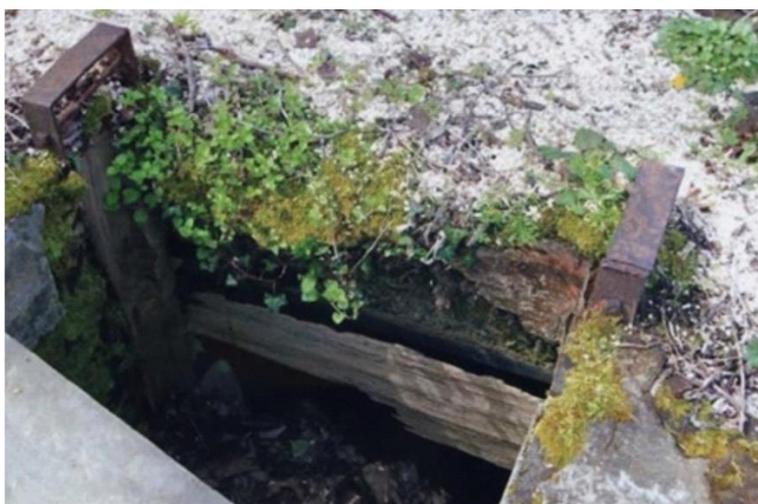
Fig.4.8.2: The sluice gate leading to the aqueduct sump. (2006)

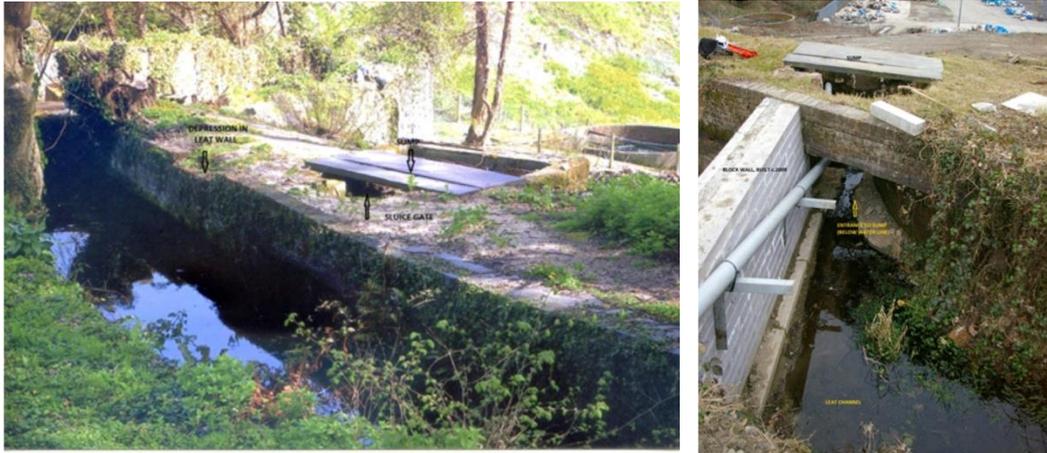
Fig.4.8.3 (left): Location of sump for turbine pipeline. (2006)

Fig.4.8.4 (right): Entrance to turbine pipeline sump. (2010)

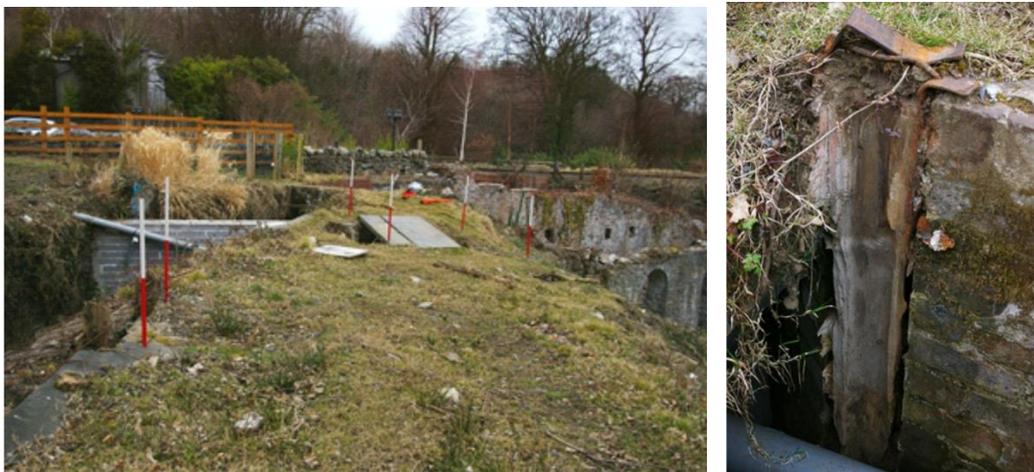
Fig.4.8.5 (left): Location of the sump prior to demolition, situated at the top of the southerly embankment. Upper yard to the Mill in the background, sluice to spillway channel marked by poles in the foreground. (2010)

Fig.4.8.6 (right): Remains of the original sluice gate. (2010)

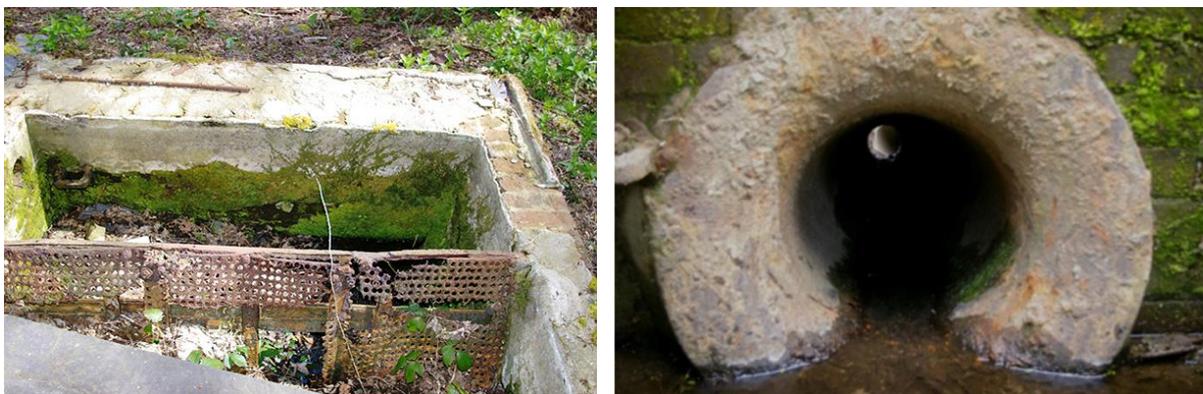
Fig.4.8.7 (left): Filter inside turbine pipeline sump. (2006)

Fig.4.8.8 (right): Bell-end of the iron pipe, showing through to the open far end. (2010)

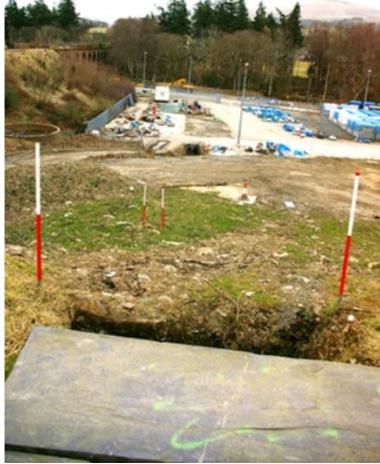
Fig.4.8.9 (left): Route from sump to far end of the original pipe. (2010)

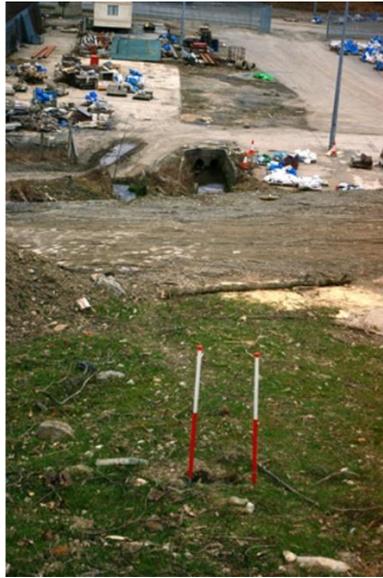
Fig.4.8.10 (right): View from end of the pipe to the spillway culvert. (2010)

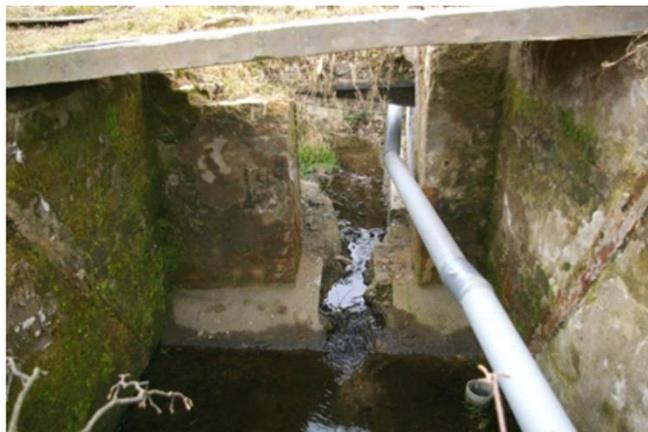
Fig.4.8.11: Inside the sump, looking toward the leat. The plastic pipe is a modern feature and not part of the original construction. (2010)

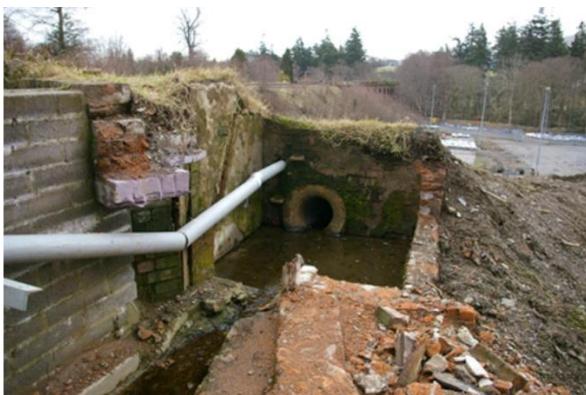
Fig.4.8.12 (left): View of sump after demolition, with iron pipe in background and remains of sluice in foreground. (2011)

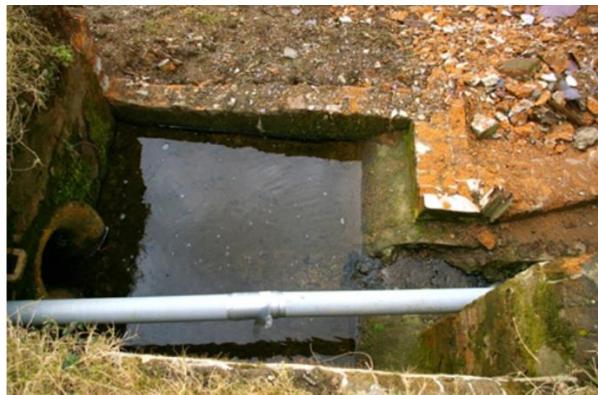
Fig.4.8.13 (right): Top view of the demolished sump. (2011)

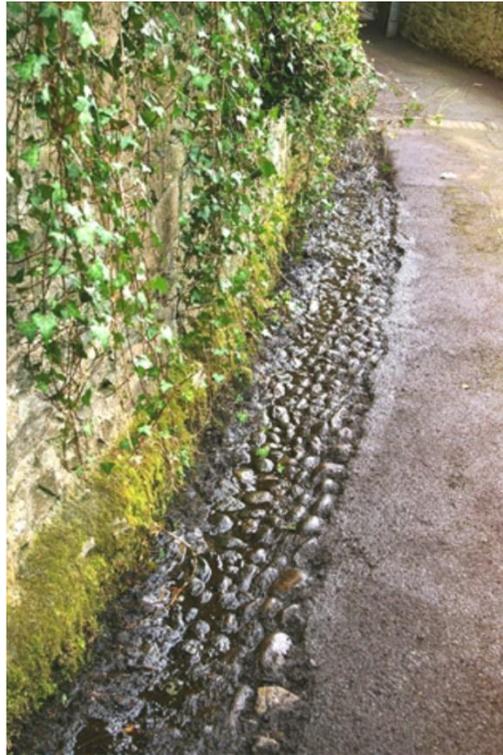
Fig. 5.1.1.: The original stone gully at Lon Pistyll. (2018)

The Caernarvonshire Turnpike Trust (later known as the Caernarvonshire Old Turnpike Trust) was set up in 1768 when powers were granted to turnpike the road between Tal-y-Cafn and Pwllheli, passing through Conway, Carnarvon, and Bangor. It existed for 114 years during which time its powers were granted and renewed by several Acts of Parliament. Originally the route through what was the then hamlet of Tal-y-Bont crossed the River Ogwen via a wooden bridge near Felin Isaf (in earlier times known as Melin y Bont), that stood in what today is known as Trefelin Yard. From there it continued up the hill (today's Trefelin), via Lon Pistyll, and on to Llandegai Square where the toll gate was located. A small section of the original stone gully at Lon Pistyll is still visible today (Fig.5.1.1).

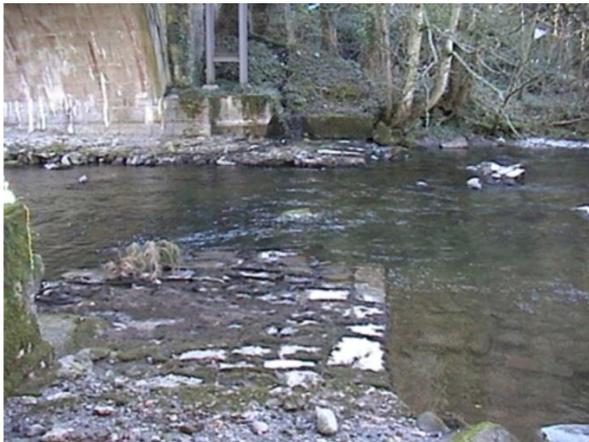
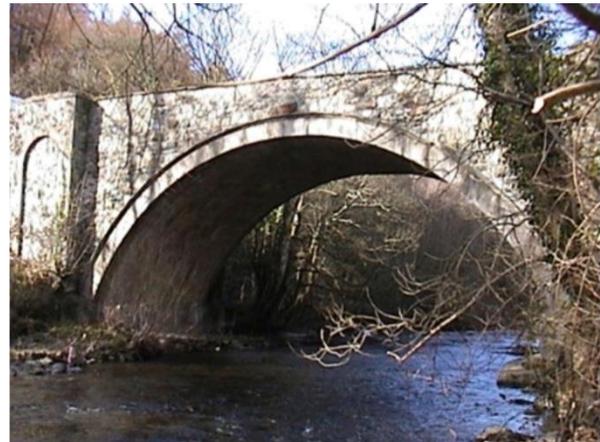
Fig. 5.1.2 (left): The stone footing beneath Tal-y-Bont Bridge, c.1824. (2004)

Fig. 5.1.3 (right): The present-day bridge, completed in 1881. (2004)

There is no evidence to indicate which of the designs was chosen or who carried out the work, although it would be safe to assume that a stone bridge was built. This assumption is based on an Order dated 2nd August 1824 being issued by the local Justices of the Peace binding the Clerk of the Peace, Richard Anthony Poole, to have the bridge repaired. The monies allocated were for the sum of £260-0-0, the task was to be performed by a Mr William Owen, and the work to be carried out was the insertion of stones into the river bed in order to protect the foundations of the bridge.²⁷⁶ Presumably this solution proved to be adequate as the bedding stones are still in evidence today (Fig.5.1.2), and it was not until 1881 that the bridge was reconstructed in its present form by Owen Morris of Caernarvon (Fig.5.1.3).
