**Richard Pennant, Samuel Worthington and the mill at Penlan
a history of the Penrhyn Mills on the Lower Ogwen**

Richard Pennant, Samuel Worthington, and the Mill at Penlan

A History of the Penrhyn Mills on the Lower Ogwen

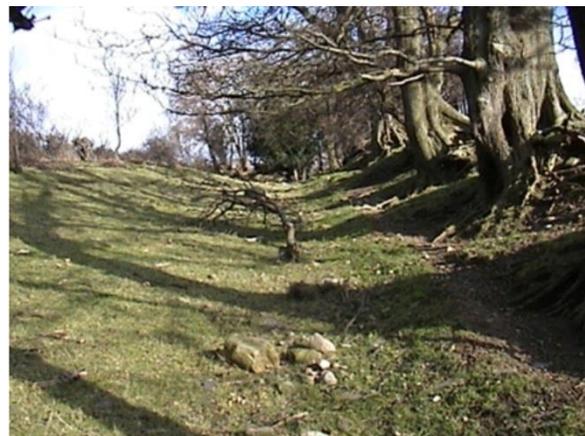
Fig. 5.1.5: Part of the original road at Groeslon field, prior to Telford re-routing it in 1822. (2004)

In 1822 Thomas Telford re-routed the road through Tal-y-Bont to avoid what was known as 'Tal-y-Bont Clip', with the new section of road following the line of today's A551 trunk road (Fig.5.1.4). Prior to this the road had passed through Tan-y-Lon and Gatehouse, between Groeslon and St Cross Church, across Groeslon field to the centre of the old part of the village near Ty Mawr and continued on to the new stone bridge (Fig. 5.1.5).

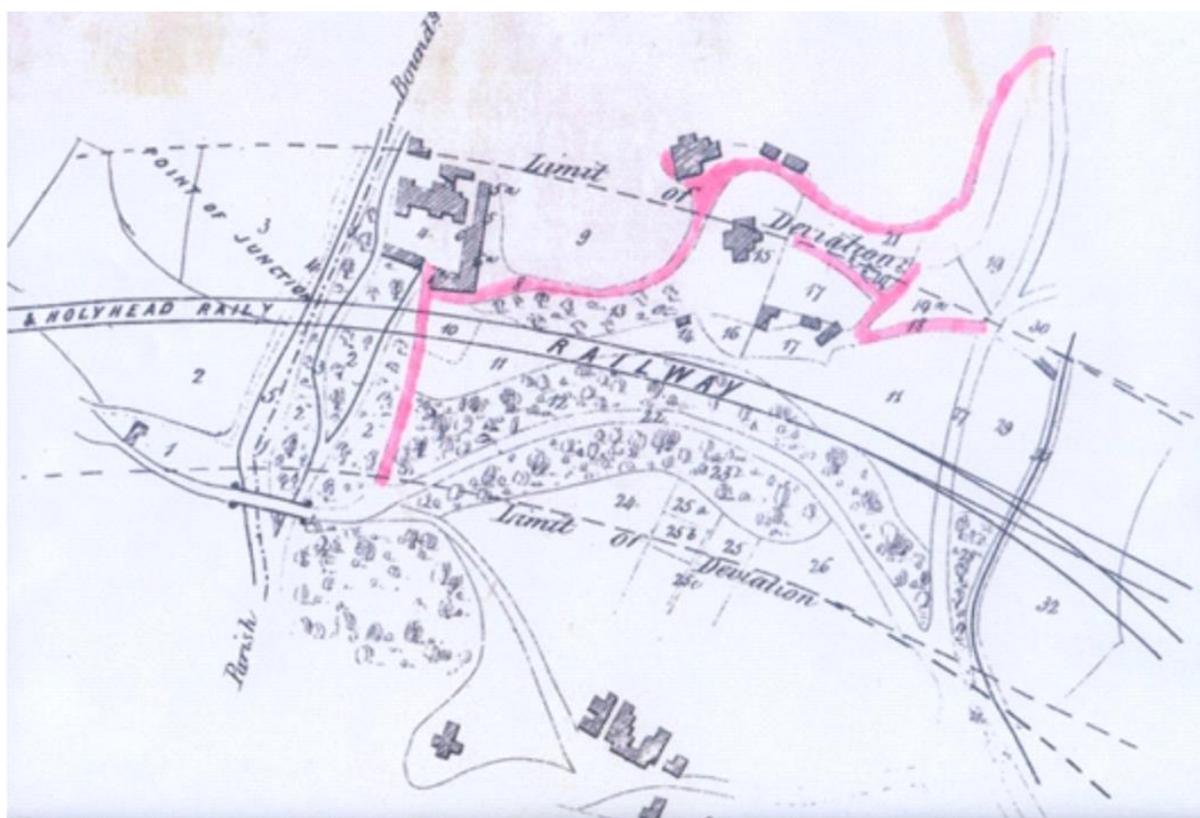
Fig. 5.2.1: The route of 'Occupation' Road c.1844.²⁸⁵

It is slightly open to interpretation but it would appear that 'Occupation' Road ran from just above Tal-y-Bont Bridge, starting at what is now the main A551 trunk road.²⁸³ It then went down the hill to the entrance of Trefelin Yard (originally Felin Isaf), around the front and side of the Yard, essentially following the same route as the present day road i.e. in front of Trefelin Cottages, beneath what is now the railway under-pass, and on to Penlan Mill. From the Mill it continued up the slope to Penlan Mill Cottage and then followed the inclined driveway to what today is the site of the plant hire company, continuing on to join the old Capel Curig to Bangor turnpike road.²⁸⁴ There was an additional section that ran from slightly further along the turnpike road, from opposite the smithy on the corner of the road up to Bryn and down the drive to Llwyn Onn (today known as the Old Vicarage), Pentwmpath, and Y Stabl.

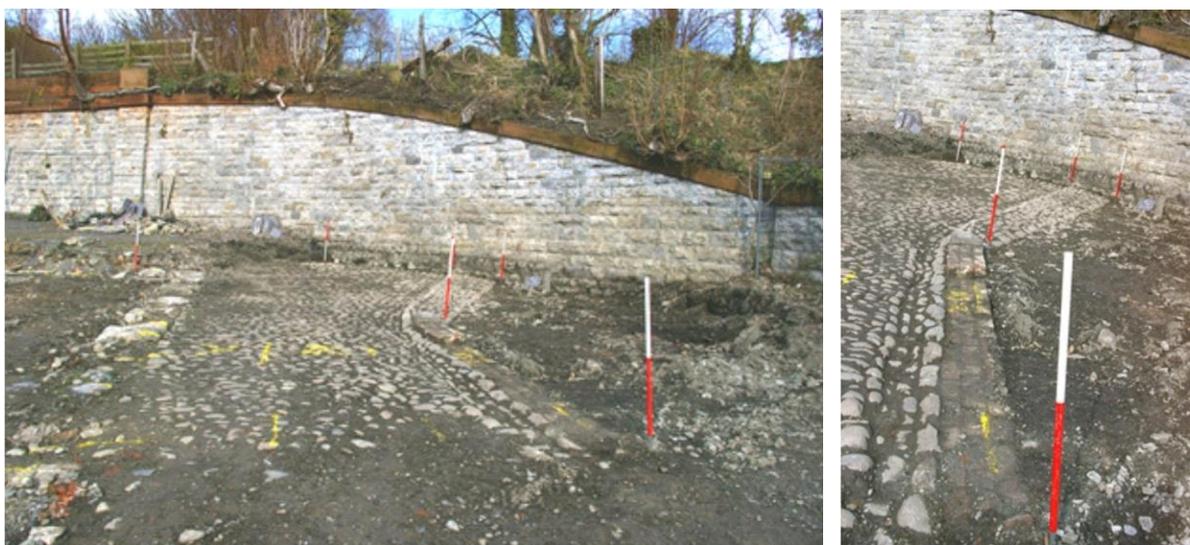
Fig. 5.2.2 (left): The remains of 'Occupation' Road, truncated by the Chester & Holyhead Railway. (2011)

Fig.5.2.3 (right): The gully to the eastern edge of 'Occupation' Road. (2011)

The total length of road exposed during excavation was approximately 16 metres, with the distance from the north east corner of the stable wall to the embankment being 4.38 metres. At its widest point, adjacent to the railway embankment, it is approximately 5 metres wide, reducing to approximately 3 metres at the southern end. For most of its length there is a gully running along the eastern edge, this petering out towards the embankment. From the southern end of the road a low brick wall runs northwards alongside the gully for approximately 4.5 metres, and southwards for approximately 2 metres. The southern section is offset at an angle of approximately 10 degrees towards the adjacent filter bed (Figs.5.2.2 to 5.2.4).

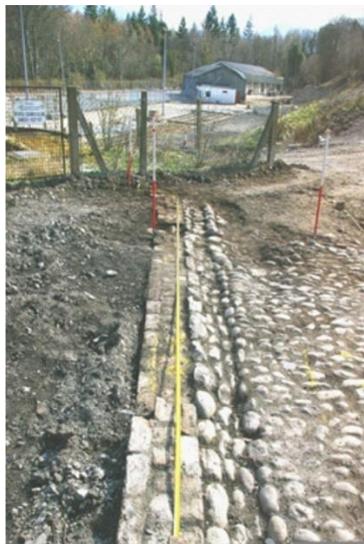
Fig.5.2.4 (left): The east edge of the road facing south, showing the brick wall and gully.

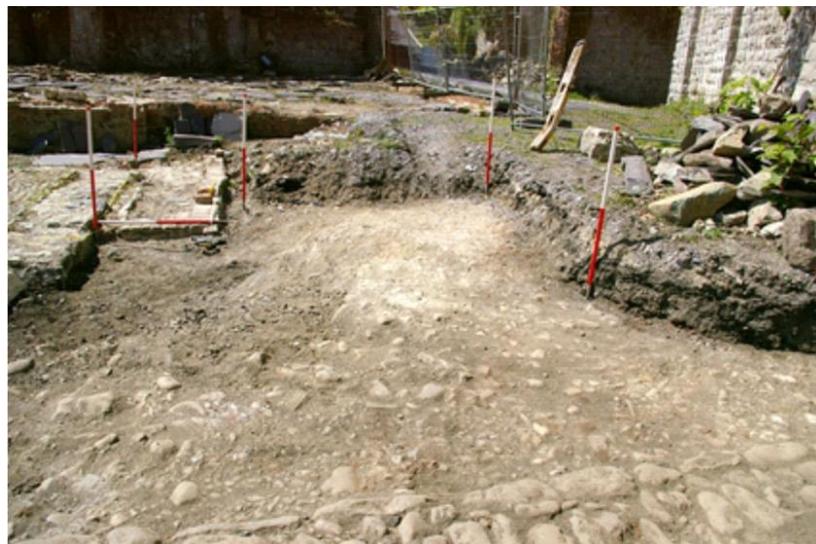
Fig.5.2.5 (right): The remaining surface of the road as it heads toward the Upper Yard and Penlan Mill Cottage. (2011)

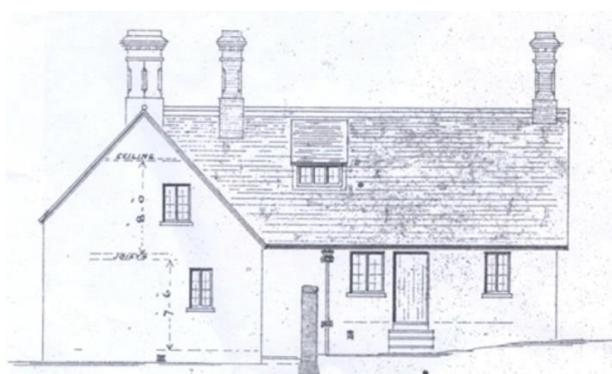
Fig.6.2.2: Carter's Cottages, rear elevation. (c1890)

There were two cottages, both of them being built in around 1890. Originally, they were designated as Carters Cottages, although in the Penrhyn Estate rent rolls they appear as Penlan Cottages (Figs.6.2.1 to 6.2.7). Apparently, they were constructed in stone with a rendered exterior and yellow brick edgings, although this is not evident from the surviving photographs and there is nothing to indicate this from the surviving plans.³²¹ The roof was slate. The cottages were adjoining with No.1 being nearest the main road. The gable end of No.1 was aligned east-west, and that of No.2 was aligned north-south. Both comprised the same accommodation with a kitchen, scullery, and one bedroom to the ground floor, and two bedrooms to the first floor. The initial source of their water supply is not known but from around 1900 it was provided from a pump that was located in the wall facing No.2, opposite what today are Ashbrook's offices (Fig.6.2.8).

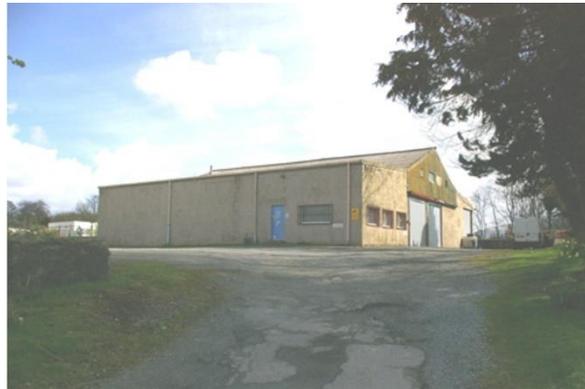
Fig.6.3.1: Former hay drying shed in centre, the two side sections being added when it was converted to a warehouse.

The site was subsequently taken over by Allenby's Ltd, a confectionary, wine and tobacco wholesaler, and it is they who extended the building to its present size by adding an additional bay to each side (Fig.6.3.1). Following the retirement of Mr Allenby in the late 1990s the building was taken over by Carters Removal and Storage, who operated their business from there until 2008. The building is now sub-divided into several units and let to a number of small businesses.

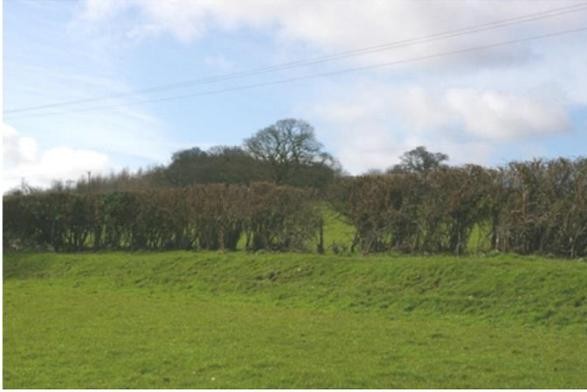
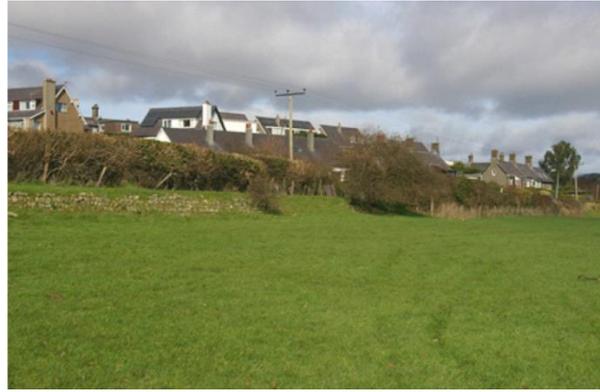
Fig.6.4.3 (left): Bed of the tramway below Bryn. (2012)
The mine site is marked by the woodland in the background.

Fig.6.4.4 (right): Continuation of tramway bed at Bryndwmchwel. (2012)

a capacity of 2/3rds cubic yards, and in the 1922 Inventory nine are listed, of which four were broken. At the foot of the incline they were then drawn for approximately 457 yards along the flat bed of what formerly had been the route of the original Penrhyn Quarry Tramway, to a point adjacent to No. 6 Tanybryn Cottages.³⁴¹ Much of the route can still be clearly seen today (Figs.6.4.3 to 6.4.7).

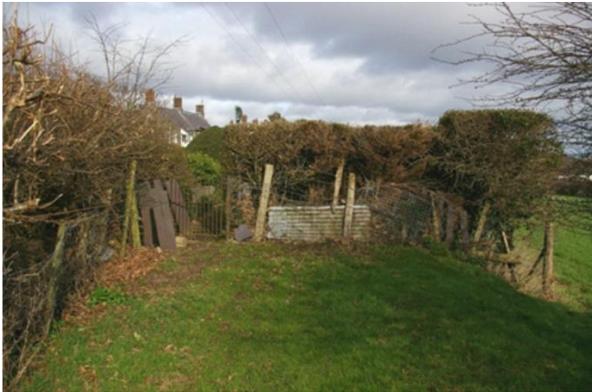
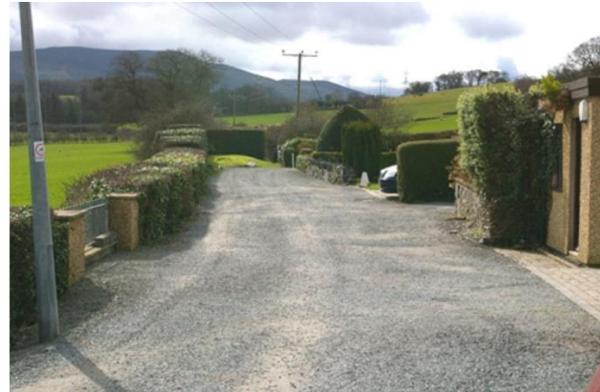
Fig.6.4.5 (left): Closed-off section of tramway at Bryndwmchwel, facing north. (2012)

Fig.6.4.6 (right): Continuation of tramway in front of cottages at Bryndwmchwel, facing south. (2012)

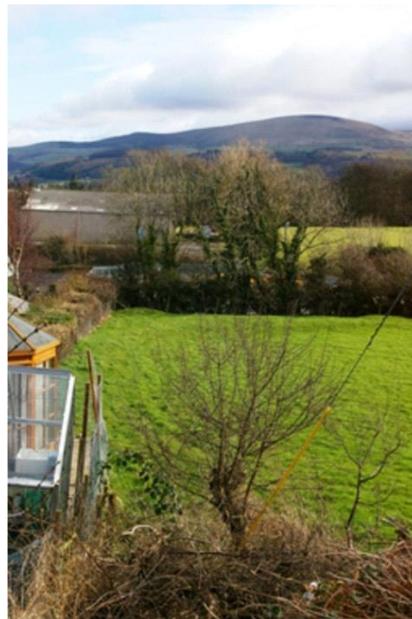
Fig.6.4.7: The raised bed at the side of the fence marks the line of the chute as it ran alongside No. 6 Tan y Bryn Cottages, facing east. (2012)

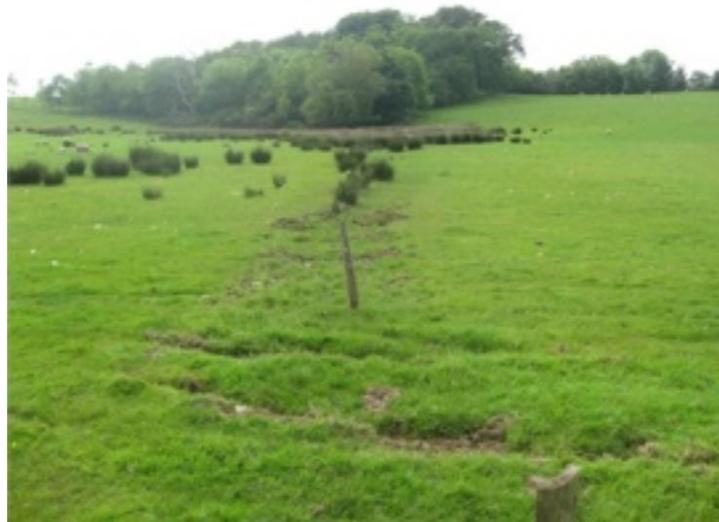
Fig.6.4.9: Route of the incline, facing west, at which time it was marked by wooden posts that subsequently have been removed.³⁴⁵ (2012)

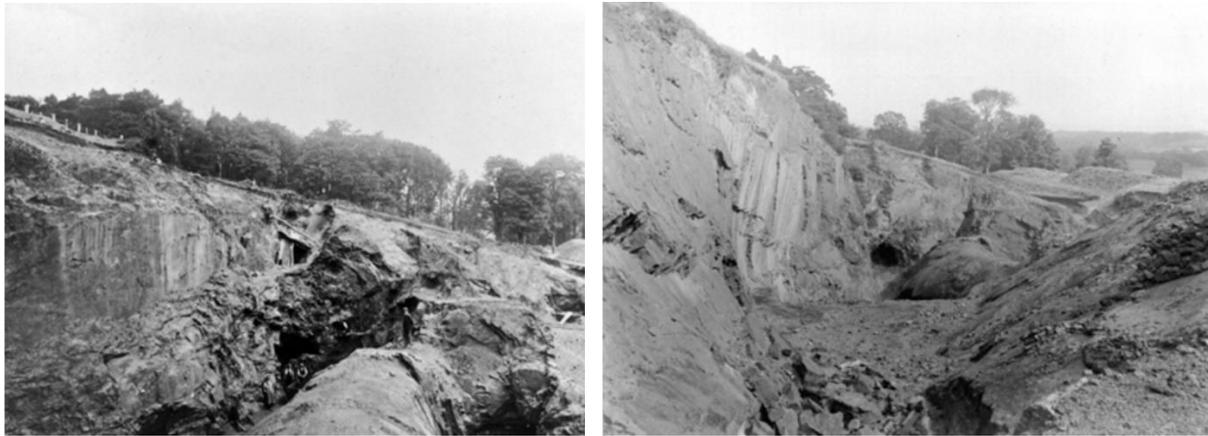
Fig.6.4.11 (left): The southern open-cast mine section in operation, 1920. The size of the three workmen in the centre foreground provides an indication of scale.

Fig.6.4.12 (right): The southern section, looking north (1928)

photograph taken in 1920 which shows the southern opencast section (Fig.6.4.11),³⁷⁴ and two further photographs taken in 1928, which show the site shortly after its abandonment (Figs.6.4.12 & 6.4.13).³⁷⁵ In 1973 David Elis-Williams took a number of contemporary photographs of the site (Figs.6.4.14 to 6.4.20), and perhaps even more fortunately, produced a sketch of the site as it was at that time (Fig.6.4.21).³⁷⁶

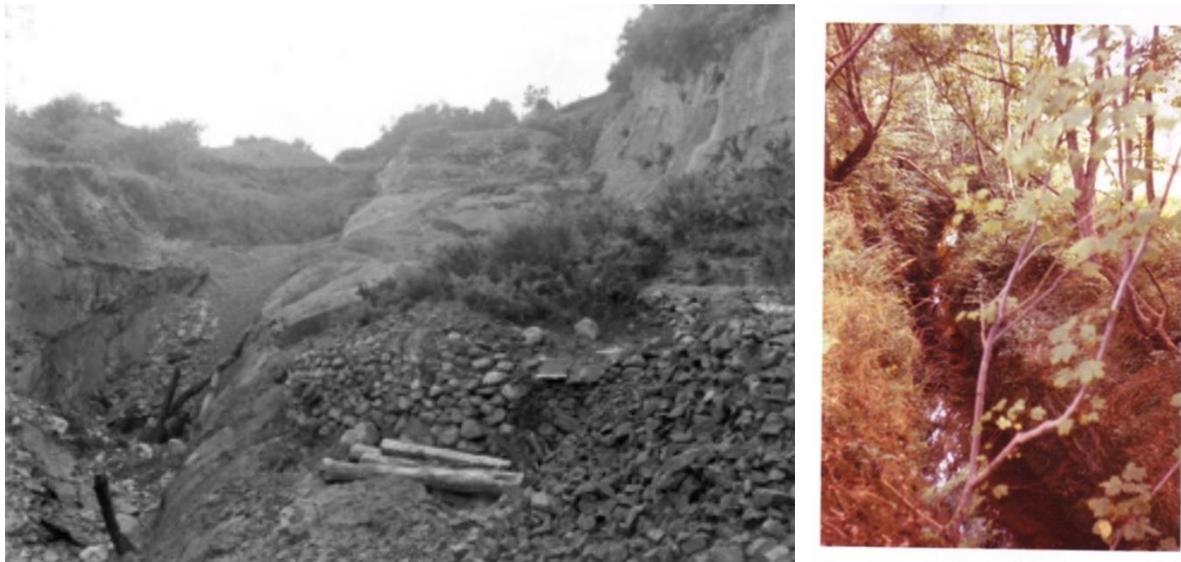
Fig.6.4.13 (left): The southern section, looking south. (1928)

Fig.6.4.14 (right): Northern section looking from above. (1973)

He describes the mine as having been in three sections. The Northern Section comprised the area within the present woodland which contained an open chasm approximately 120 metres in length and varied in depth from 2-10 metres below the land surface: the bottom being roughly horizontal, with the difference being due to the variations in the height of the land (Figs.6.4.14 & 6.4.15). He observed that at this point the ore bed was almost vertical, with the chasm being the result of open mining. There was a pile of loose rock with patchy scrub lying to the southeast of the chasm, possibly being a tip of mine overburden.

The Southern Section he describes as being more complex, essentially comprising an open-cast pit of up to 15 metres depth below ground level, this being split into eastern and western branches. Figs.6.4.13 and 6.4.18 show the western branch of this section; firstly, as it was in 1928 and secondly, as it was in 1973: the latter highlighting the amount of vegetation growth that had taken place since abandonment. At this point the structure of the ore bed could be observed, which essentially was twisted in an anticline. The shape of the pit was the result of excavation following the ore bed down each side of the anticline. At the centre of the anticline the rounded top of the rock underlying the ore bed could be observed, as shown in Fig.6.4.19. The same structure can also be observed in the foreground of Fig.6.4.11 and the middle ground of Fig.6.4.12. The anticline was penetrated by an access tunnel (Fig.6.4.20). In the eastern branch of this section the remains of a small hut were still visible.

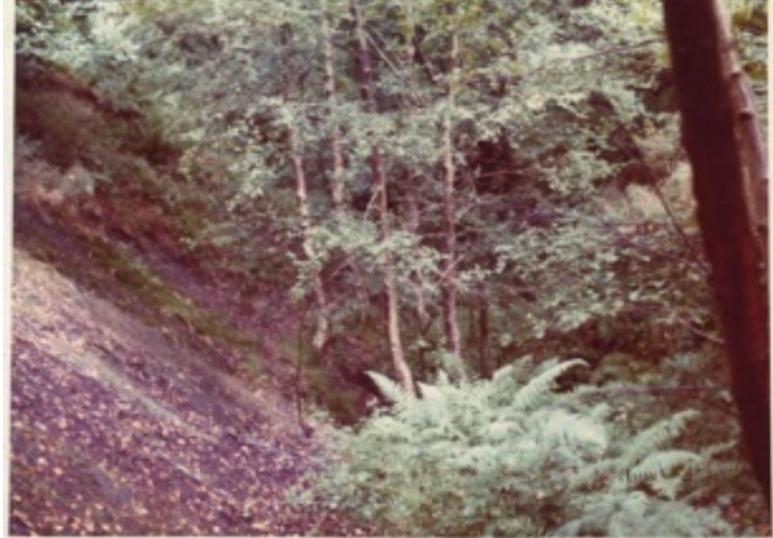
Fig.6.4.15 (left): Northern section looking north. (1973)

Fig.6.4.16 (right): Middle section, looking North. (1973)

The Middle Section he describes as being a short section where the ore bed dip was now 50 degrees, and the chasm a little wider and shallower: around 6 metres (Fig.6.4.16). It is in this section that signs of underground mining were observed, with four shafts following the slant of the ore bed downward. As all of the shafts were flooded to the same level he believes that they were joined underground.

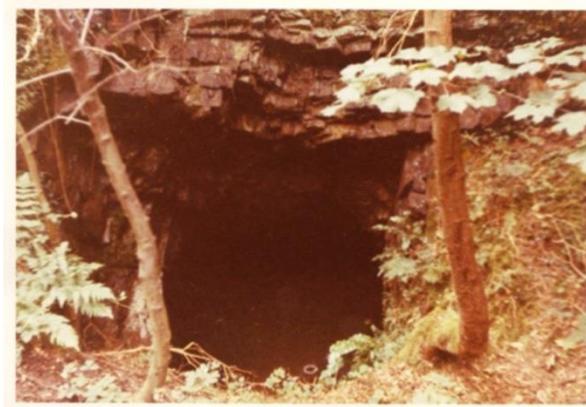
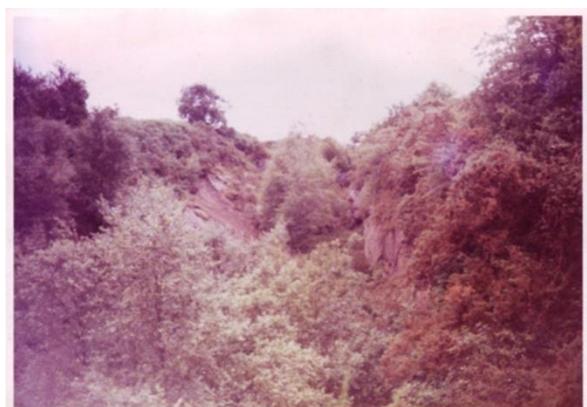
Fig.6.4.17 (left): Shaft in the Middle section, looking down. (1973)

Fig.6.4.18 (right): Southern section, Western branch, looking south from above. (1973)

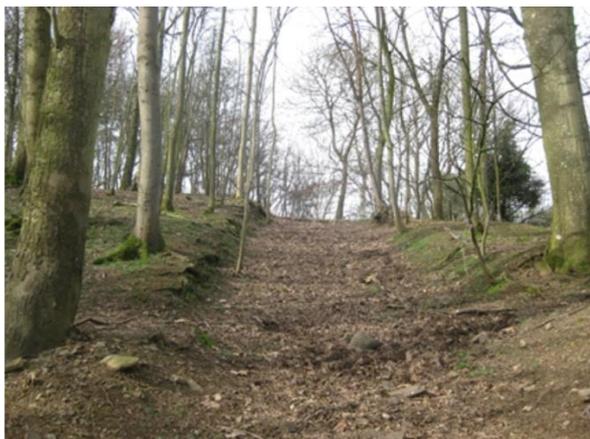
Fig.6.4.22 (left): The roadway, facing uphill toward the A5. (2012)

In 2012 Mr Elis-Williams re-visited the site where he observed that the protective plastic sheaths originally placed around saplings planted on the reclaimed land had not been removed, and as a result it was still possible to see the line of the northern section of the mine, together with new planting in the vicinity of the supposed overburden tip to the south east of the site. Also observed was a roadway cut into the base rock, running in a line from the edge of the mine chasm, upwards toward the gateway adjacent to the A5 (Figs.6.4.22 and 6.4.23). The average width of the roadway is 9 feet.

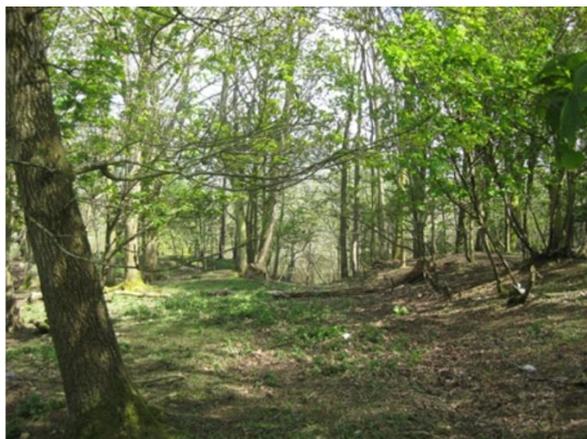
Fig.6.4.23 (right): The roadway, facing downhill. (2012)

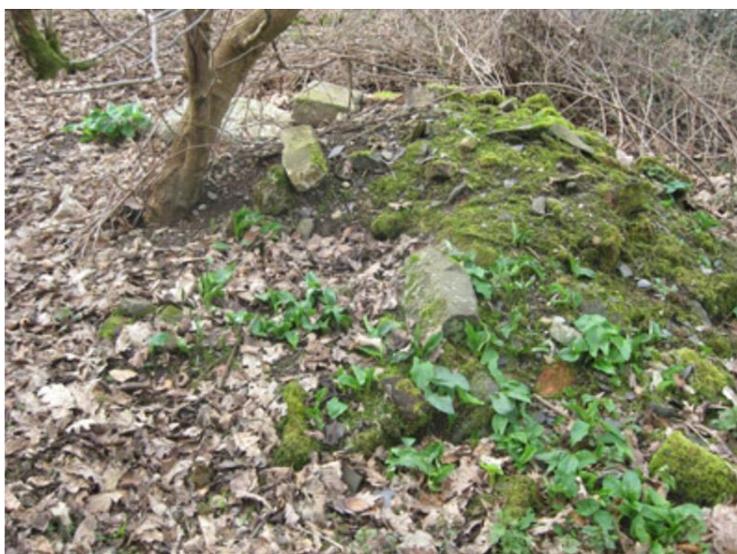
Fig.6.4.24 (left): Location of the mound (2012)

While there are no remaining traces of the original buildings, at a point some 32 feet in from the boundary wall (opposite the gated entrance) and immediately adjacent to the roadway there is a small mound of material measuring some 9 feet in diameter (Fig.6.4.24). To date no attempt has been made to excavate the mound, which on the surface comprises some old bricks, slate, and a broken concrete block. There is also a small piece of timber with an iron nail embedded. It may simply be that the mound was created when the site was back-filled with spoil from the construction of the new A5 road: alternatively, based on its size and location, it could be conjectured that it was the site of either a powder magazine or a gatehouse. However, without further examination it is not possible to fully ascertain either its true extent or purpose.

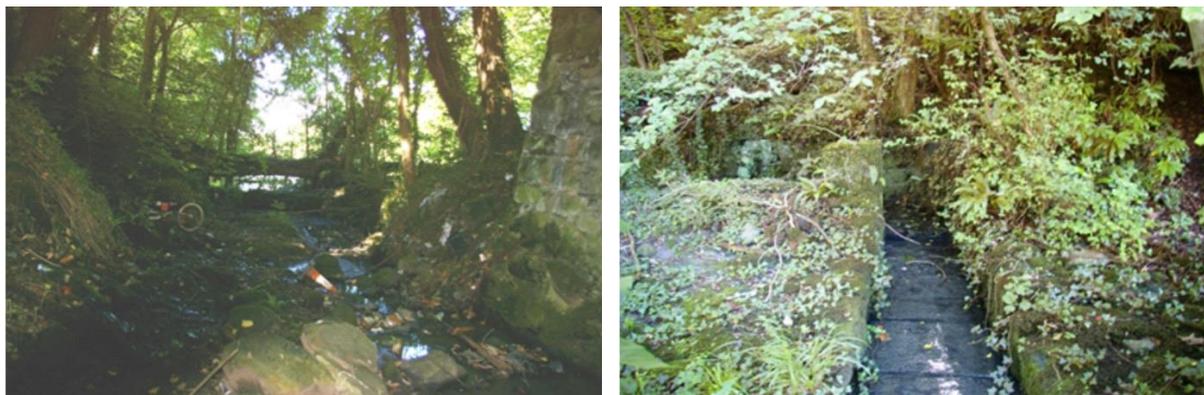
Fig.7.1.5 (left): Bed of exit race from beneath Tal-y-Bont Bridge. (2012)

Fig.7.1.6 (right): Cascade from exit race to River Ogwen. (2012)

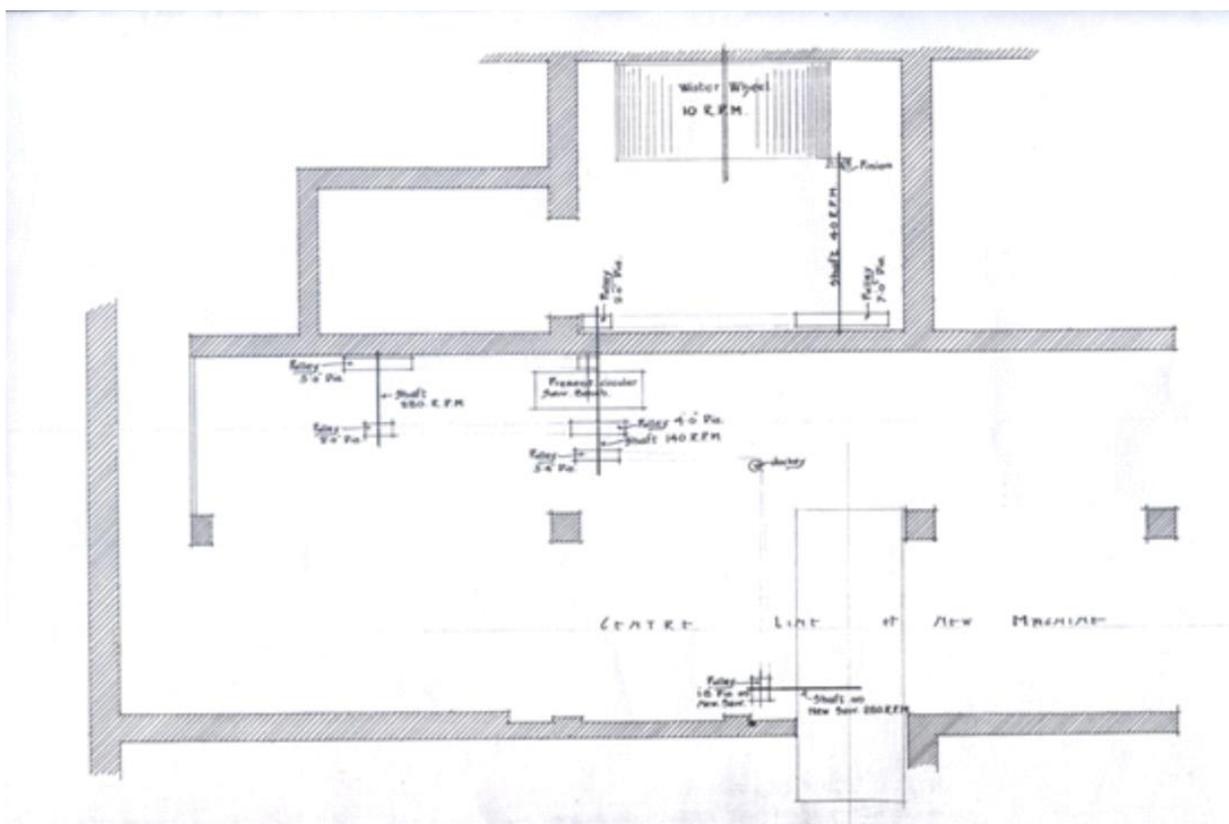
Fig.7.1.11: Plan showing re-arrangement of machinery.⁴²⁸ (1909)

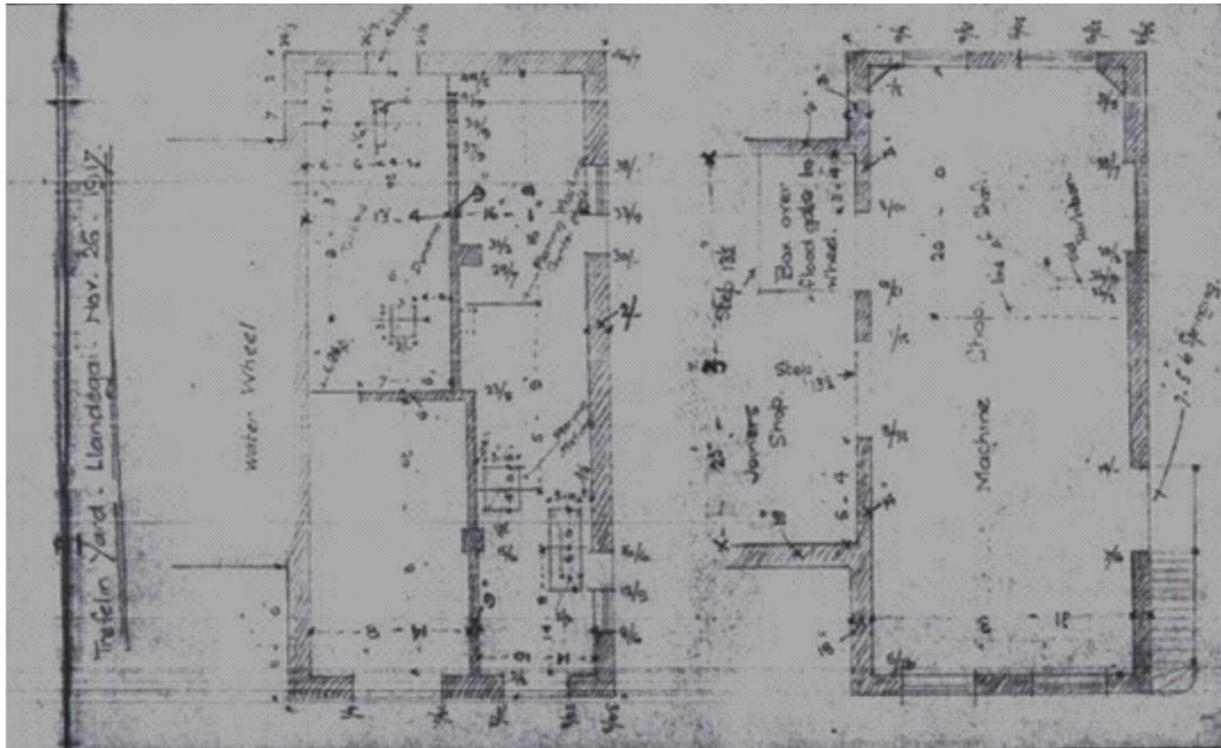
Fig.7.1.12: Plan of the saw mill and workshops.⁴²⁹ (1917)

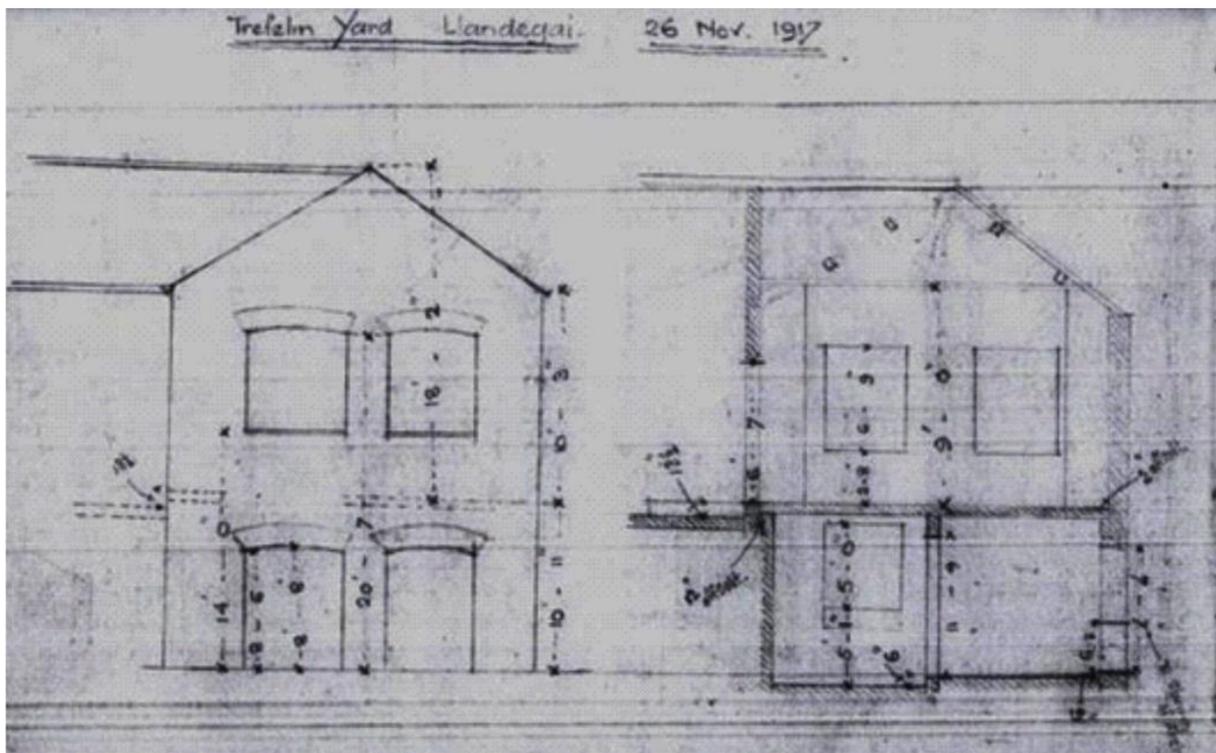
Fig.7.1.13: Elevations of the saw mill and workshops.⁴³⁰ (1917)

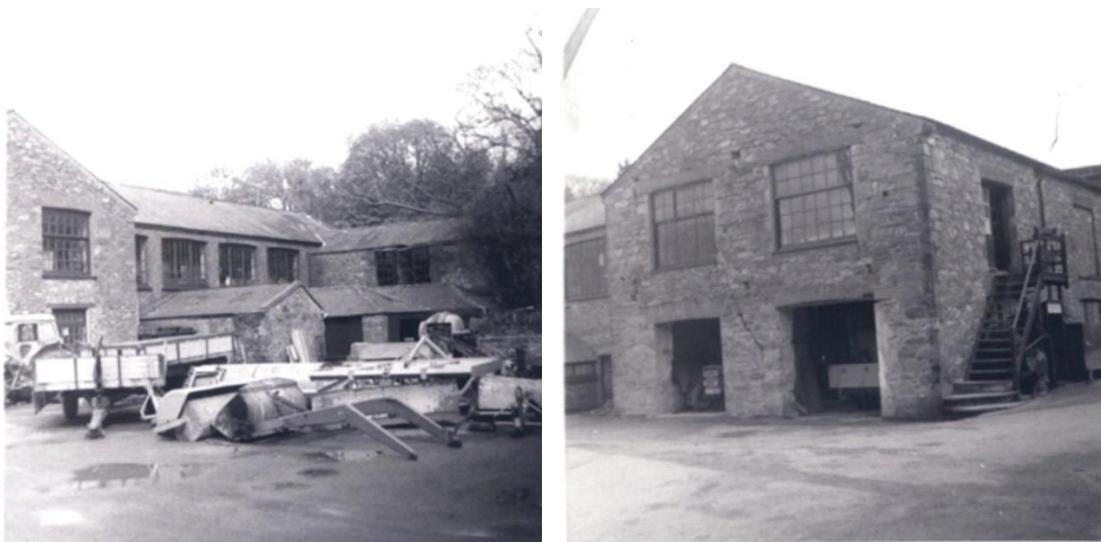
Fig.7.1.16 (left): The old mill left and right with Worthington's brick extension in the centre. (1972)

Fig.7.1.17 (right): The old mill with dated stones above windows.
Machine room and Joiners workshop above. (1972)

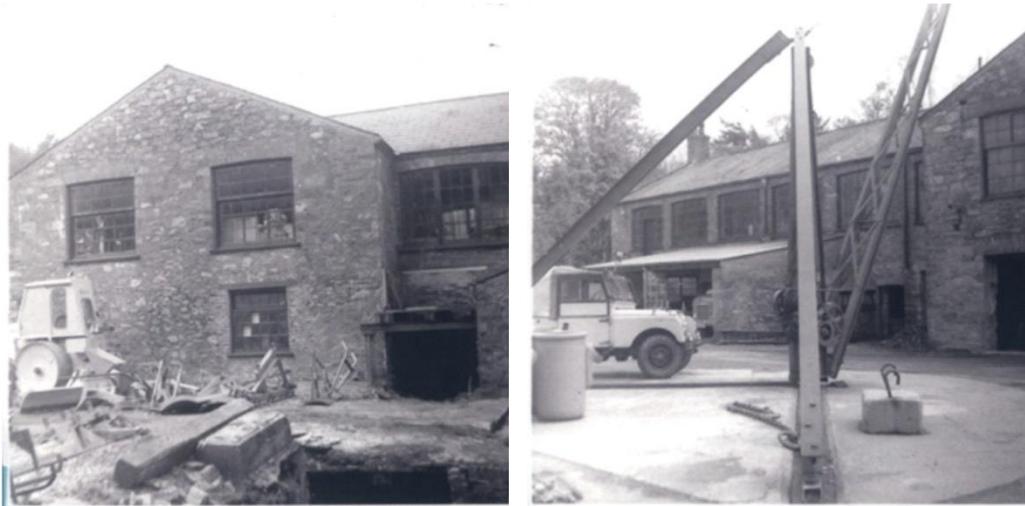
Fig.7.1.18 (left): Original stone mill from rear with brick extension to the right.
Openings to water wheel pit to right. (1972)

Fig.7.1.19 (right): Original stone mill to right with red brick extension to left.
Derrick crane used by Forestry Dept, and 6cwt test block. (1972)

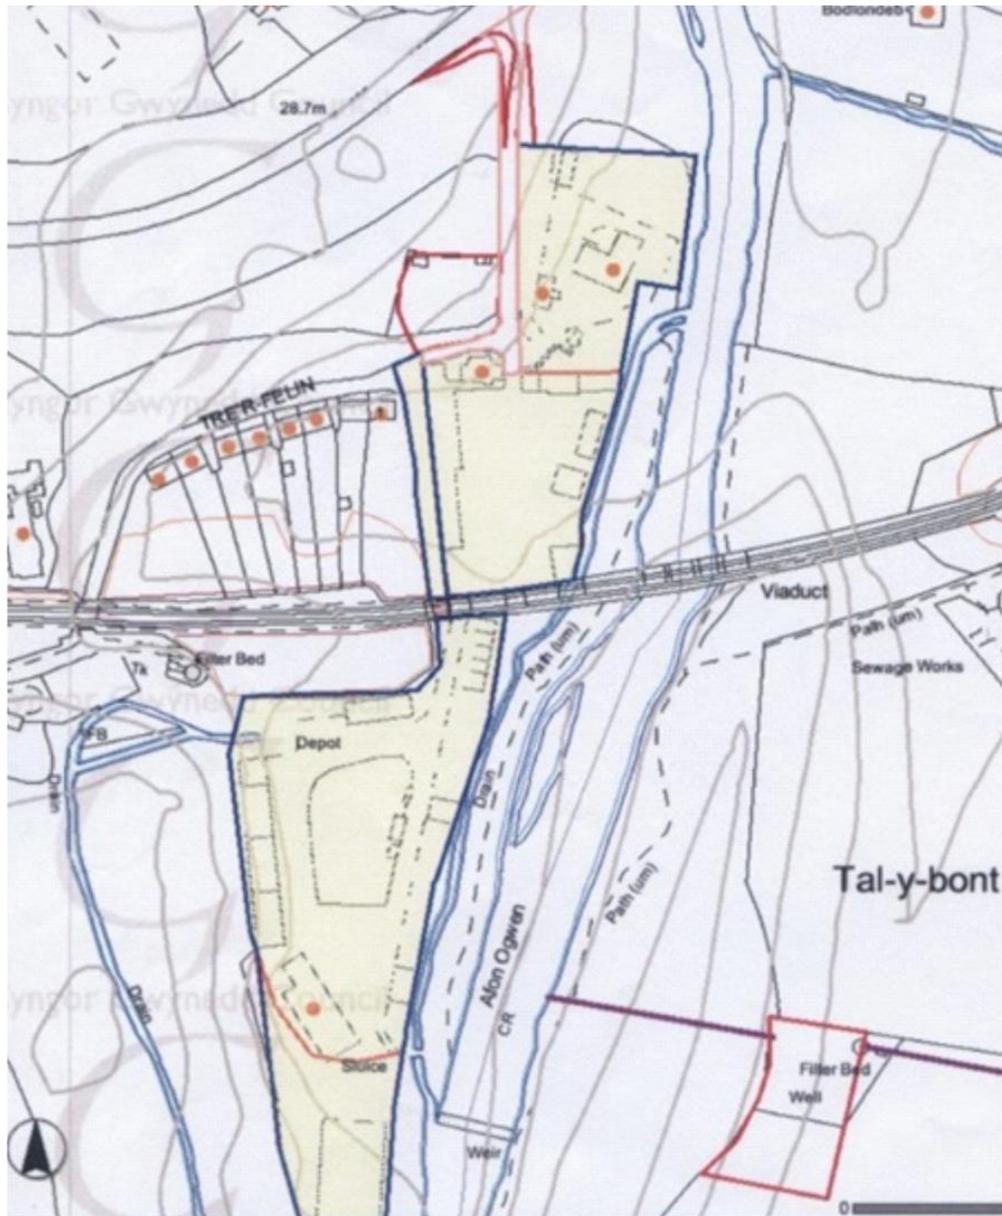
Fig.7.1.20: Extended Yard with new buildings added and the mill building demolished.⁴⁴³

Prior to the demolition of the mill the layout of the Yard comprised a series of buildings ranged along the entire west side, including a smithy and slate works. The north side comprised the Foreman's/Mill Manager's house (Trefelin House) which stands adjacent to the gated entrance, and then a further terrace of buildings which included cart sheds, a chaff store, a stable, a harness room, a store room and the old saw pit. The mill buildings and workshops occupied the main part of the south and east part of the yard, with the eastern boundary being formed by the River Ogwen. Three new buildings had been added by this time. One was in the south west corner of the site, and another two in the north east, adjacent to the river in the previously unused area outside the main yard (Fig.7.1.20). Demolition of the mill and associated buildings finally took place during October 1980.⁴⁴²

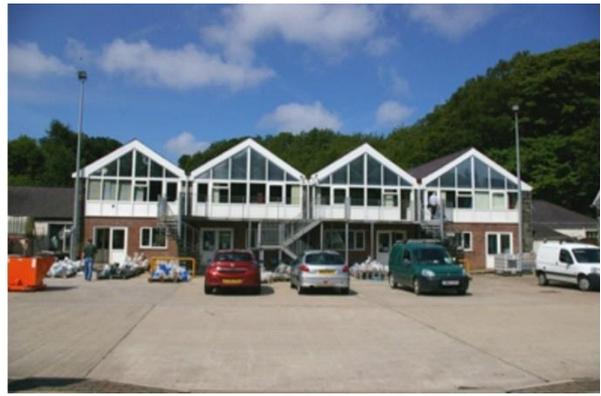
Fig.7.1.22 (right): New buildings to the west side of the yard, replacing what in 1844 had been stables and a granary. (2015)

The new office suite to the west side of the upper yard (Fig.7.1.22) replaced the original buildings, with the only remaining feature being the stone pillars separating each of the four bays.

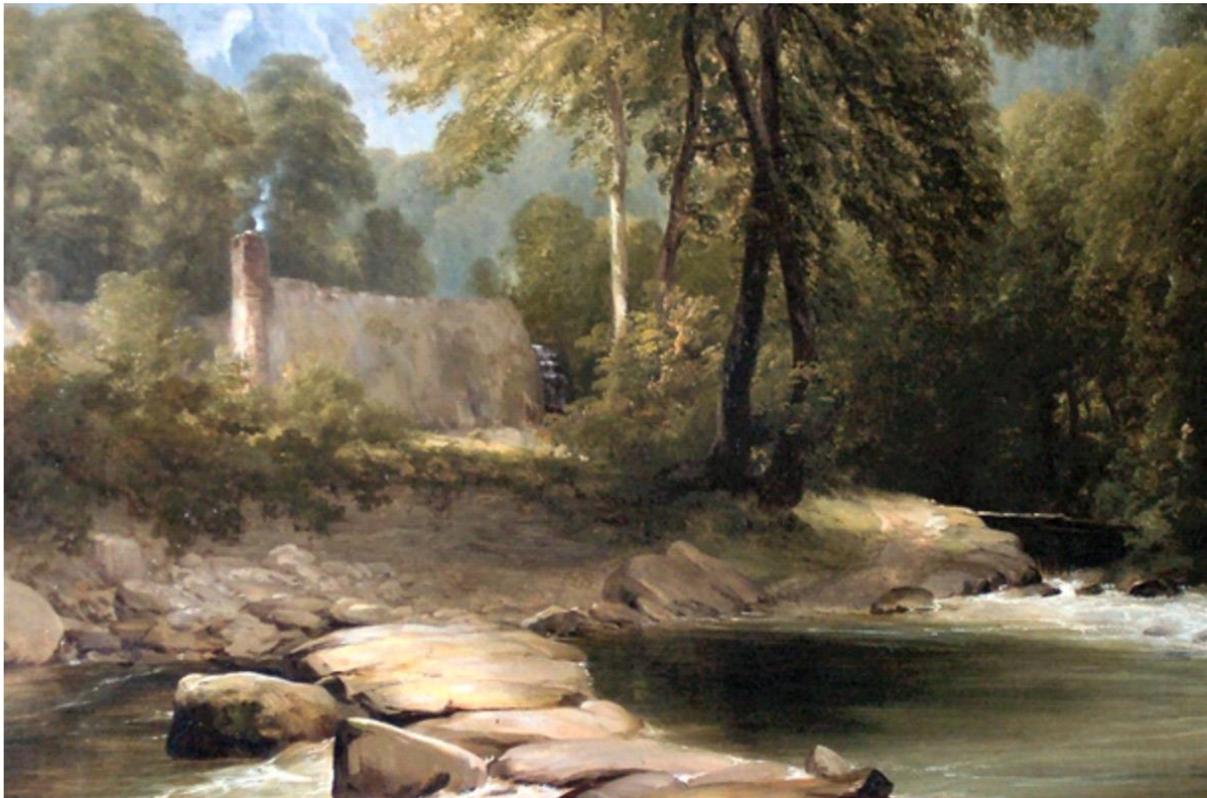
Fig.7.2.1: The original Cochwillan Mill c.1849. The roof of what became known as 'Factory Cottage' can be seen in the background.⁴⁴⁹

west it now faced north-south. The old mill was located adjacent to what today is the garage, with the mill wheel being located adjacent to the west wall.

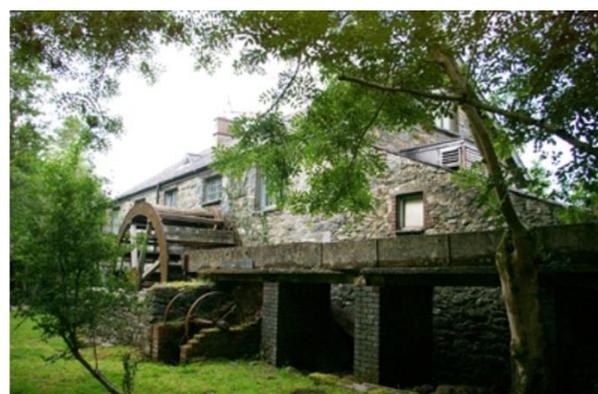
Fig.7.2.4 (right): The head race. Note additional small pair of wheels in foreground. Mr Barker had intended connecting these to the mill, but the work did not proceed. (2008)

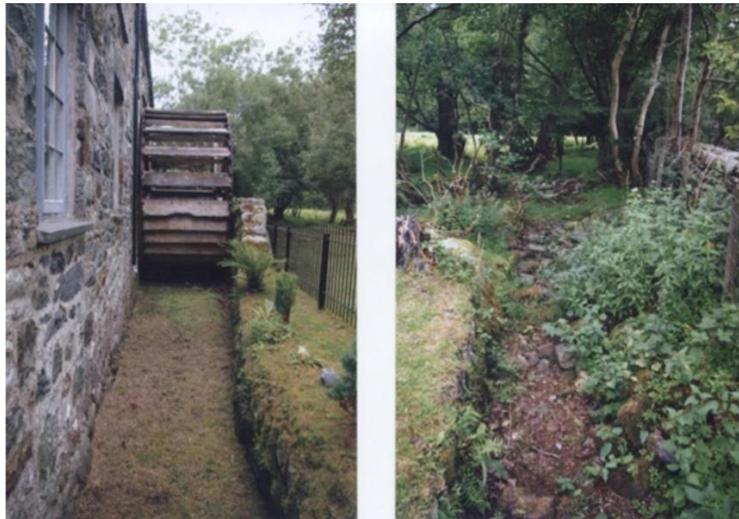
Fig.7.2.6 (left): The wheel and tail race.

Fig.7.2.7 (right): Part of the original exit race, facing north.

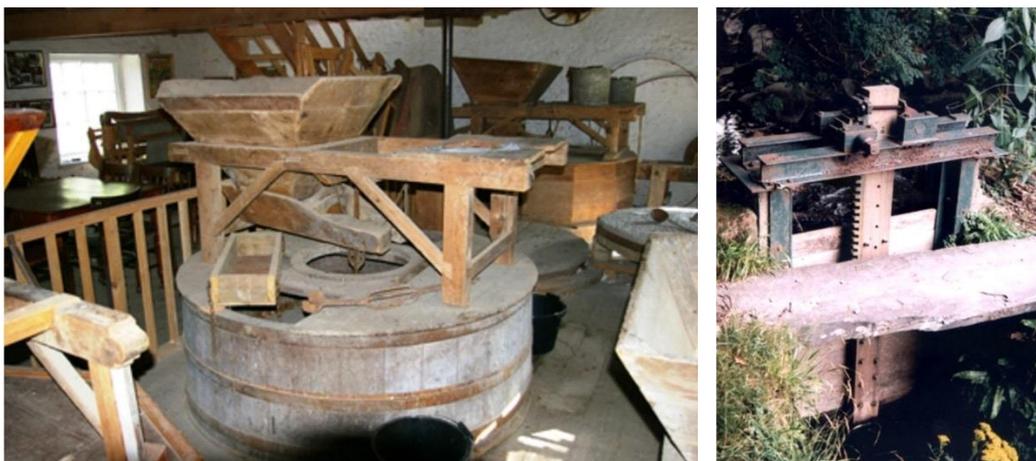
Fig.7.2.8 (left): Machinery on the upper floor. (2008)

Fig.7.2.9 (right): The new sluice at the leat entrance from the River Ogwen. (2003)

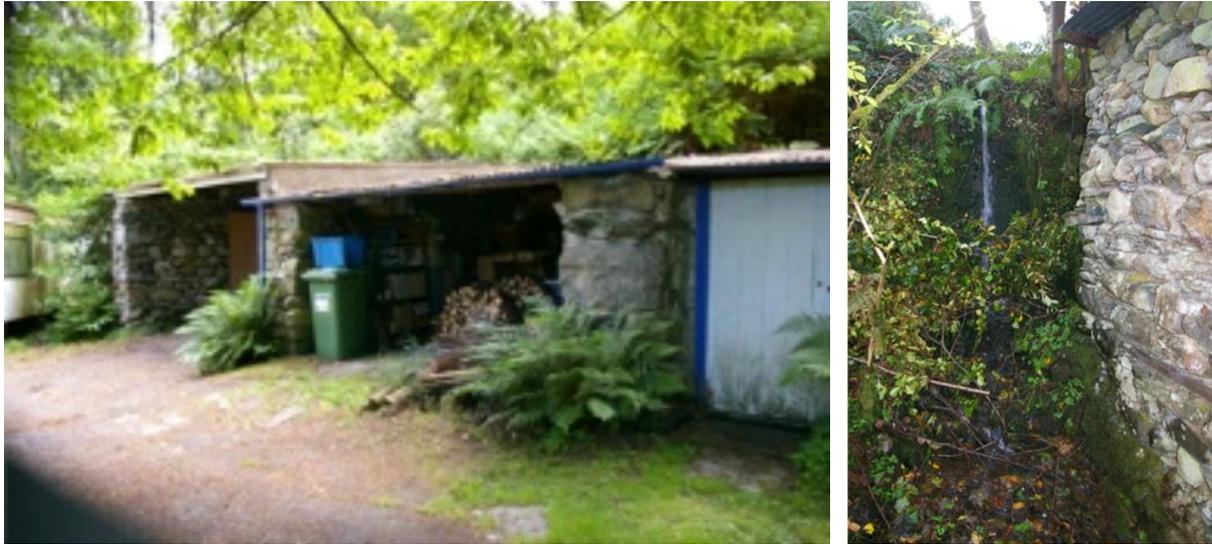
Fig.7.3.1 (left): The remaining mill buildings at Felin Hen, with the original mill to far left⁴⁸¹. (2011)

Fig.7.3.2 (right): Site of the head race exiting from the mill pond, (2011)

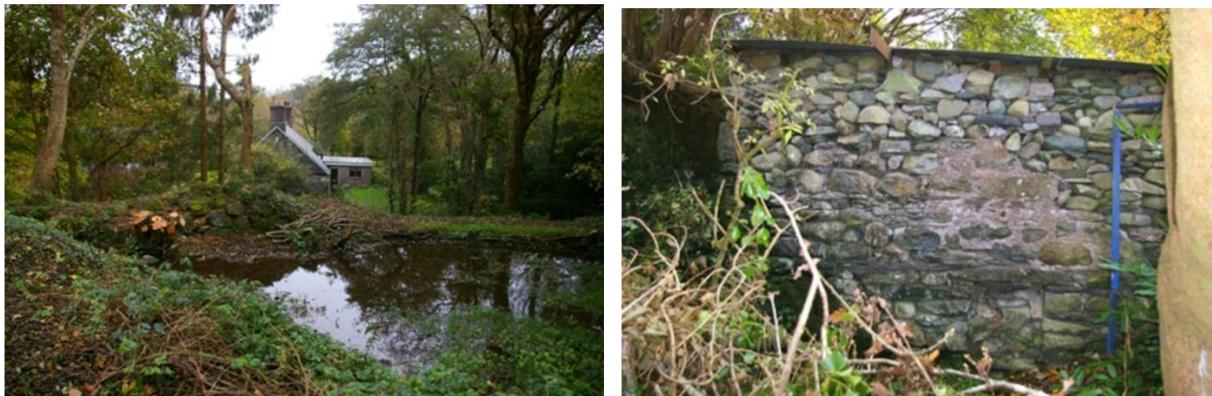
Fig.7.3.3 (left): the Gable end of Mill Cottage with mill pond in foreground (2011)

Fig.7.3.4 (right): Likely location of the water wheel. (2011)

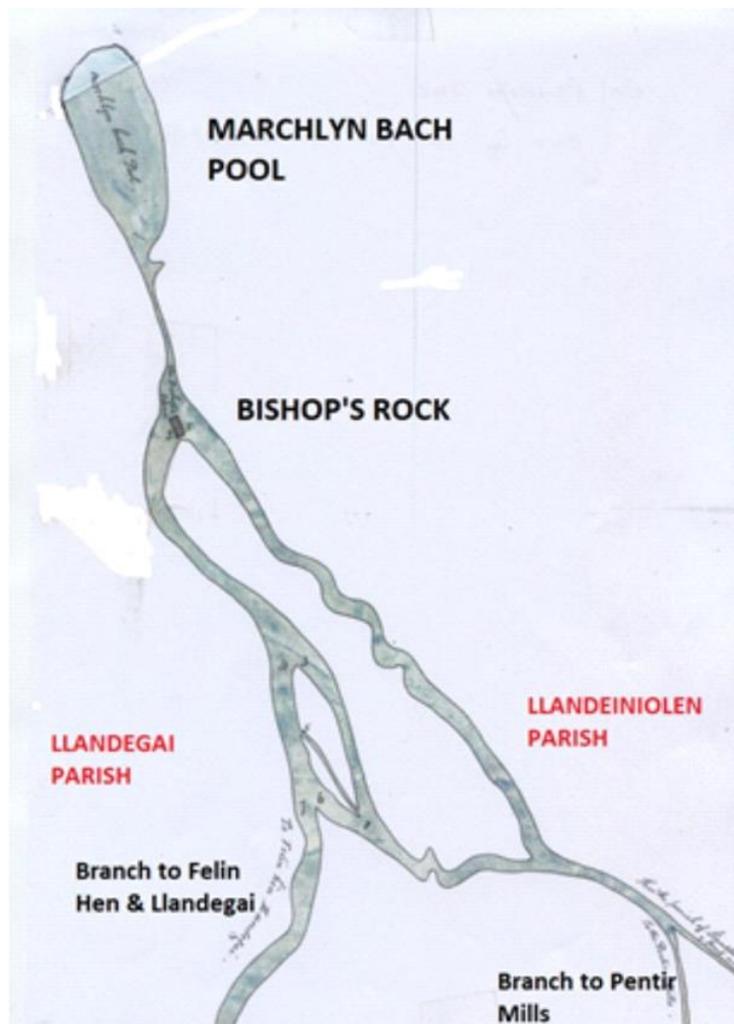
Fig. 7.3.6: Disputed water supply to Felin Hen, 1820.⁴⁸²

in order to ensure an equal supply, and the means by which this had been implemented was the insertion into the stream of a large stone, known locally as the Bishop's Stone (see Fig.7.3.6)

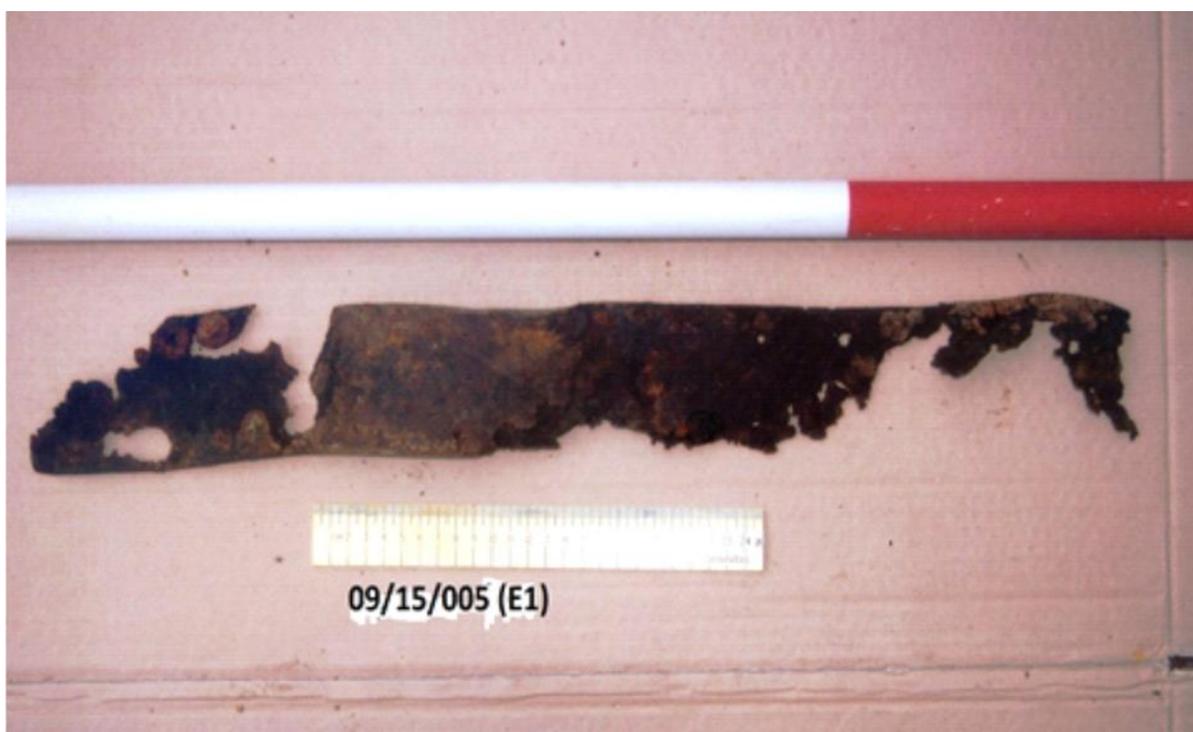
Fig. 8.2.1

09/15/005 (E1) A piece of leather drive belt. 600mm overall x 70mm x 7mm (Fig. 8.2.1)

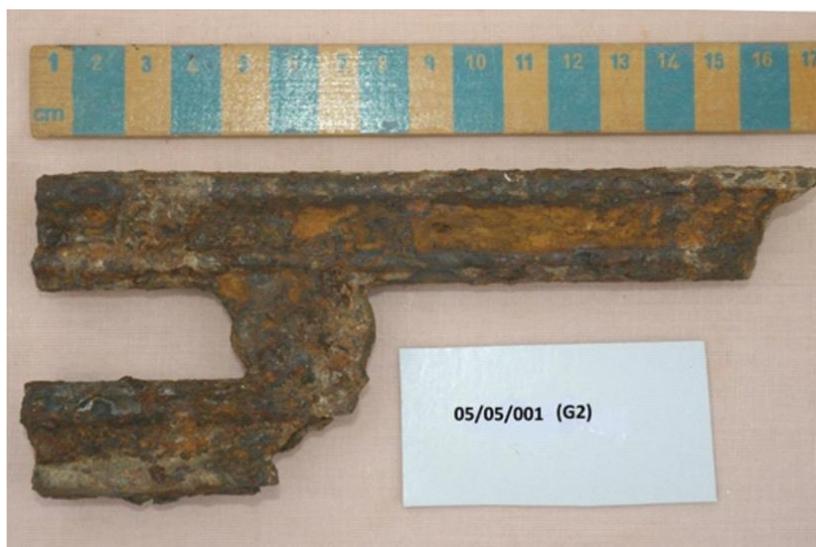
Fig. 8.3.1 (left)

05/05/001 (G2) An odd piece of metal casting shaped like the letter 'h'. There are grooves on both sides of the vertical legs. (Fig. 8.3.1)
