**Richard Pennant, Samuel Worthington and the mill at Penlan
a history of the Penrhyn Mills on the Lower Ogwen**

Richard Pennant, Samuel Worthington, and the Mill at Penlan

A History of the Penrhyn Mills on the Lower Ogwen

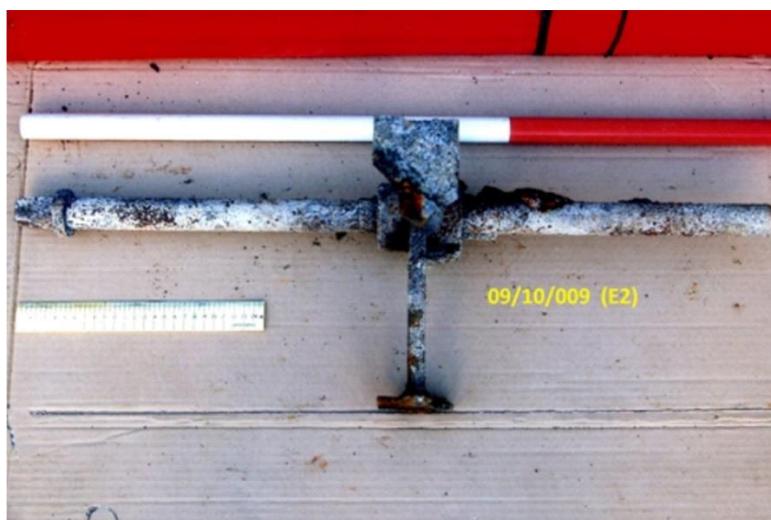
Fig. 8.3.13

09/10/009 (E2) A round drive shaft 750mm long x 30mm in diameter. At one end there is a square lug 23mm square x 40mm long (the lug tapers up to 26mm square). At the point where the lug joins the round shaft there is a round collar 50mm in diameter. Almost centrally along the shaft there is the centre boss of a wheel, with two curved arms protruding. At the end of each arm there is the remains of the outer circumference of a wheel, measuring 72.5mm wide x 7mm thick. There would have been four arms originally, the other being shown as 09/10/007 and 09/10/008. On this basis the diameter of the wheel would have been 380mm. (Fig. 8.3.13)

09/10/007 & 09/10/008 (E2) Two sections of a cast-iron wheel for a belt drive. Each part comprises a part of the 72.5mm outer circumference of the wheel, and the attached arm. They appear to be part of the wheel shown at 09/10/009.

09/10/010 (E2) Another curved piece of the outer circumference of the drive wheel shown above. It measures 220mm overall (on the curve) x 72.5mm wide x 7mm thick.

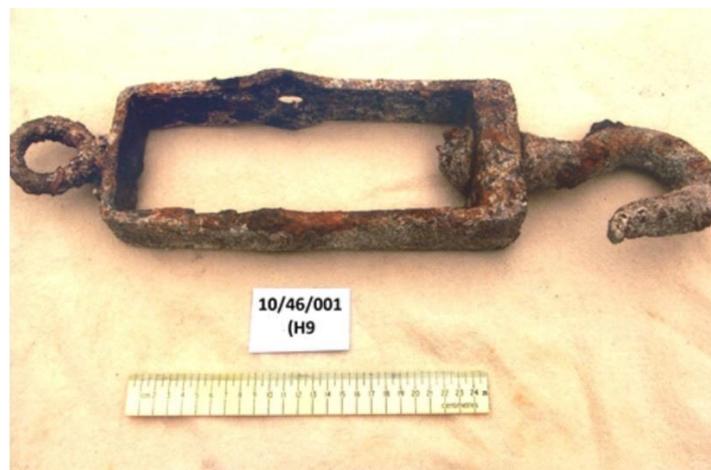
Fig. 8.3.16

10/46/001 (H9) A crane hook assembly comprising a rectangular metal frame 300mm long x 125mm wide x 45mm deep in the centre, widening to 55mm at one end and 50mm at the other. There is a circular iron ring at one end of the frame, and a large iron hook at the other. In each of the long sides of the frame, 130mm from the ring end, one side has a hole 23mm square. The opposite side has a matching round hole 25mm in diameter. Where the holes are, the sides of the frame have been widened to retain strength. The widening is in the form of a triangle protruding from beneath and above the side. The ring has a 65mm outer diameter and 35mm inner diameter. The hook is a maximum of 150mm overall, with the actual hook being 100mm. It has an average thickness of 32mm. Whereas once both the hook and ring probably would have swivelled, they now are corroded. (Fig. 8.3.16)

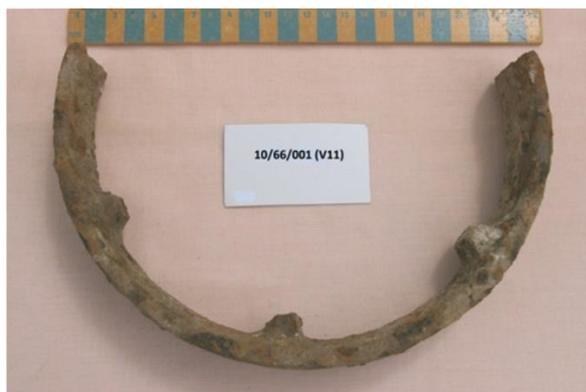
Fig. 8.3.17 (left)

10/66/001 (V11) Half of a belt drive wheel with 3 broken off arms to the inner side. 230mm outside diameter x 42mm x 10mm. (Fig. 8.3.17)

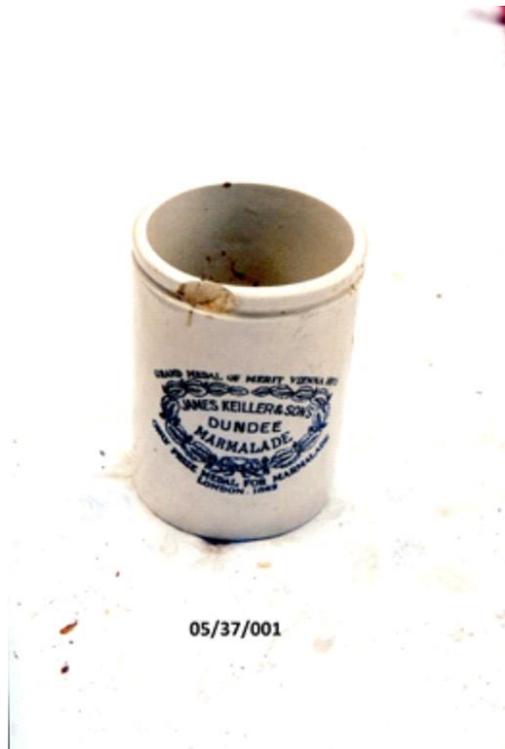
Fig. 8.4.3 (left)

05/37/001 A cream-coloured jar marked
GRAND MEDAL OF MERIT VIENNA 1870
JAMES KELLER & SONS
DUNDEE
MARMALADE
ONLY PRIZE MEDAL FOR MARMALADE
LONDON 1862
The neck of the jar is slightly chipped, otherwise it is intact. The base is marked '7VF'. (Fig. 8.4.3)

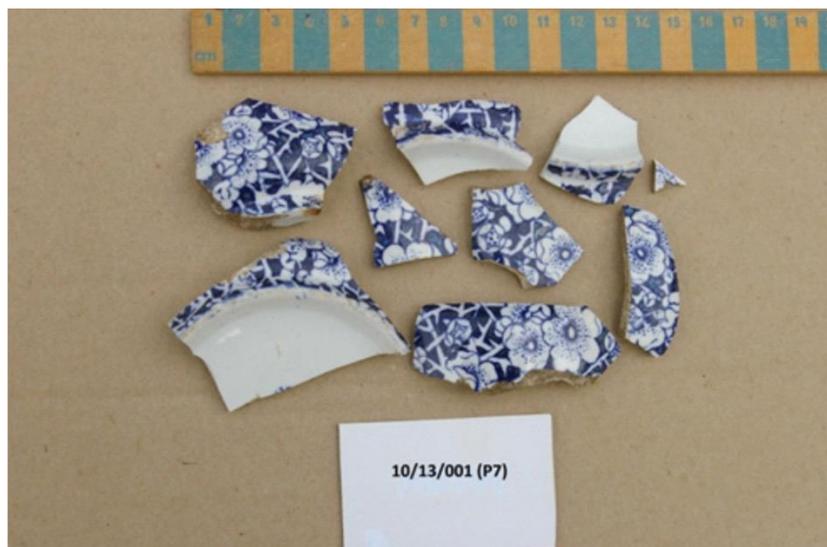
Fig. 8.4.5 (left)

10/13/001 (P17) Nine fragments of glazed dark blue and white pottery. (Fig. 8.4.5)

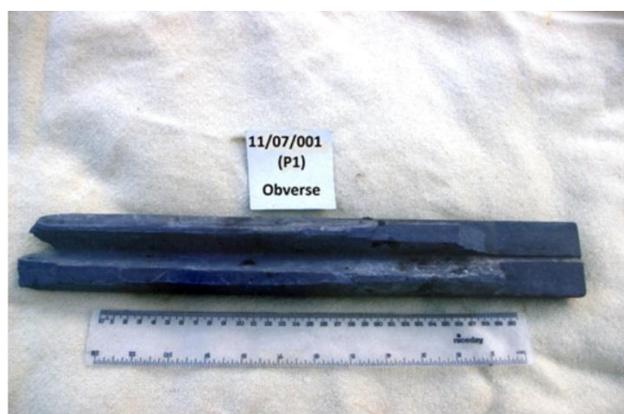
Fig. 8.5.1

11/07/001 (P1) A length of machined slate 410mm x 55mm diameter. Parts are broken, but it has a flat section at one end 65mm long and 15mm deep. Along the entire length there is a 'V'-shaped groove 20mm deep. (It has been suggested that this is part of a ridging tile, as used by Penrhyn Estate). (Fig. 8.5.1)

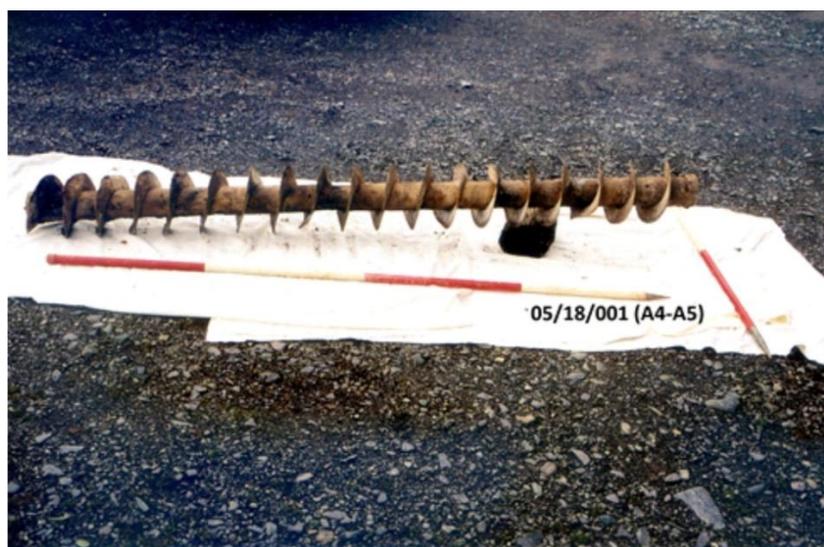
Fig. 8.6.1 (left)

05/18/001 (A4-A5) A large grain-moving screw, intact, 2.24m long with the round wooden shaft being 10.2cm in diameter. It has a total of 19 metal screw blades in total. The ends of the shaft are capped with steel bands and the first 35.5cm of the shaft has a metal sheath around it. The screw has been transferred to Cochwillan Mill for display and safe keeping. (Fig. 8.6.1)

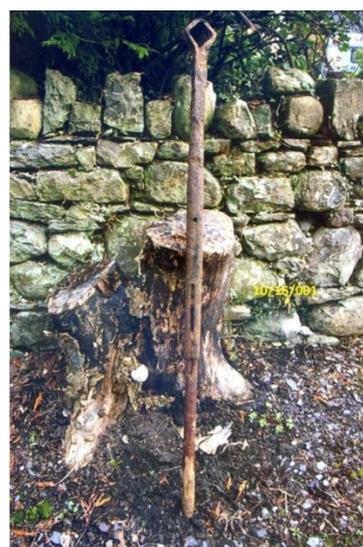
Fig. 8.6.2 (right)

10/16/001 A heavy metal key or spanner, probably used for operating the sluices, or possibly tightening the large bolts holding down machinery. It appears to have been fabricated from several different pieces of metal. Now located at Cochwillan Mill for display and safe keeping. (Fig. 8.6.2)

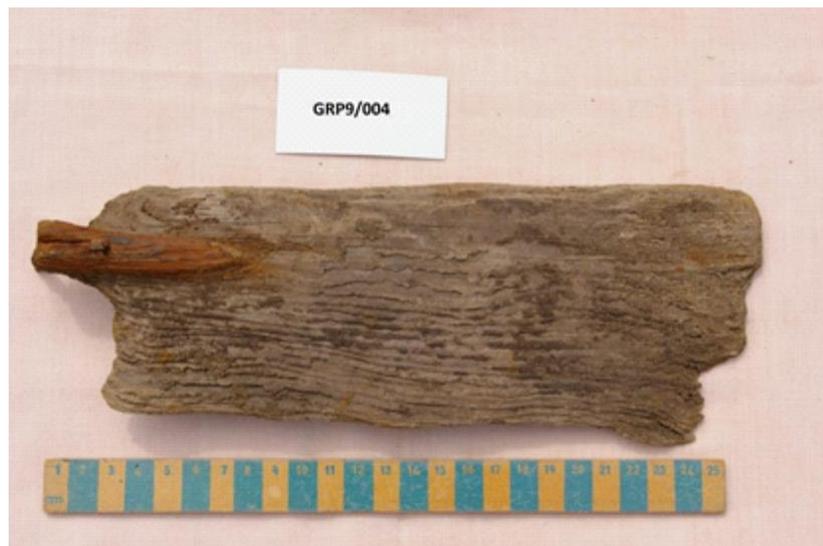
Fig. 8.6.4 (right)

GRP9/004 A piece of wood, shaped on one side, and with a nail protruding through the shaped end. Possibly part of a wooden grain shovel. (Fig. 8.6.4)

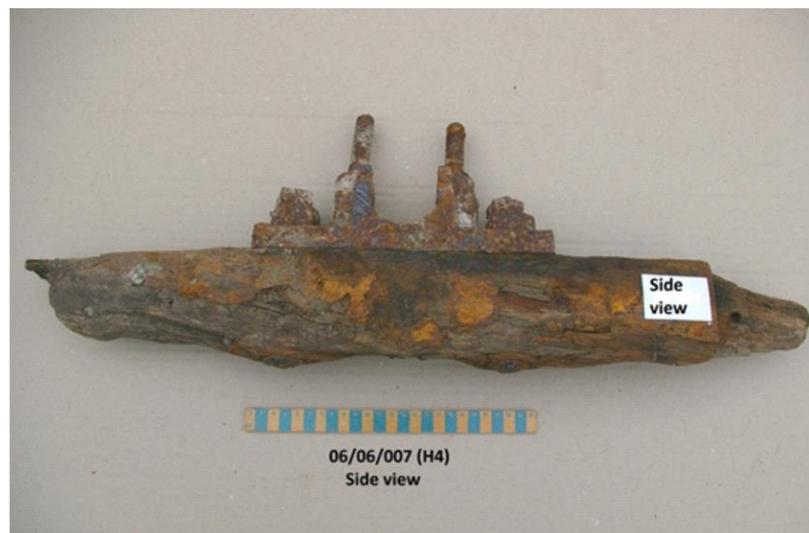
Fig. 8.7.2 (right)

06/06/007 (H4) A piece of timber 675mm max x 85mm max x 72mm. There is half of a shaft housing mounted on top, held in place with 2 coach bolts and 25mm square head nuts. There are threaded bolts protruding upwards from the housing, set to receive its upper half. (Fig. 8.7.2)

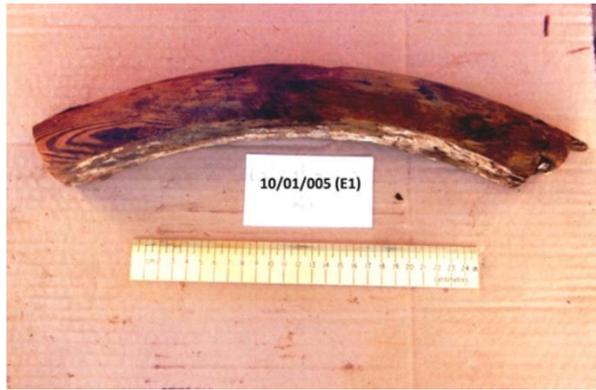
Fig. 8.7.3 (left)

10/01/005 (E1) A curved piece of timber formed into an arc. 360mm overall x 57.5mm on one flat surface and 50mm on the other. Possibly part of a window frame. (Fig. 8.7.3)

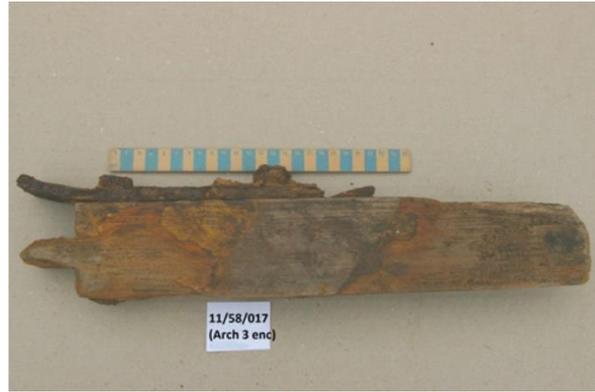
Fig. 8.7.4 (right)

- 11/54/003 (Head race above launder) Two pieces of rotten timber, each with an iron nail protruding.
- 11/58/017 (Arch 3 enclosure) A rust-stained piece of timber 430mm overall x 70mm x 50mm. There is a metal plate 230mm x 50mm x 10mm attached to the 50mm top side, secured by 2 square head bolts and nuts that go right through. (Fig. 8.7.4)

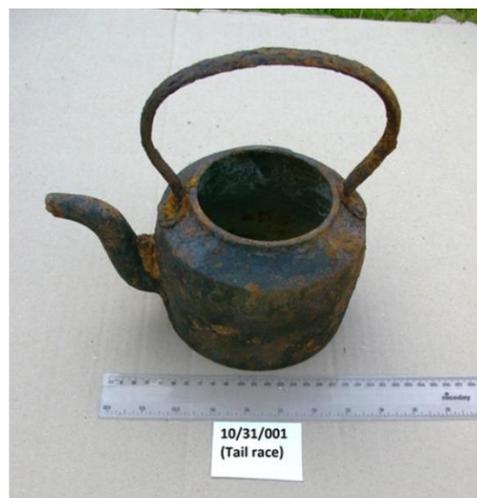
Fig. 8.8.2 (right)

10/31/001 (Tail race) An iron kettle. (Fig. 8.8.2)

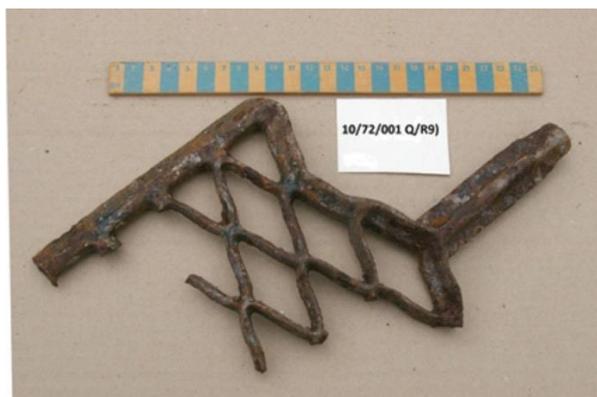
Fig. 8.8.3 (left)

10/72/001 (Q9/R9) A piece of cast iron grating, possibly from a hearth. Part of the handle remains, as does some of the base. The body is 155mm long x 175mm wide. The handle is 100mm long x 26mm wide where it joins the main body. There is a hole in the open end of the handle, indicating that probably it had a further extension piece to it. The diamond-shaped holes in the body of the grating are 60mm x 25mm. (Fig. 8.8.3)
