The corrosion protection of aluminium

Roberts, Erica Wyn

The Corrosion Protection of Aluminium

This thesis is concerned with the corrosion protection of aluminium. Specifically, it investigates alternatives to chromate containing conversion coatings for aluminium extrusions of alloy 6063, used in architectural applications, and also examines these coatings on sheet alloy 3105.

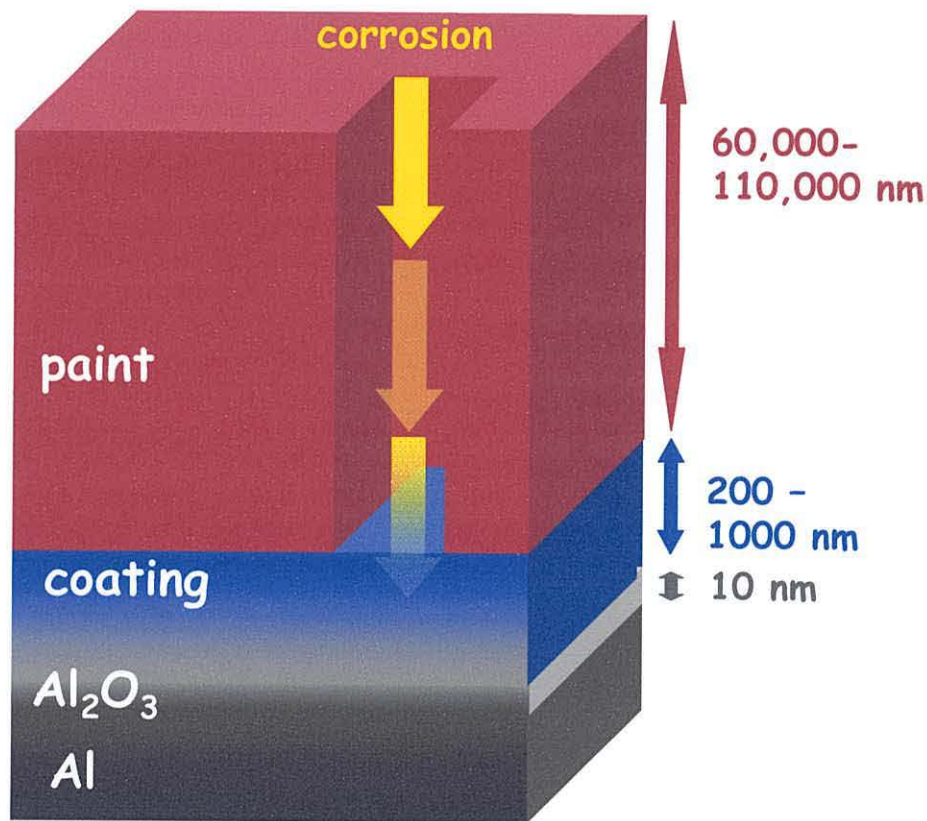
Figure 1.5 Schematic of the main components of an aluminium surface which has been subjected to a conversion coating followed by powder coating

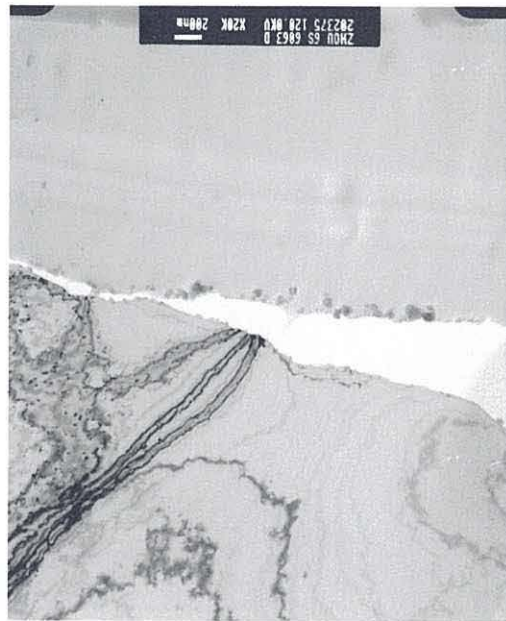
Figure 3.25 Ultramicrotomed cross sectional TEM images of alloy 6063 coated with Pretreatment 2 for 6 minutes, and subsequently powder coated, and Lockheed tested. Delamination of the treatment layers can be seen, probably caused by the ultramicrotoming process

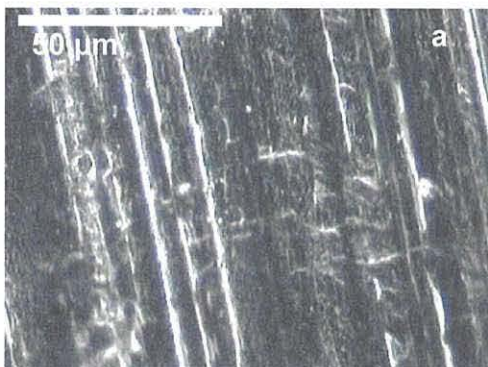
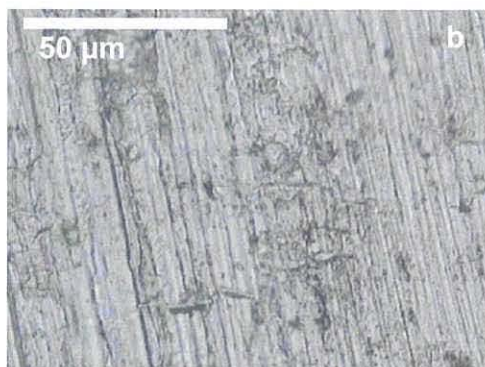
Figure 6.2 Optical images of untreated alloy 3105 a) dark field and b) bright field, both prior to corrosion treatment. c) dark field and d) bright field, both after 16 h in tap water

However, although pitting was observed, neither tap or DI water are suitable as potential corrosion test solutions as there is insufficient variation in response between the different substrates to give differentiated test results for different pre-treatments.
