Investigation of the structural changes in LDPE and XLPE induced by high electrical stress.

Investigation of the Structural Changes in LDPE and XLPE Induced by High Electrical Stress

Thesis submitted to the University of Wales in
candidature for the degree of Doctor of Philosophy
September 2001

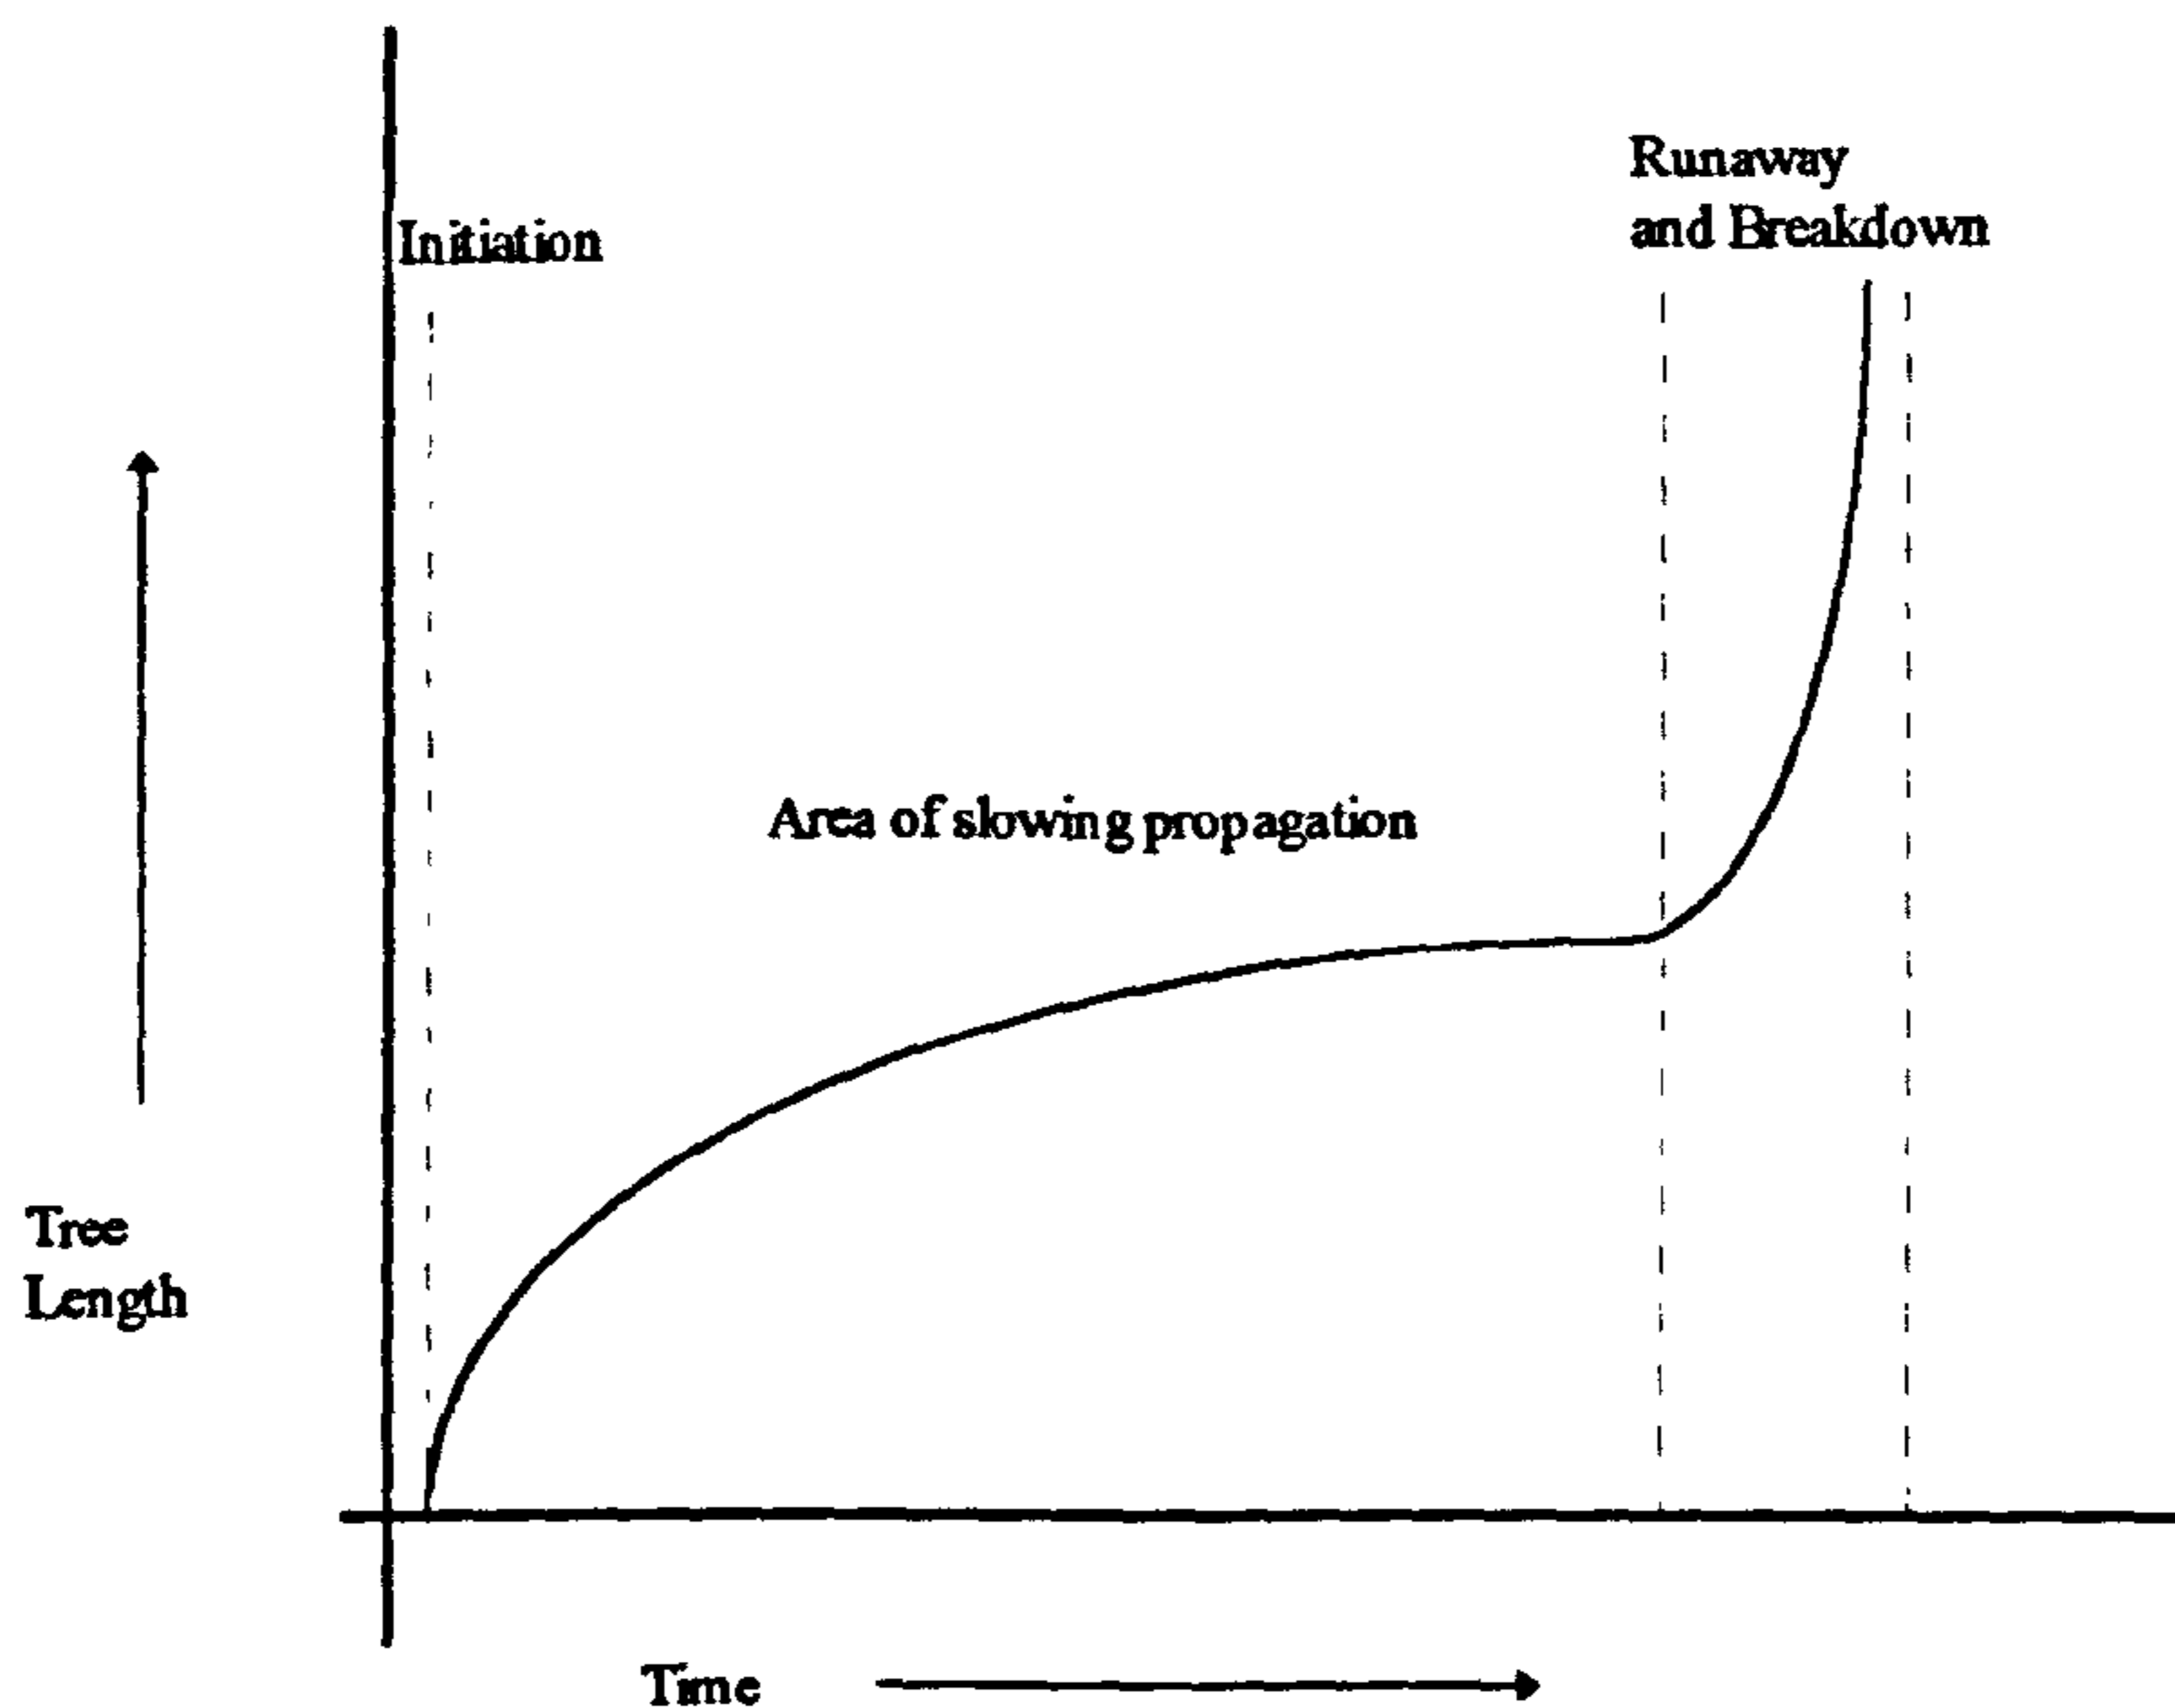
Figure 3.4 Schematic representation of electrical tree growth showing the decelerating growth rate and then the runaway or avalanche breakdown. [Dissado, *et al.*, 1992].

The typical growth pattern of an electrical tree is shown in figure 3.4,

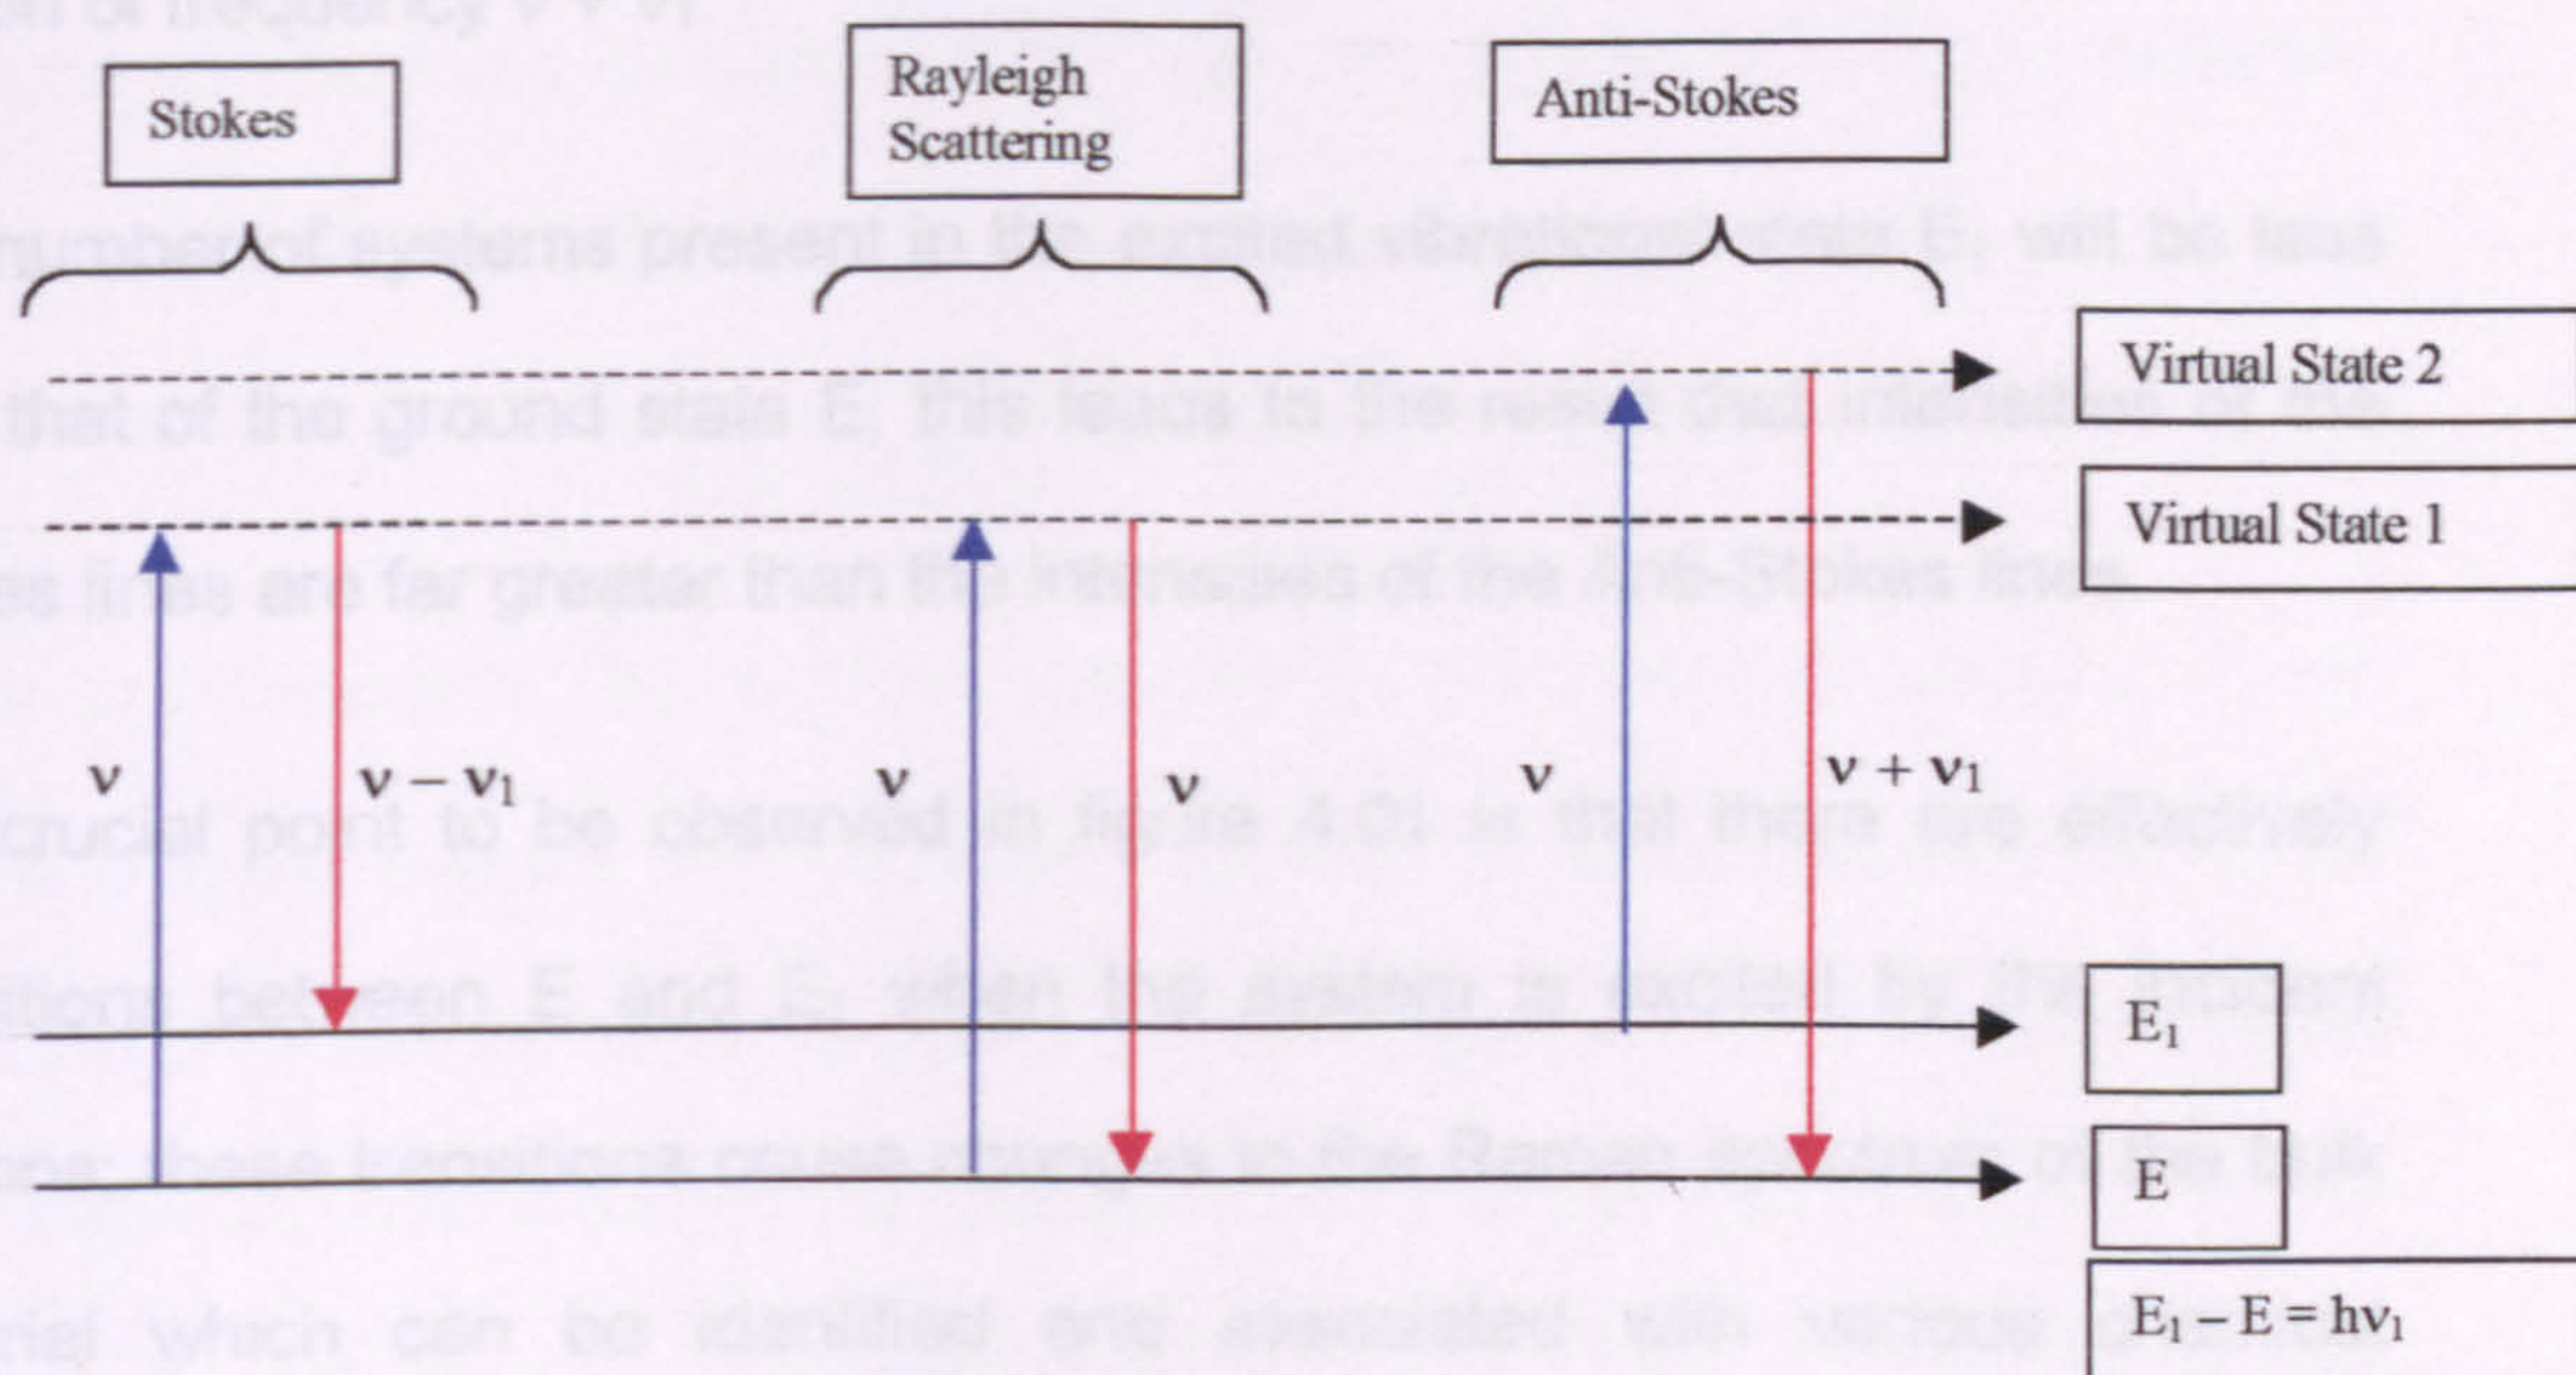
Figure 4.01 Energy level diagram showing the raising of the molecule to a 'virtual state' and then that energy being lost, resulting in the production of the Stokes and anti-Stokes lines. The population of the excited vibrational state, E_1 , is less than that of the ground state and as a result the Anti-Stokes lines are weaker than the Stokes lines.

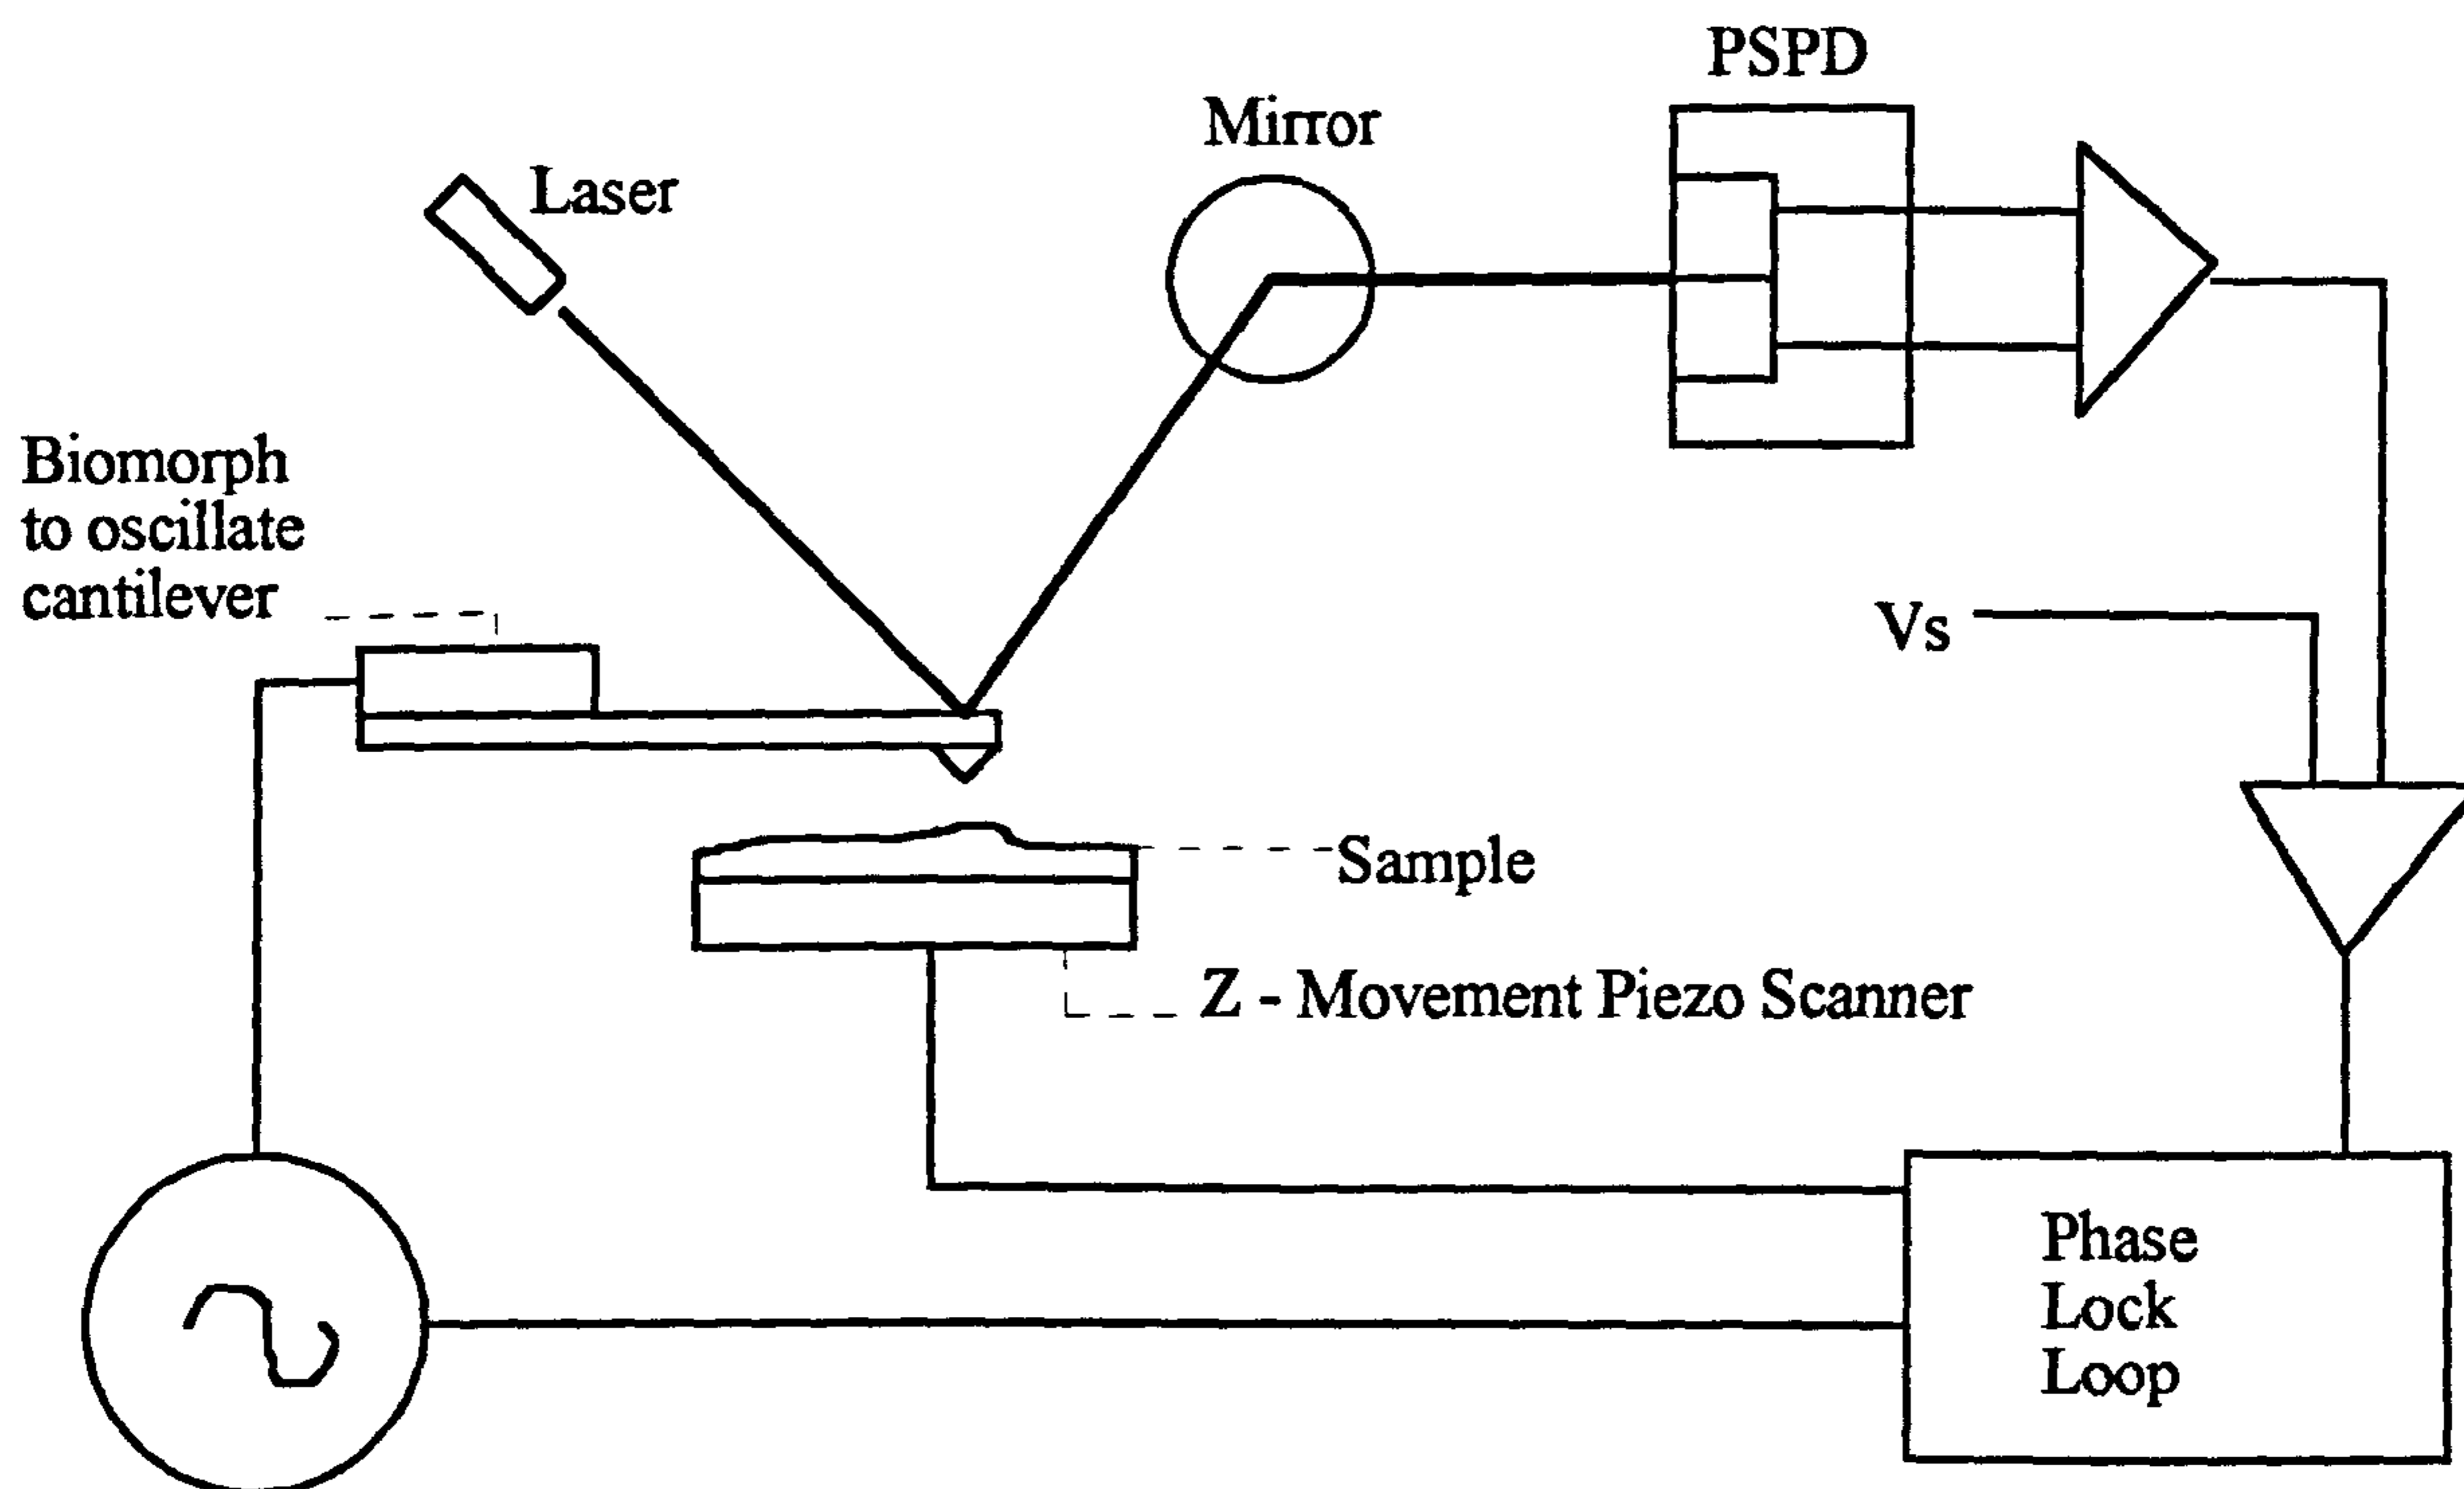
Figure 4.10 Schematic showing feedback loop operative during tapping mode.
