**Investigation of the structural changes in LDPE and XLPE induced by high electrical stress.**

# Investigation of the Structural Changes in LDPE and XLPE Induced by High Electrical Stress

Thesis submitted to the University of Wales in  
candidature for the degree of Doctor of Philosophy  
September 2001

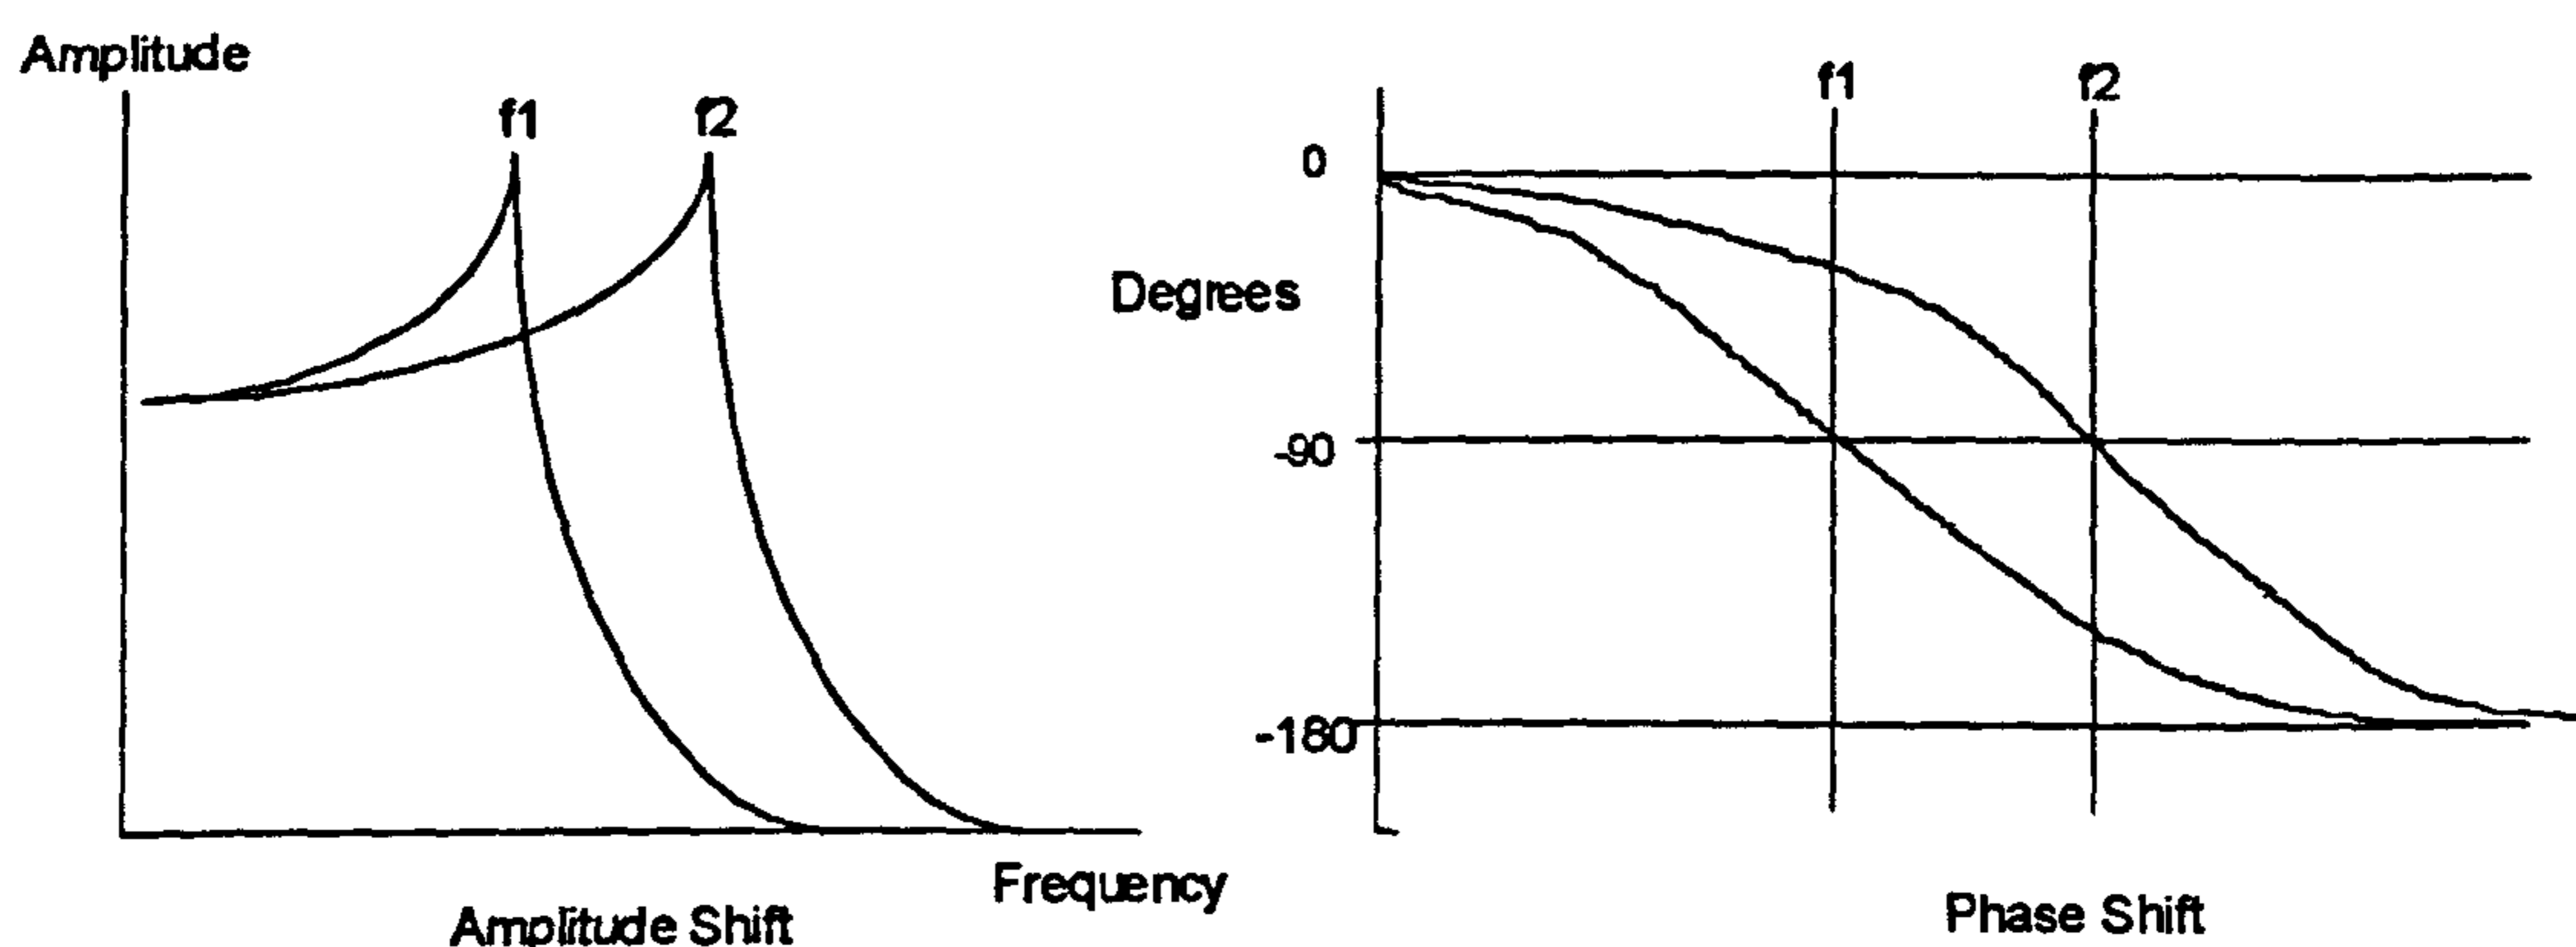
**Figure 4.09** Sketch showing frequency dependence. Frequency  $f_1$  is for a tip far from the sample and  $f_2$  is for the tip and sample close together.

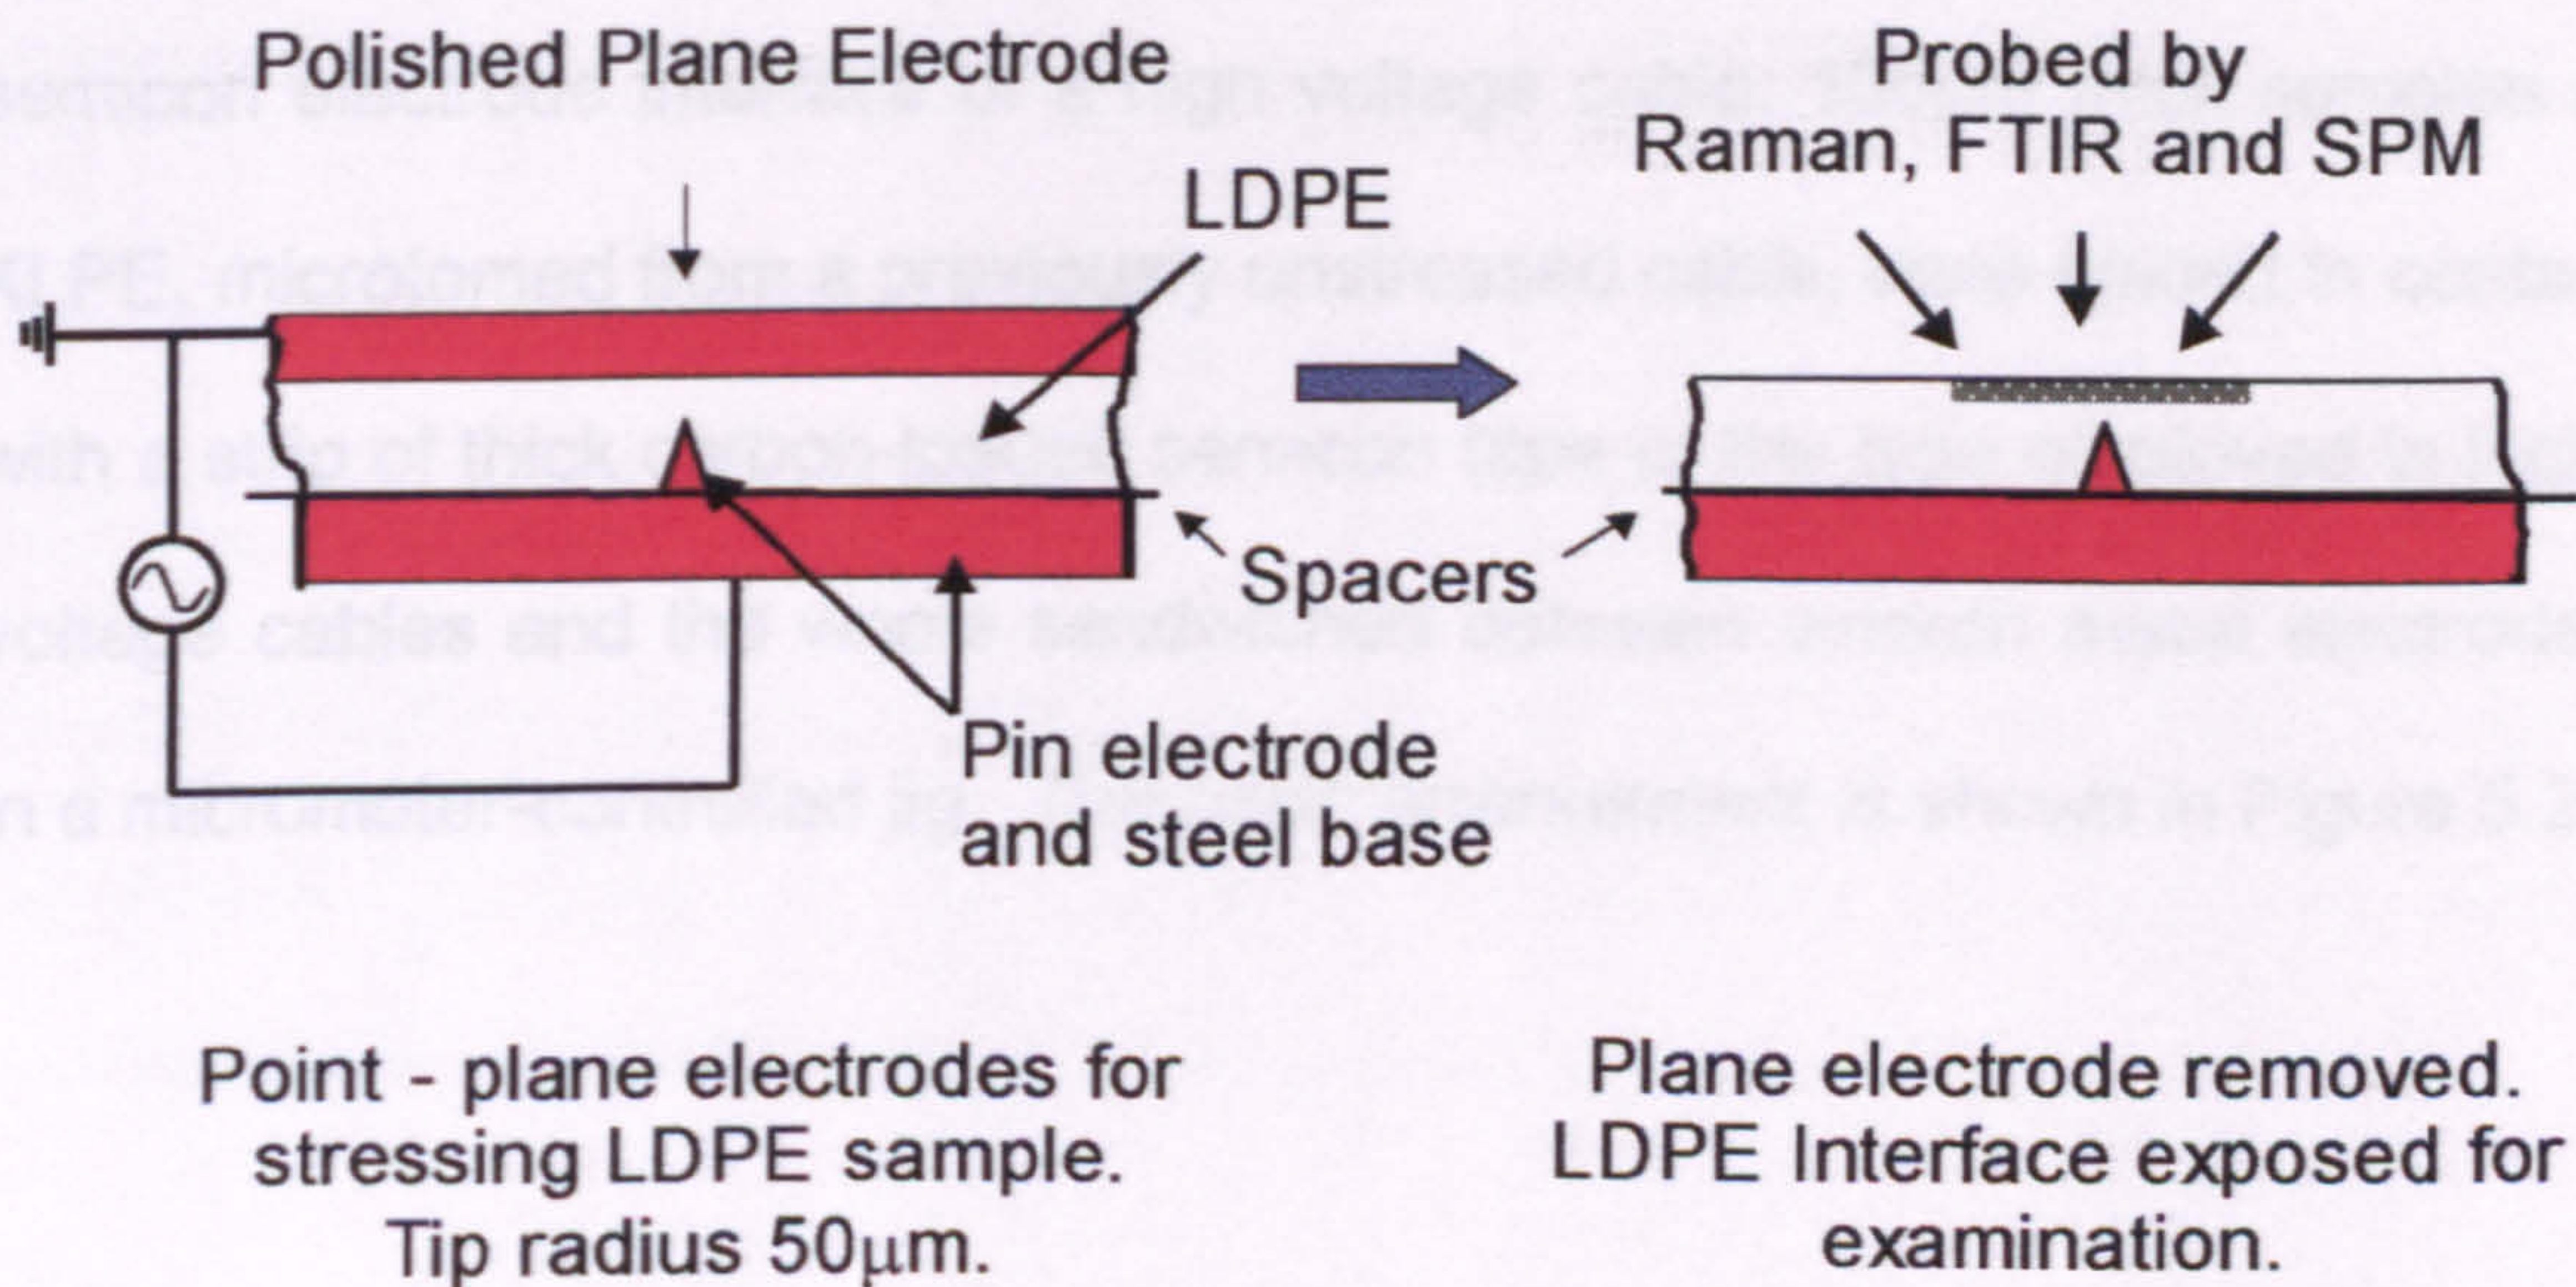
Figure 5.1 Point plane electrode arrangement showing removable plane electrode, sample, spacers, steel point electrode and steel base. The grey region defines the area examined.

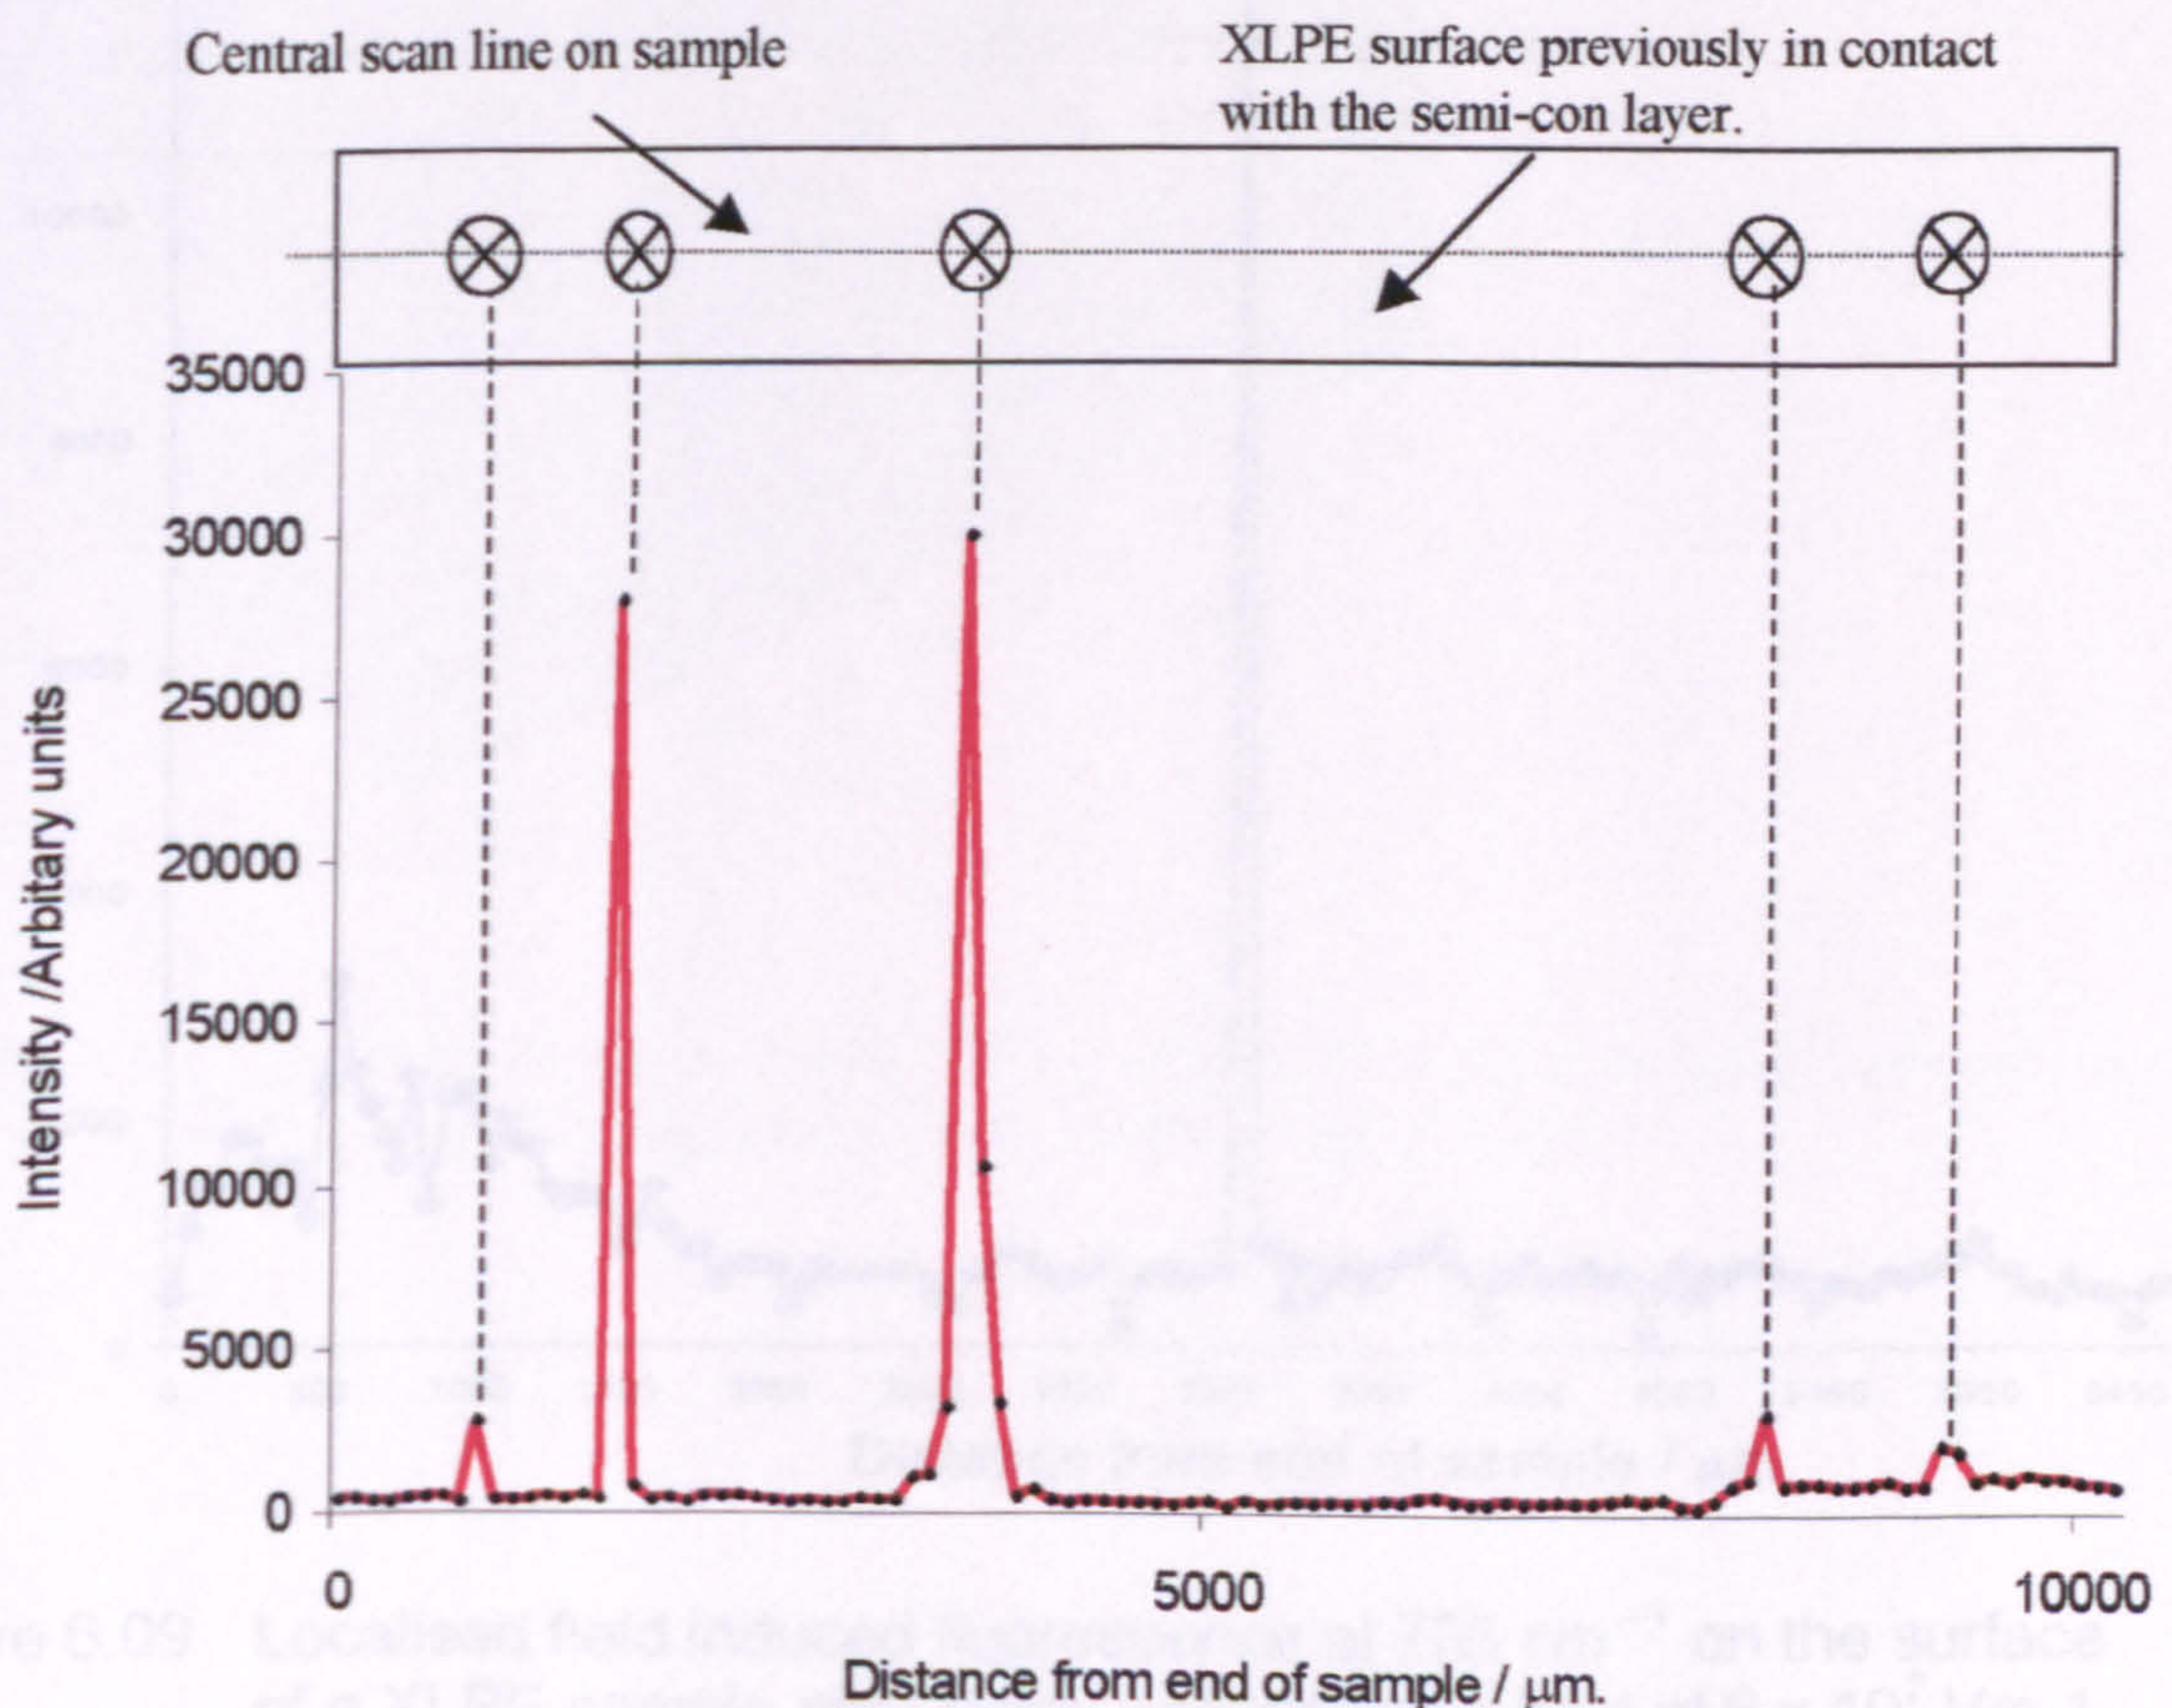
Figure 6.08 Field induced fluorescence at a Raman shift of  $767\text{ cm}^{-1}$  on the surface of a XLPE sample exposed to a field of  $6 \times 10^7\text{ Vm}^{-1}$  in contact with a semicon electrode for a time of 6 hours.
