Investigation of the structural changes in LDPE and XLPE induced by high electrical stress.

Investigation of the Structural Changes in LDPE and XLPE Induced by High Electrical Stress

Thesis submitted to the University of Wales in
candidature for the degree of Doctor of Philosophy
September 2001

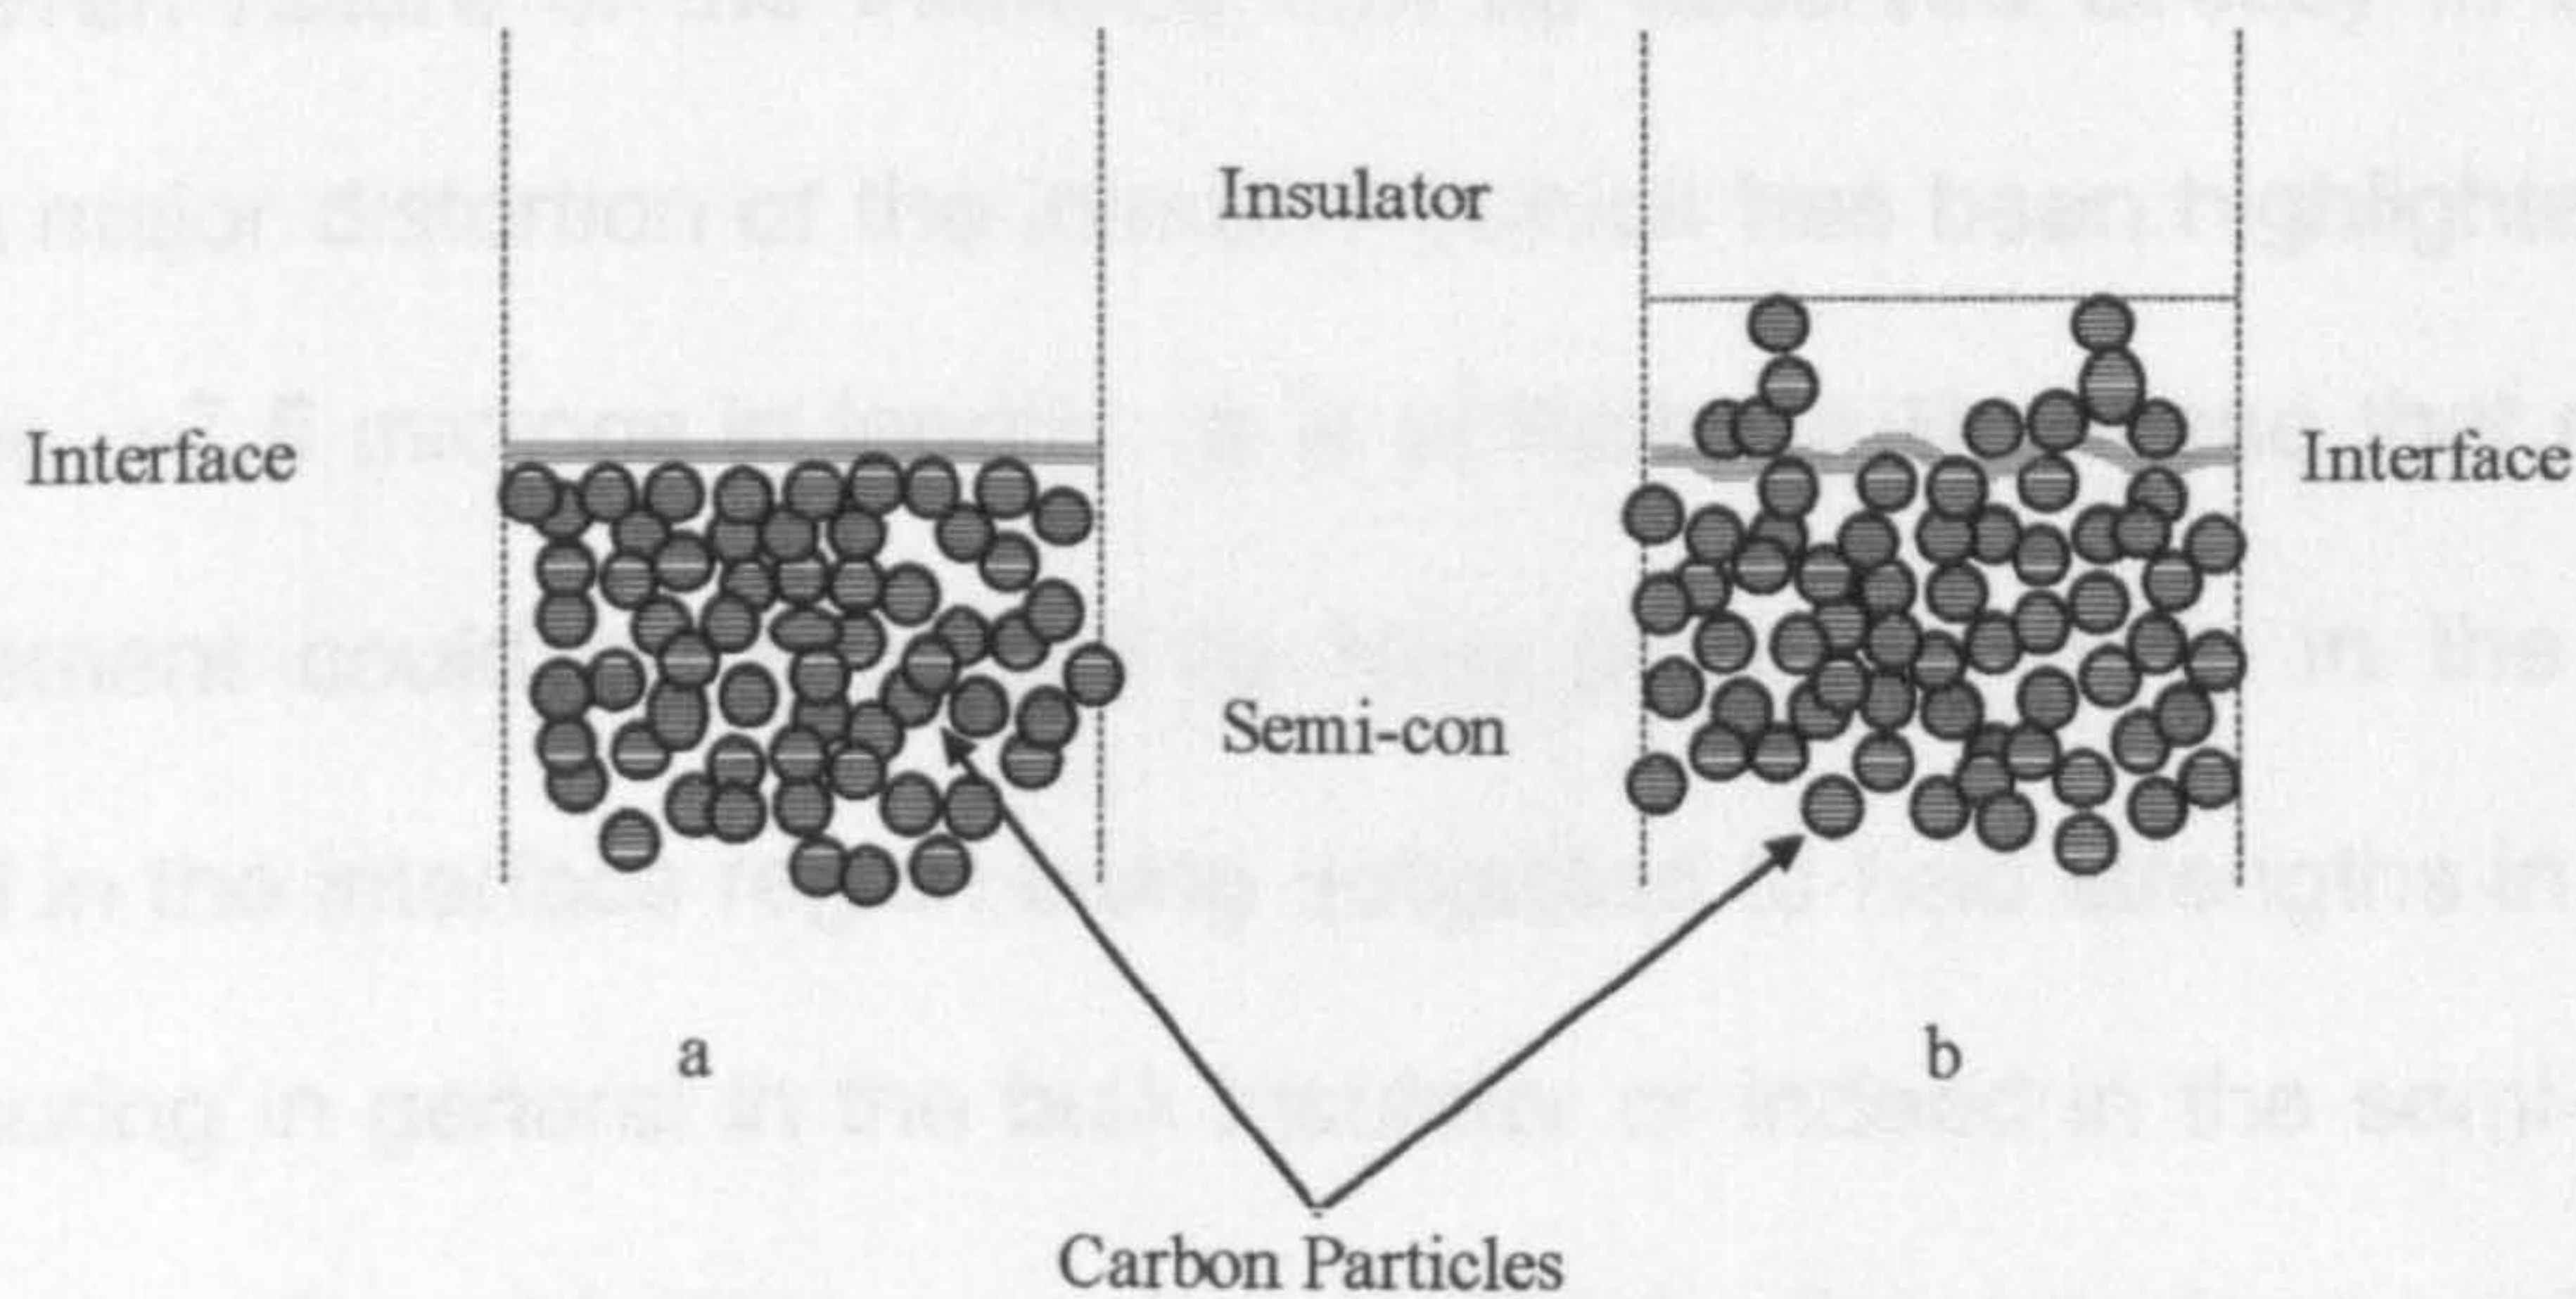
Figure 2.6 Diagram showing diffusion of carbon particles into insulator layer. (a) Shows an ideal interface whilst (b) shows a typical interface layer. Note the sharp semi-con points in (b).

The ideal interface, a in figure 2.6, presents a regular even interface between the carbon-loaded polyethylene and the bulk polyethylene insulator which avoids the possibility of any field enhancement at the edges of any protuberances. The interface region in the real world however has been found to resemble the situation shown in figure 2.6 b. (Betteridge *et al*, 1998.) These findings were confirmed by the author using the Scanning Probe Microscope as shown in figure 2.7.

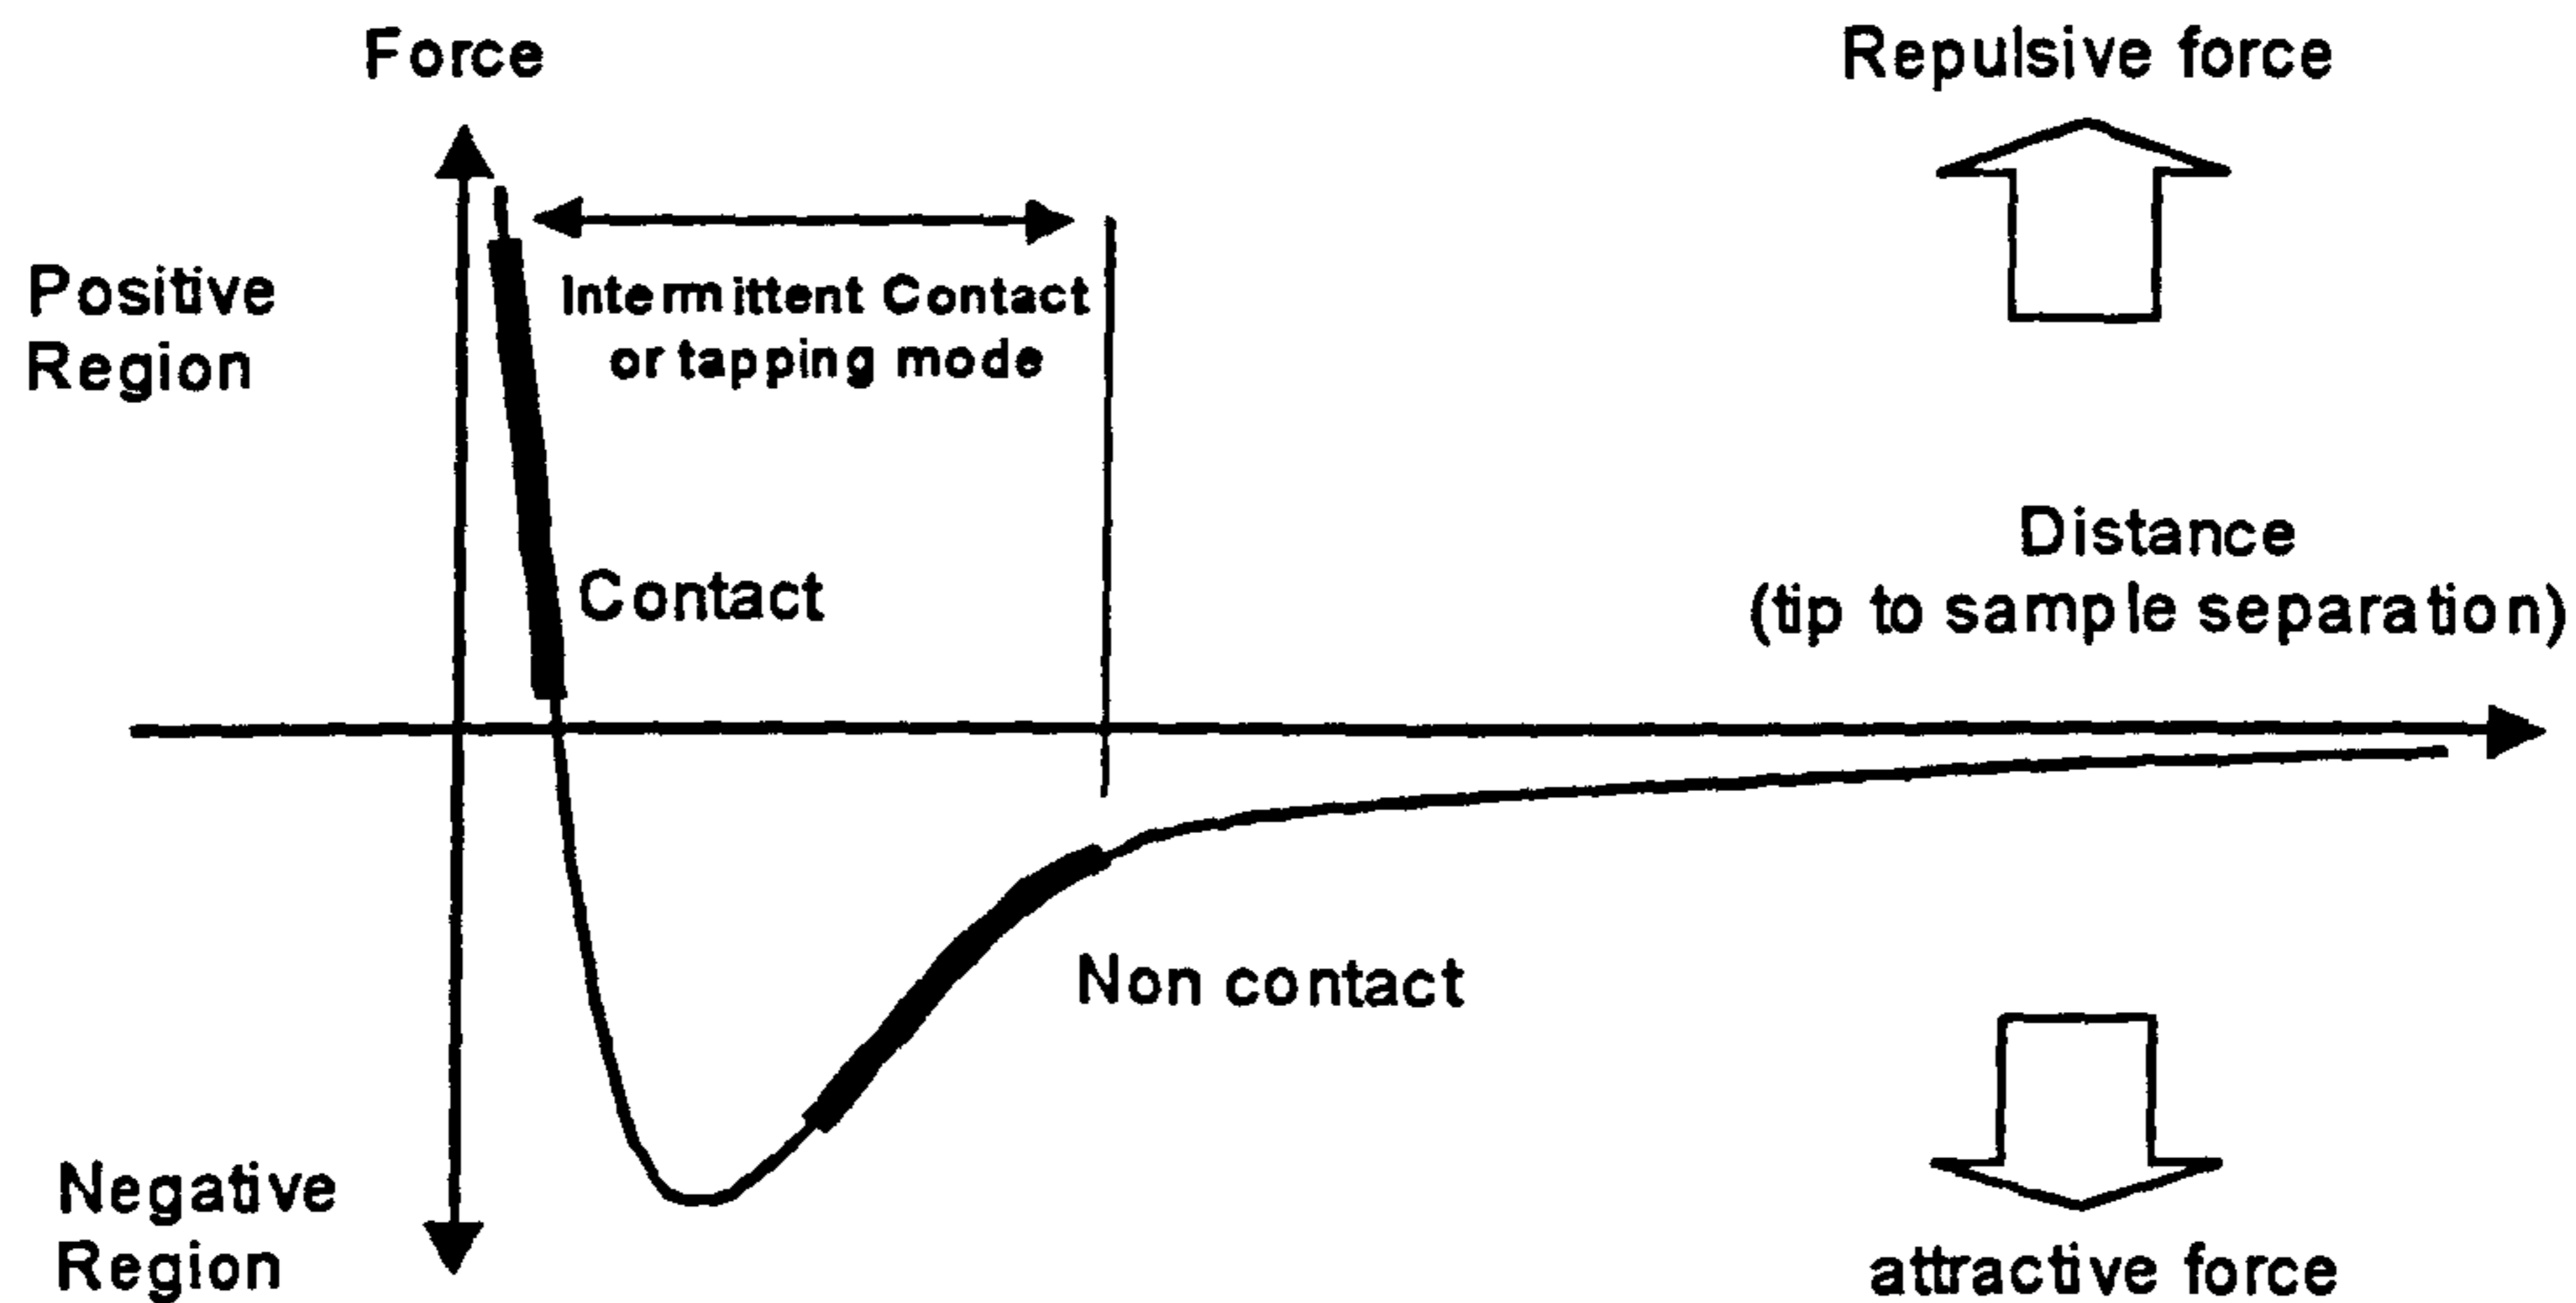
Figure 4.08 Sketch showing Force-Vs-Distance between the tip and sample. The main operating regions of the SPM are indicated.

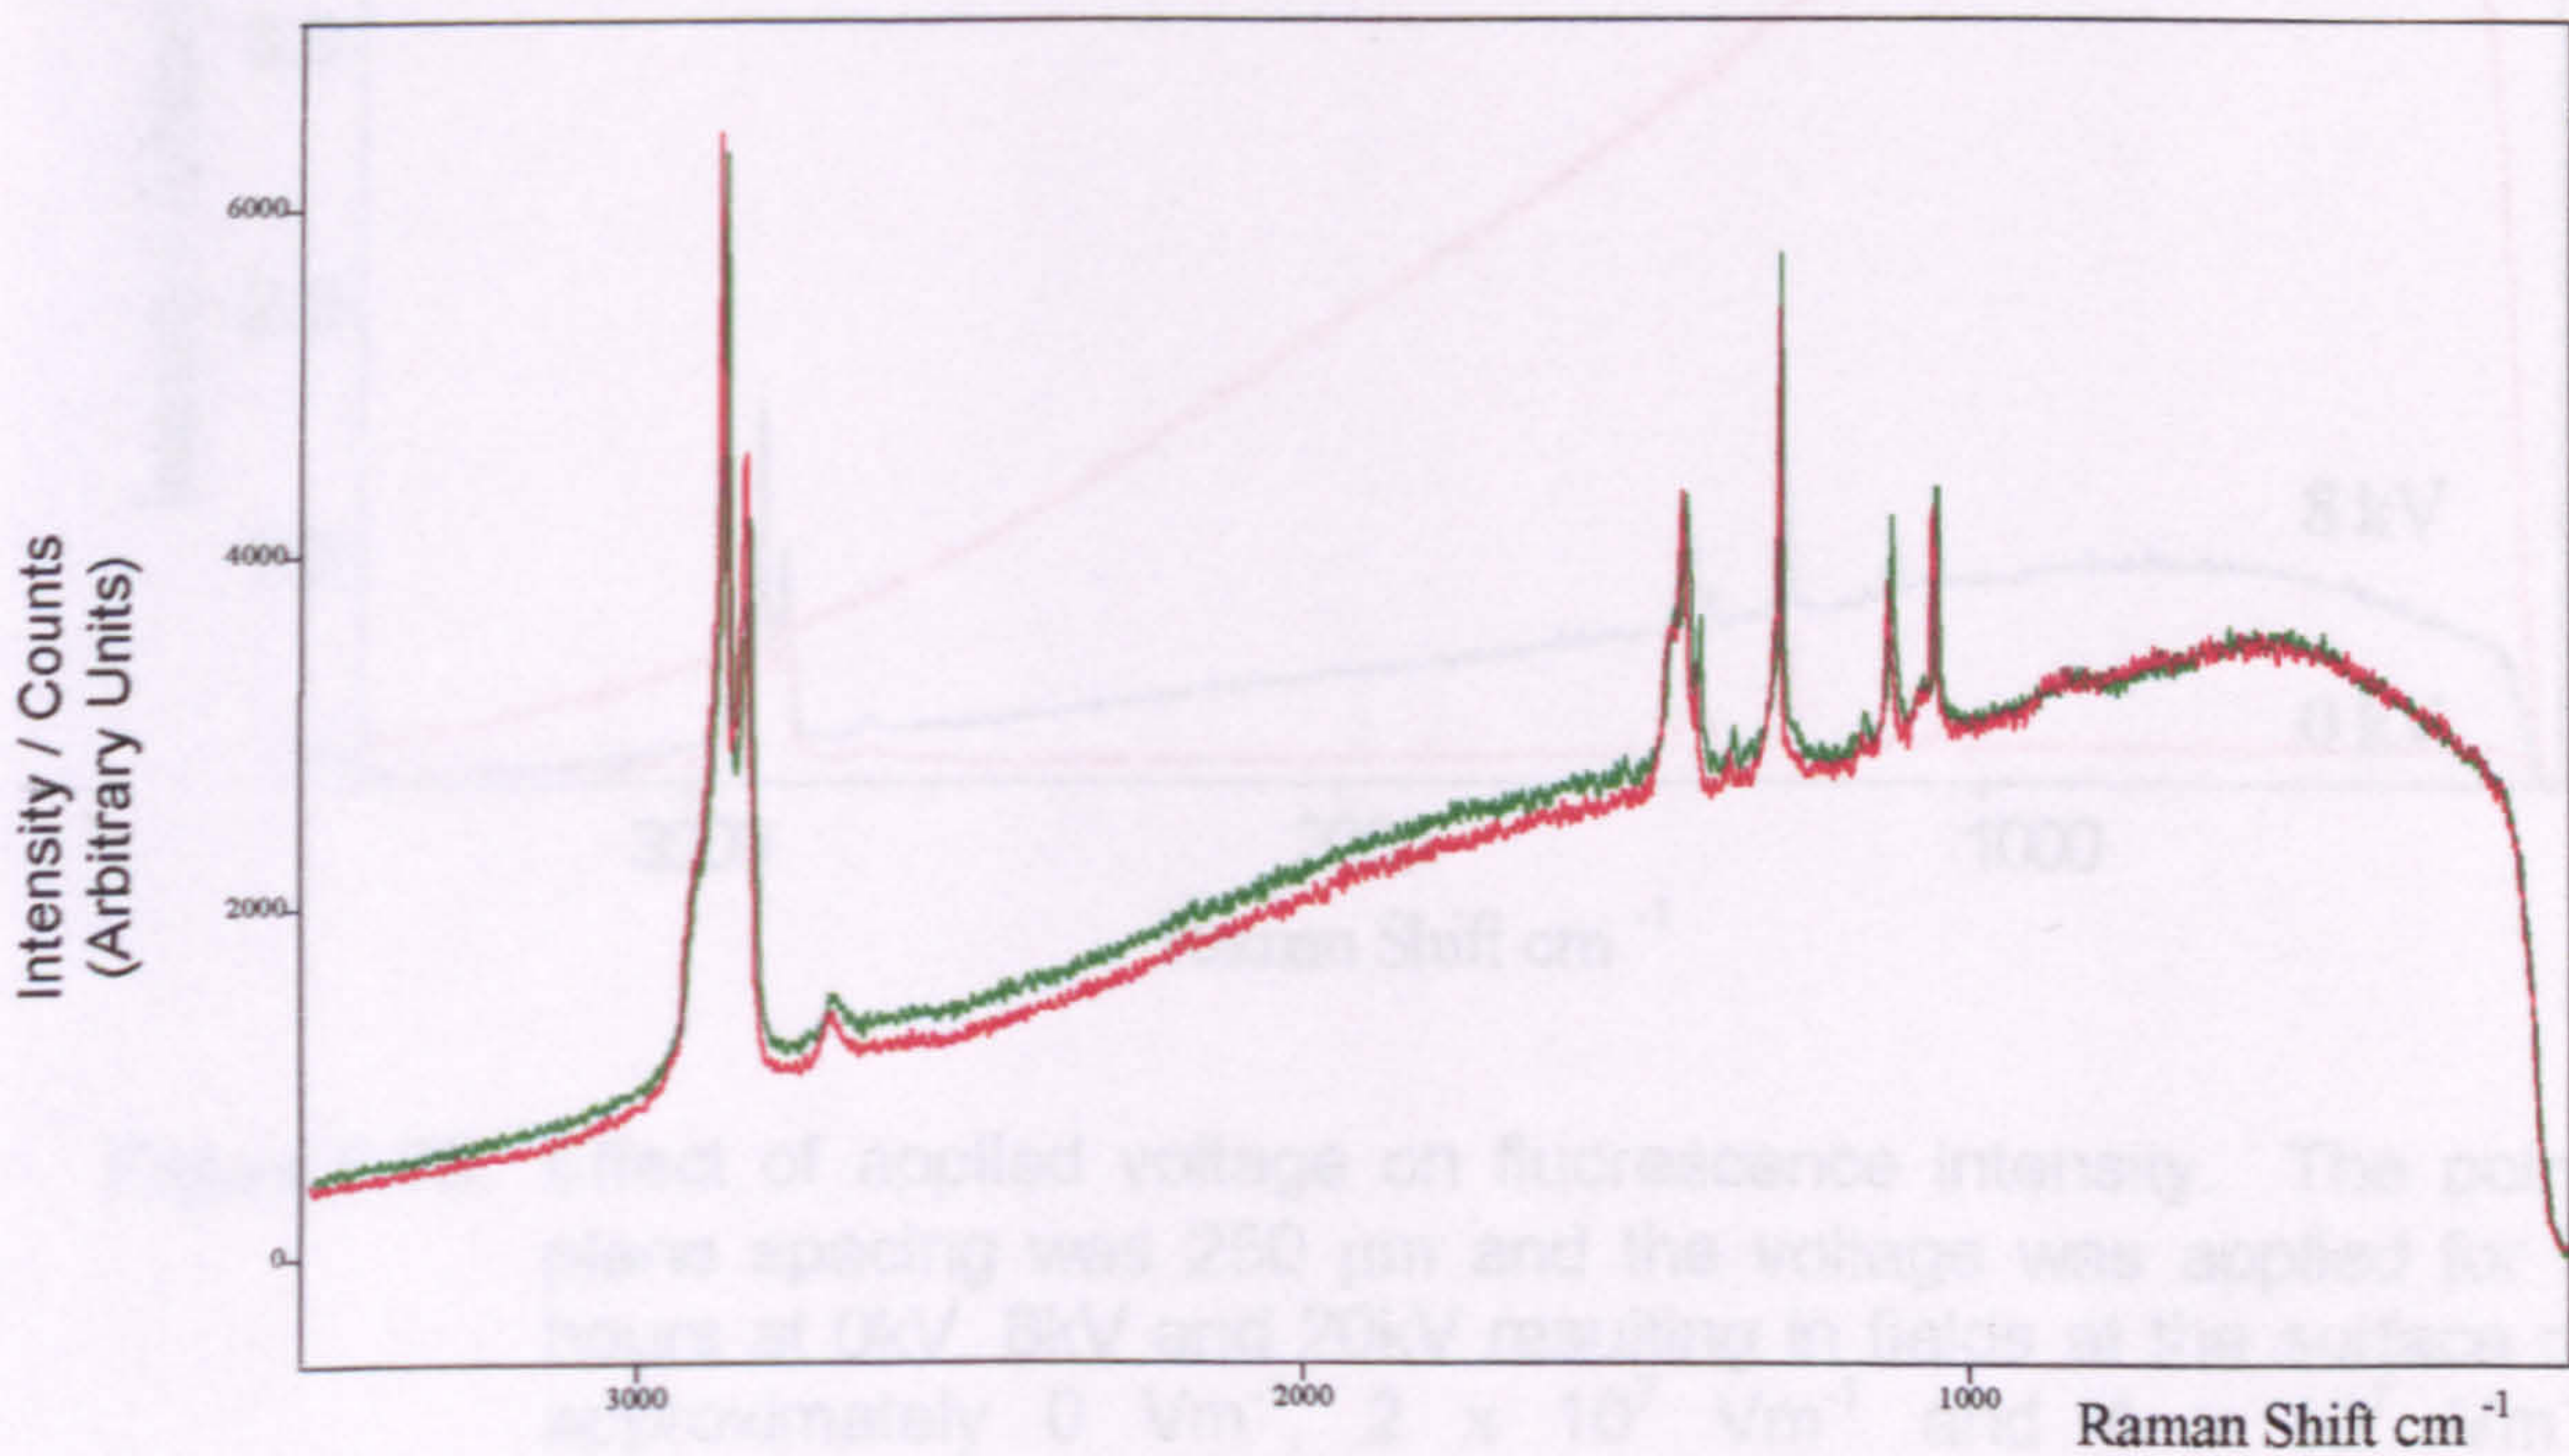
Figure 6.04 A typical result showing the change in the background fluorescence after leaving the sample (LDPE) under the laser light of the Raman spectrometer for twenty-four hours.
