Interpretierte Eisenzeiten 8

Honey, fetch me a cool beer from the fridge! Comfortable living in Iron Age Wales

Raimund Karl

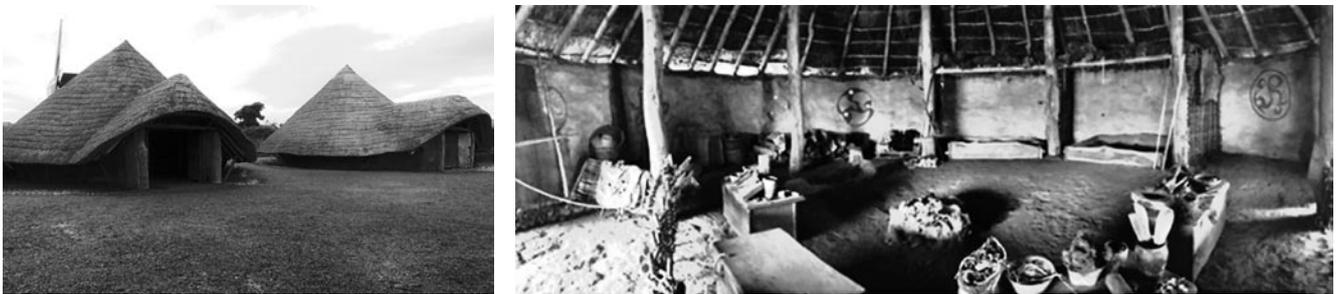
Fig. 3: The exterior and interior of roundhouse reconstructions at Llynnon Mill, Anglesey.

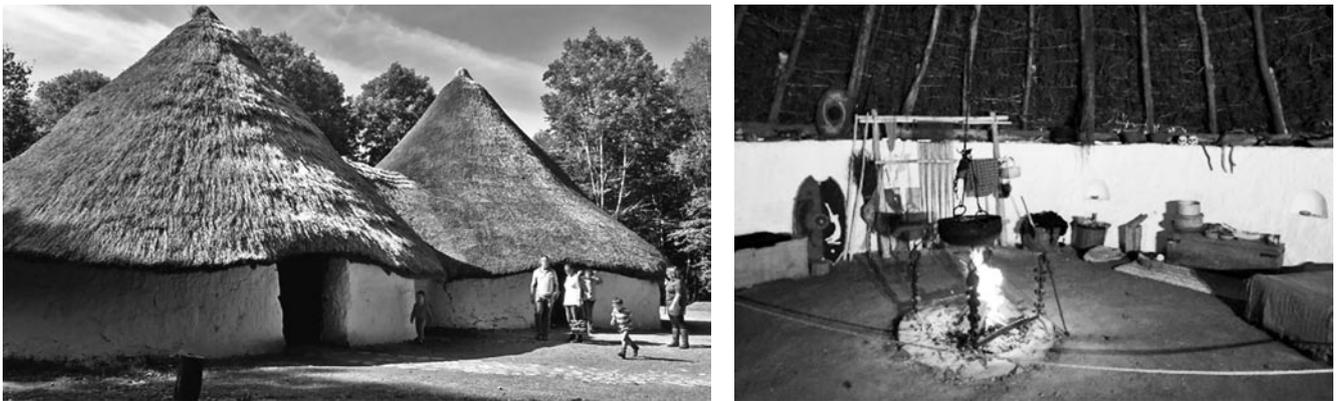
Fig. 4: The exterior and interior of roundhouse reconstructions at the National Museum of Wales, St. Fagans.

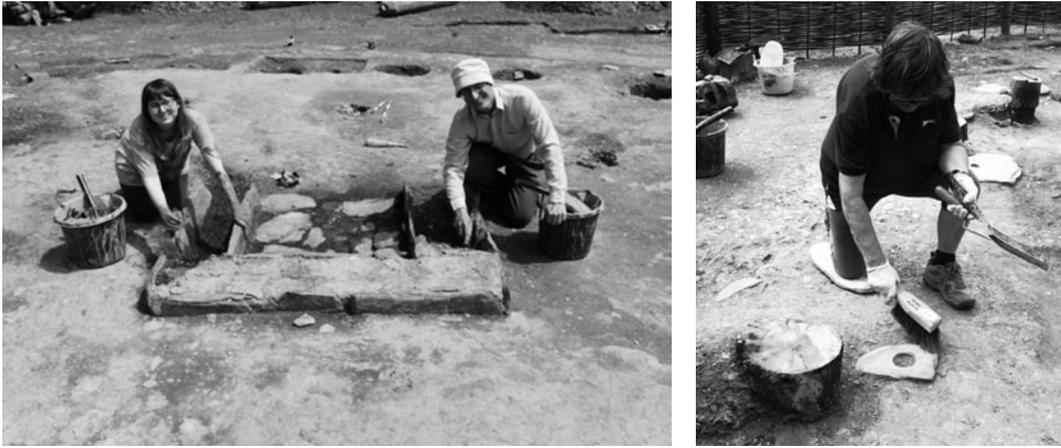
Fig. 5: Later anachronistic additions to Mytum's original reconstructions during excavation. Harold Mytum is visible on the left image to the right of the stone-built hearth being cleaned (Mytum 2017).

What Mytum found during his excavations of the reconstructed roundhouses can be described as a quite distinctive archaeological record. Leaving aside obvious 'flaws' like a solid stone-built hearth or stone hinges for the doors added later to his original reconstructions (fig. 5), the excavations produced evidence for – partially substantial – floor deposits, some of which had been intentionally introduced in several subsequent attempts to level the floor of a house which had been built on a slope, while others had naturally accumulated through constant visitor footfall (fig. 6). Clearly, these floor deposits had the typical, highly compressed structure and slightly rigged surface of floor deposits known from some excavations, contained repairs of 'potholes' and other depressions that had been created by constant use, some including ashy deposits from the activities that had been conducted in the houses (figs. 5–6). They also contained substantial deposits of 'earlier' phase hearths, and in some places also the odd find of modern portable 'antiquities' (fig. 7). In other words: these floor deposits appeared as one would expect them to if a house floor was used (that is, walked, jumped, trampled, etc. upon) for c. 30 years by people 'inhabiting' it (even if, in the particular case, only very temporarily, though I personally inhabited one of them for three consecutive days when attending a hand-fastening of an acquaintance in 2002 at Castell Henllys), with the odd one occasionally dropping something on the floor which got swept behind something and ultimately becoming a part of the floor deposit.

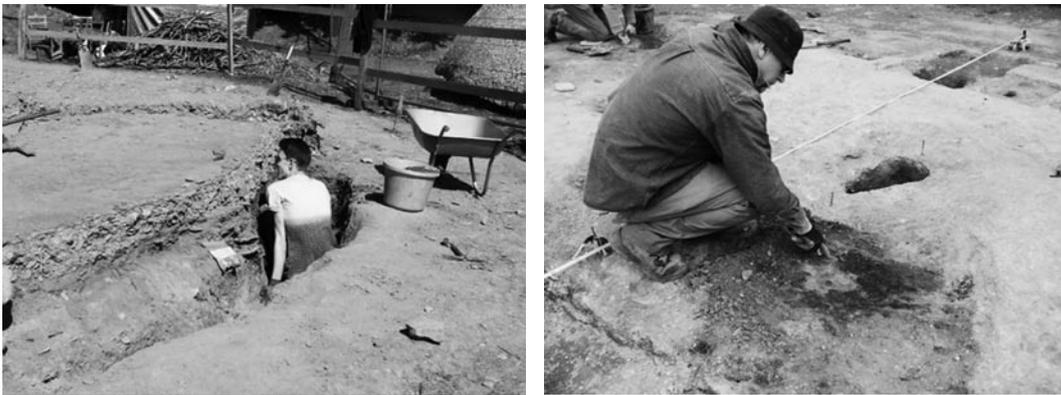
Fig. 6: Substantial trampled floor deposits introduced intentionally (left; Mytum 2018) or having naturally accumulated through visitor activities and footfall (right; Mytum 2017).

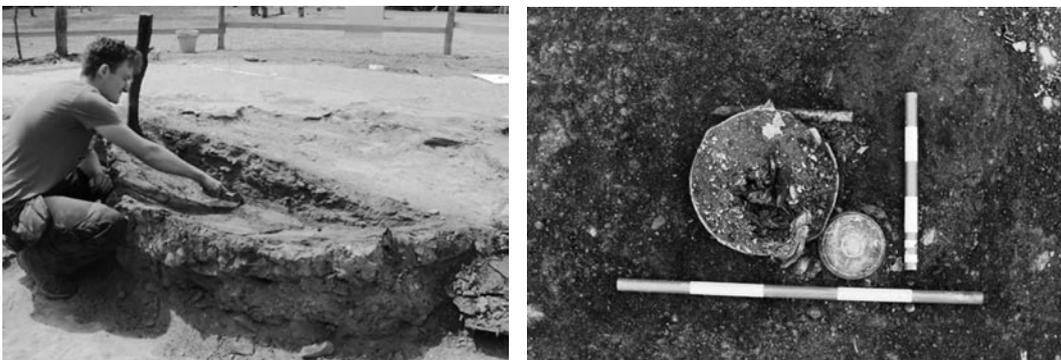
Fig. 7: The substantial deposits associated with a hearth pit in one of the roundhouses (left; Mytum 2018) and finds of portable 'antiquities' in situ (right; Mytum 2017).

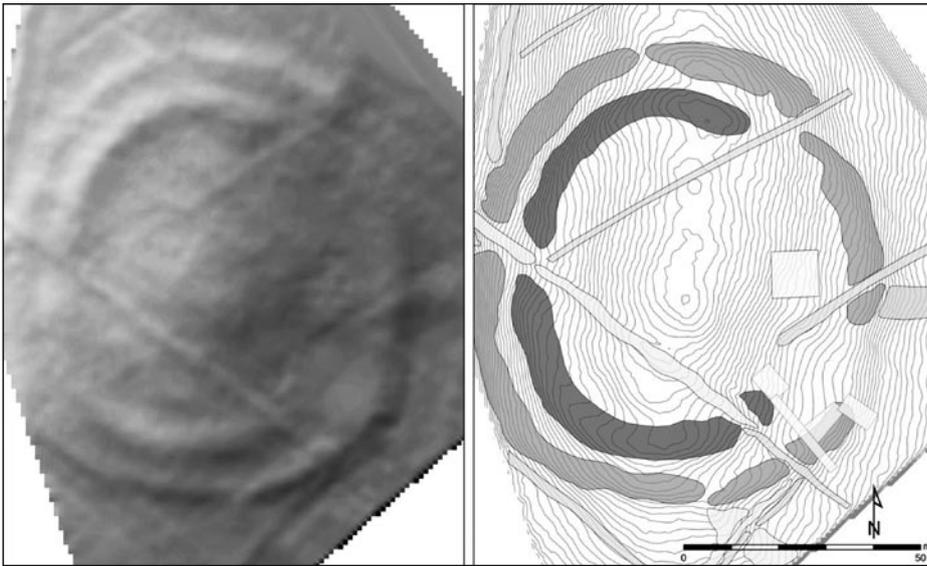
Fig. 8: Hillshade and elevation model of Meillionydd (Löcker et al. 2013: 20, Abb. 12).

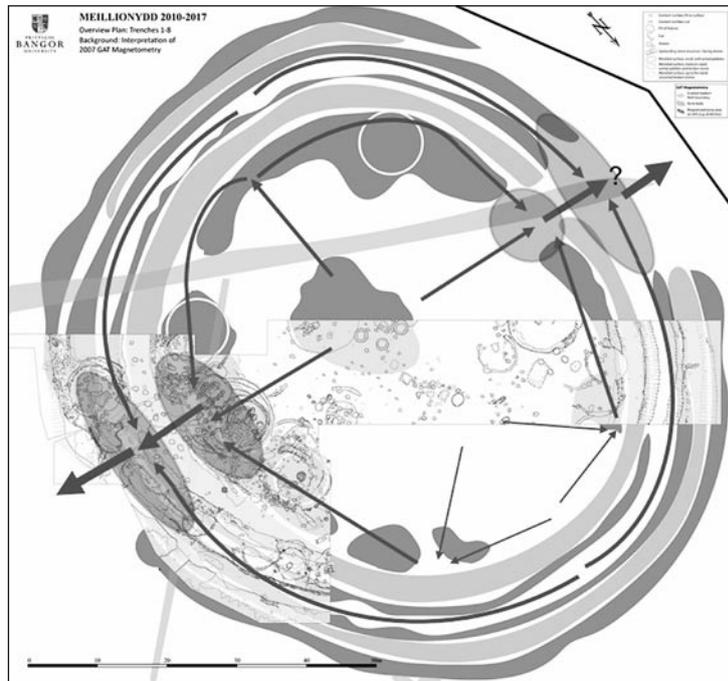
Fig. 9: Drainage of surface water from the enclosures at Meillionydd.

The site sits on the crest of a little hill, which in the embanked phases was completely enclosed apart from where the entrances were, which were placed at the lowest points of the enclosure (this also applies to a possible second entrance through both banks to the West, not just the already excavated entrance to the East; fig. 8). The banks also have, particularly close to the excavated entrance, internal quarry hollows following them. Thus, the only way for surface water having fallen anywhere within the enclosures to drain would be, first, into the quarry hollows – where the houses sit – and then – but only through these houses – out through the entrances (fig. 9).

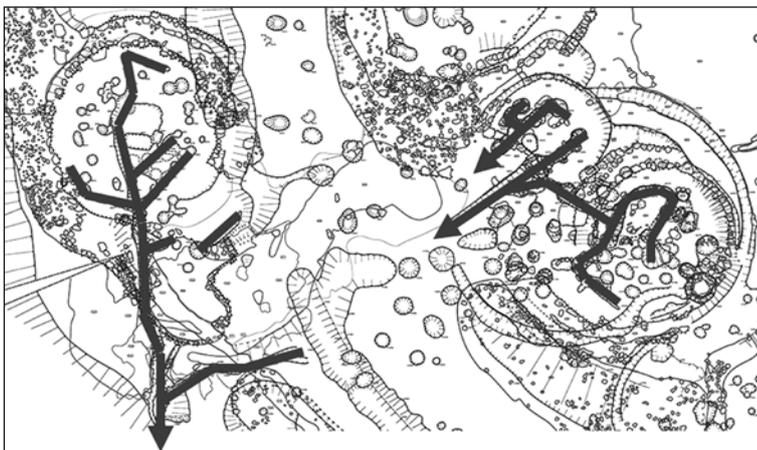
Fig. 10: Drainage management by stone-lined and (at least partially, mostly within houses) stone-capped gullies in the roundhouses associated with and in the eastern entrance area.

This must have created significant drainage problems, at least during times of heavy rainfall, resulting in considerable efforts having been invested into the management of water in house floors, particularly in the entrance areas, by the inhabitants of the site. To ensure sufficient drainage, especially of the floors of houses set in the terminals of the inner quarry hollows of both the inner and outer bank, gullies were constructed (fig. 10). Particularly within the houses, they were partially stone-lined and covered with – in some cases quite sizeable – reasonably flat capping stones, which nonetheless did not create an even remotely level surface for the house floor, but rather stick out quite far in places, and leave awkward gaps and crevasses between them (fig. 11). These gullies drained the houses through culverts exiting underneath the house wall in case of the inner entrance gully system; and underneath the southern outer bank terminal in case of the outer entrance gully system (fig. 10; also see George, this volume).

Yet, apparently, no attempt was made to prevent that by putting in water drainage management features, as is clearly evident in case of the pit in the more southerly of those two houses (fig. 10, close to the right edge of the

plan). This is one of the houses which had a substantial and also well-planned drainage system in its floor, which, however, only starts roughly in its centre, rather than on its northern side. This indicates quite clearly that the builders of this house either simply did not care, or indeed intentionally put the pit in this place where surface water would, at least during periods of heavy rainfall, inevitably seep into it.

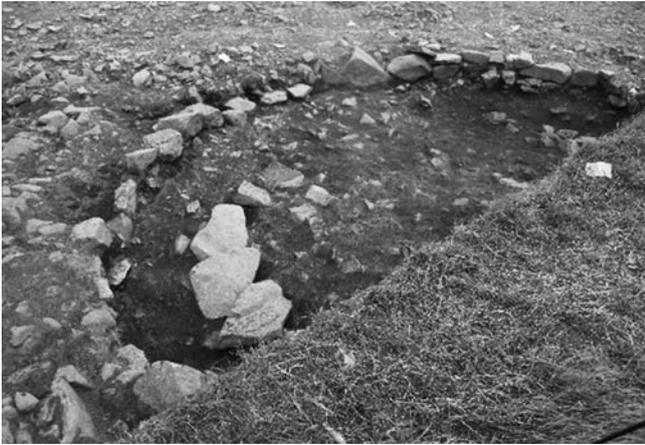
Fig. 11: Capped drainage gully in the southern half of the round-house built into the terminal of the northern inner quarry hollow alongside the inner bank, closest to the inner entrance passage into the enclosure (the curve of large stones in the house floor on the left in the image). Note that while covering the gully, the capping stones do not create a level surface and do not cover the gully completely. Also note the stones irregularly sticking out of the natural which makes up the hut floor, and that the inner drystone facing of the house's walls is not set into a foundation trench, but rather partially sits halfway up the sloping sides of the inner quarry hollow terminal.

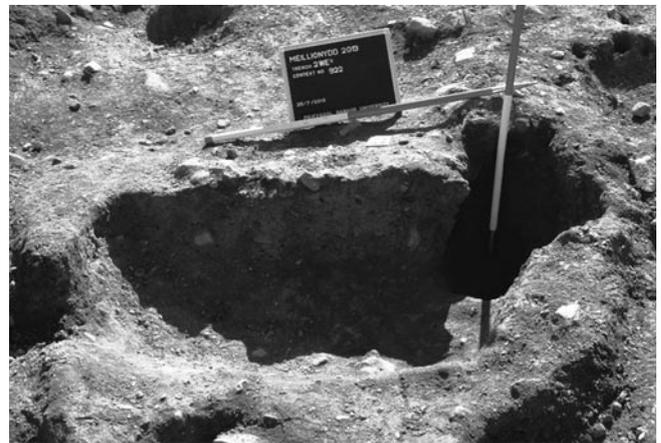
Fig. 12: The ash-pits of the roundhouse immediately south inside the outer entrance after excavation. Note that the natural in which they have been dug shows no indication whatsoever of ever having been affected by heat.

deposits, in some cases mostly or almost exclusively consisting of ash. Frequently, intermixed with the ashes, are a few irregular, but partially quite sizeable, bits of lightly burnt clay / daub like one would expect to form on a hearth's surface (cf. fig. 7 left for such a hearth and its surface from Castell Henllys). Yet, the sides and bottoms of those pits never show any evidence of having been at all, let alone seriously, affected by heat, let alone actually having been burnt (fig. 12), as would inevitably happen if there ever had been a fire burning in them.

Thus, while on site we tend to refer to them colloquially as 'hearth', they are actually not hearths, but would better be described as ash-pits. Of course, as ash-pits – that is, quite literally, pits to collect and at least temporarily store ashes – they will obviously have been associated with hearths or fireplaces, from which the ashes collected in them will have been swept. Yet, no such hearth or fireplace – that is, a sizeable clay or daub surface burnt like the bits we sometimes do find in the fill of the ash-pits – have as yet been found in any of the house floors, or indeed anywhere outside any of the remains of houses on site. Thus, while hearths or fireplaces associated with these ash-pits must obviously have existed, and presumably were placed right next to these ash-pits (that is, at

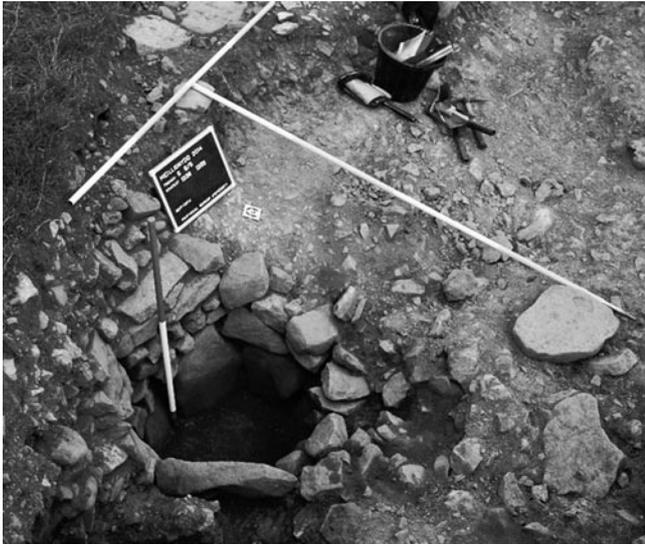
Fig. 13: The stone-lined pit set in the northern wall of the round-house immediately north of the inner entrance passage during excavation.

Also, two houses immediately north of the inner entrance, set in the inner quarry hollow alongside the inner bank, contained stone-lined pits, with c. 80 cm inner diameter, of c. 50 cm depth, in their floor. In one case, this pit must have been constructed, including its stone-lining, when the house was built, since its uppermost stones (visible in the trench section on fig. 13) were actually not so much part of the pit's stone lining, but the bottom layers of the inner drystone facing of the house's wall. In the other case, the pit may have equally been constructed to have its lining continue unbroken into the inner drystone facing of that house's wall (which was not preserved in this place), or may have been built just slightly inside of it. In both cases, however, these pits were set into the northern side of the respective house, that is, uphill towards where the inner quarry hollow was sloping downwards towards the inner entrance passage. Thus, they were located within their respective houses where surface water would have collected outside the house's outer wall facing and then (all the walls have an earth core with inner and outer drystone facing) slowly seeped through it into the house, also unavoidably seeping into these pits.

While we believe that these stone-lined pits were used as burial pits as their final use (see Möller 2017: 71-74; George this volume), they most likely were not origi-

nally built for this final function. Rather, most likely, they were used as in-house storage pits for most of their use-life. Yet, not just because of their location in the worst possible place anywhere on site for, but also because we did find considerably more sizeable, not stone-lined, outdoors grain storage pits (one of them still containing about 30 litres of charred grains) at the very crest of (and thus the driest place on) the enclosed hill, it seems evident that these pits were not used for grain (or other dry) storage. Instead, they were put in the darkest, wettest and thus presumably also coolest place one could find on the site, and were – thanks to the stone lining – also very well protected from cave-ins of the pit walls. I would thus suggest that these in-house storage pits were originally intended as cold (or at least cool) storage, to keep perishable goods ‘refrigerated’ and thus extend their use-live as much as possible.

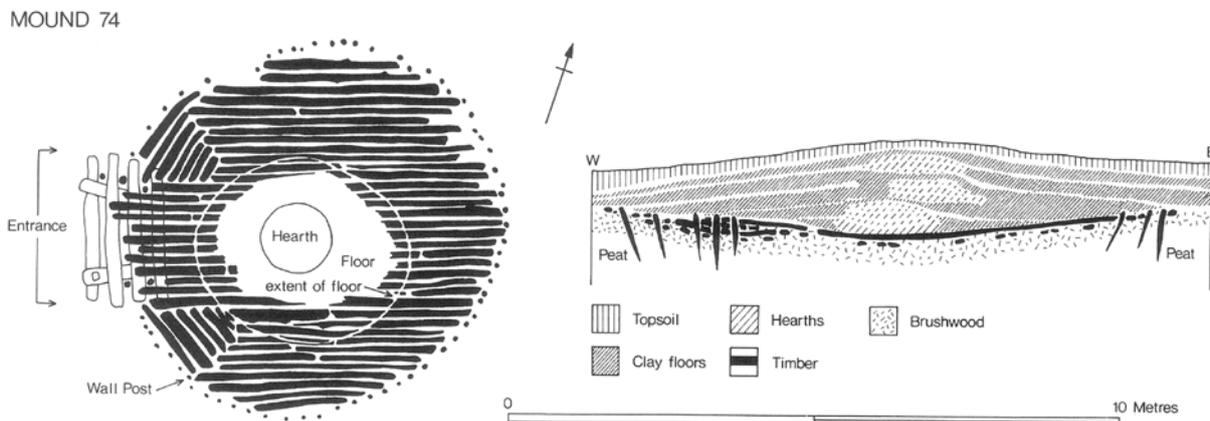
Fig. 14: Iron Age boarded floor in a Glastonbury Lake village roundhouse (Cunliffe 1991: 241).

cases) used in the British Iron Age cannot reasonably be denied: there is direct proof positive available in the results of the excavations of Glastonbury Lake village (Cunliffe 1991: 241; fig. 14). While the ones at Glastonbury admittedly were not floating floors, it also cannot be denied that floating floors were known and used at least in other parts of Iron Age Britain: after all, *brochs* (effectively, complex drystone-built tall roundhouses; Armit 2003) are partially still standing, with some showing clear evidence of upper storeys (including nice stone stairs leading up to them in the drystone-built walls). These upper storeys must have had floating floors, unless one wishes to assume that Iron Age Scots were actually floating people.

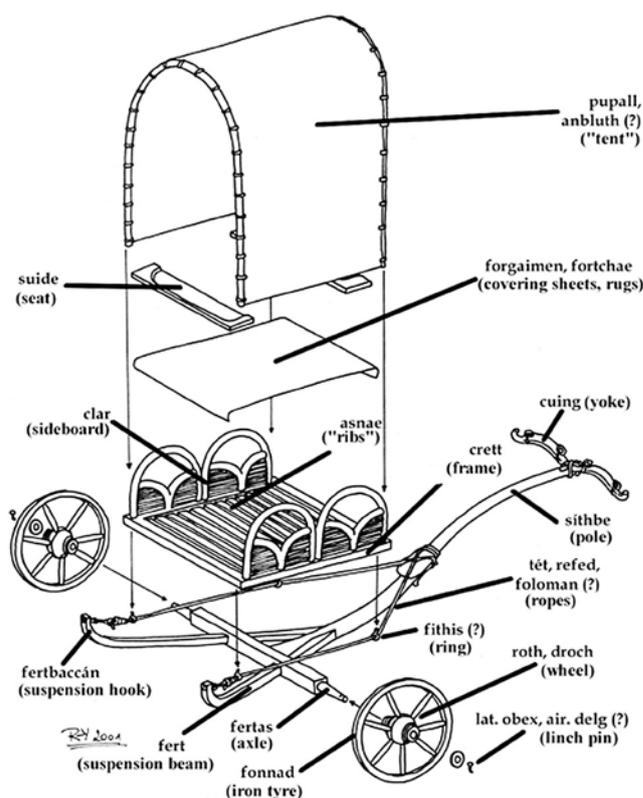
Fig. 16: A reconstruction of an Iron Age chariot, terminology based on Early Medieval Irish saga literature (Karl, Stifter 2013).

We do know a few bits and pieces though, which tell us about Iron Age woodworking skills, like that stave-built tankards were used, some covered in sheet metal with elaborately decorated handles like the *Trawsfynydd Tankard* (Lynch 2000 et al.: plate 12; fig. 15). We also know that Iron Age wheelwrights were able to shrink continuous iron tyres onto segmented or steam-bent spoked wooden wheels; and that Iron Age ‘carts’ (fig. 16) seem to have been rather elaborate constructions created

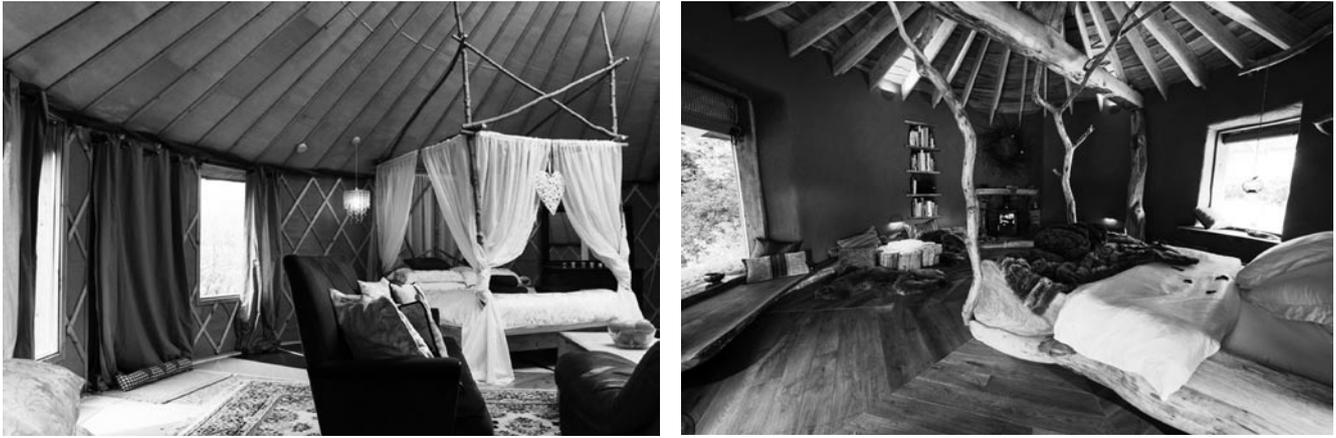
Fig. 17: 21st century AD ‘glamping’ roundhouses, Stratton-on-the-Fosse, Somerset (left, <http://glossy-glamping.co.uk/theroundhouse/#more> [13.1.2019]) and ‘Love in the Round’, Cornwall (right, https://www.canopyandstars.co.uk/britain/england/cornwall/love-in-the-round/love-in-the-round#search_type=keyword&search_text=& [13.1.2019]).

or the ‘Love in the Round’ ‘glamping’ house in Cornwall (fig. 17). Well, perhaps, unless you were happened to be married to the fat, lazy head of the household, who, when slouching on his comfy sofa listening to the latest bard who had happened to pop by couldn’t be bothered to move his butt and shouted, for the umpteenth time that evening: “*Honey, fetch me a cool beer from the fridge, will ya?!? ... Burp.*”.
