River sediment geochemistry and provenance following the Mount Polley mine tailings spill, Canada: the role of hydraulic sorting and sediment dilution processes in contaminant dispersal and remediation

Applied Geochemistry

Published: 01/11/2021

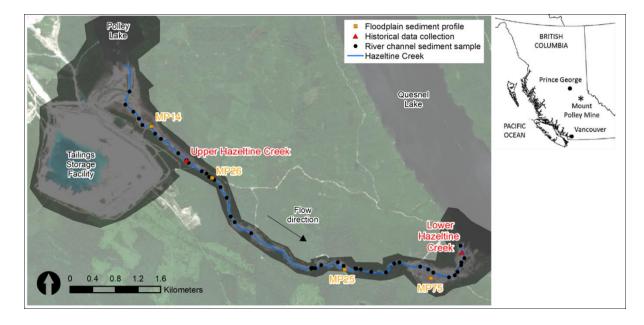
- 130
- Figure 1. Map showing the study area including the location the Mount Polley TSF and sample sites
 used for the collection of river channel sediment and floodplain sediment and the location of longer term sampling in Hazeltine Creek.
- 134
- 135

- 120 The deposit is located approximately 55 km north-east of Williams Lake, British Columbia, within the
- 121 112 km² Hazeltine Creek catchment (Figure 1). Hazeltine Creek is a tributary catchment within the
- 122 larger Quesnel River Catchment, and flows for 10.3 km from the southern end of Polley Lake at 920
- 123 m asl, into Quesnel Lake at 730 m asl (Burge and Cuervo, 2015).
- 124 Mining began at Mount Polley Mine in 1997 and 95 M tonnes of ore were processed between the
- 125 commencement of mining and 2014, producing 94.2 M tonnes of tailings in the same period
- 126 (Kennedy and Day, 2015). Concentrations of most metals within the tailings are relatively low, but
- 127 the material is relatively enriched in Cu and V (86-296 and 8-55 mg kg⁻¹, respectively) (Kennedy and
- 128 Day, 2015).
- 129

342 are shown in Figure 1. Concentrations of metals and As within river channel sediments indicate that 343 Cu and V showed the largest enhancement compared to pre-spill levels in Hazeltine Creek . For 344 example, maximum post-spill Cu concentrations are 17 and 19 times more enriched in the upper and 345 lower Hazeltine Creek, respectively. In comparison, the maximum enrichment for As (2.3 times), Pb (2 times) and Zn (1.2 times) are much lower. The concentrations measured in samples collected in 346 347 2014 and 2015 indicate that the upper reaches of Hazeltine Creek were more affected by the spill. Concentrations of Cu reduced from 952 to 512 mg kg-1 at the upper site (Figure 5), but 348 349 concentrations at the lower site had reduced to 88 mg kg⁻¹ in 2015 compared to 556 mg kg⁻¹ in 2014 350 (Figure 5). The concentrations present in samples collected after the spill, and differences between 351 upper and lower Hazeltine Creek, reflect, at least in part, the influence of grain-size effects and 352 hydraulic sorting noted previously. However, these patterns are also to likely reflect the spatially-353 variable nature of post-spill remediation works. For example, in the lower part of Hazeltine Creek 354 (upstream of the lower Hazeltine Creek sample site), it potentially reflects the influence of settling 355 ponds, constructed. Copper concentrations in the lower Hazeltine Creek sample site (downstream of the settling pond) in 2015, were 89 % (silt-rich sediment) and 84 % (sand-rich sediment) lower 356 357 than those measured at the same location in 2014, after the spill but prior to the ponds' 358 construction (Figure 5).
